Giuseppe Cazzaniga, Liutaio.

Bernareggio, 28 Maggio 2009

## “Nicola Rossi 1844” Double Bass Restoration

The instrument is property of the “Conservatorio G. Verdi” of Milano

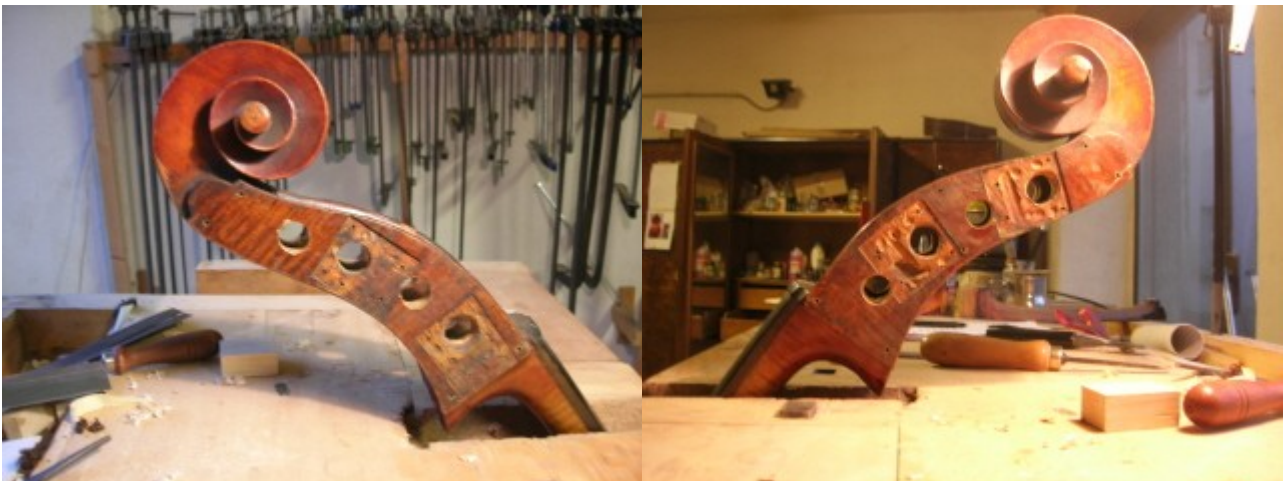
**Figura 25, Figura 26**

The mortise is almost perpendicular, and some plane tree pieces are glued in.

I take off the neck.

I will make a new neck graft to cut the heel at D, which is a condition now for playability.

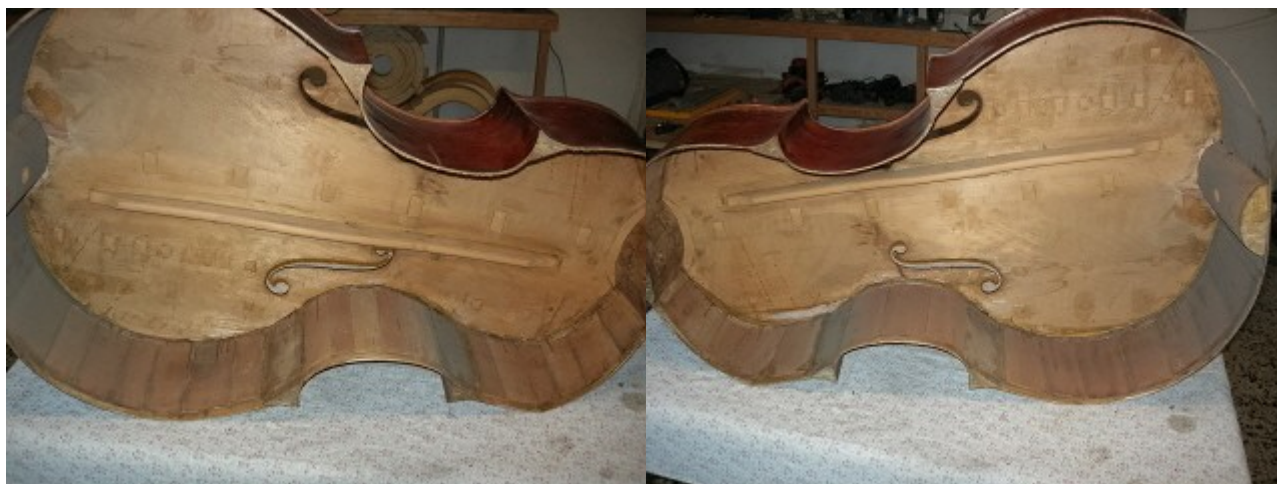
**Figura 29, Figura 30**

The ribs are completely doubled ( except under the linings) with perpendicular fiber spruce

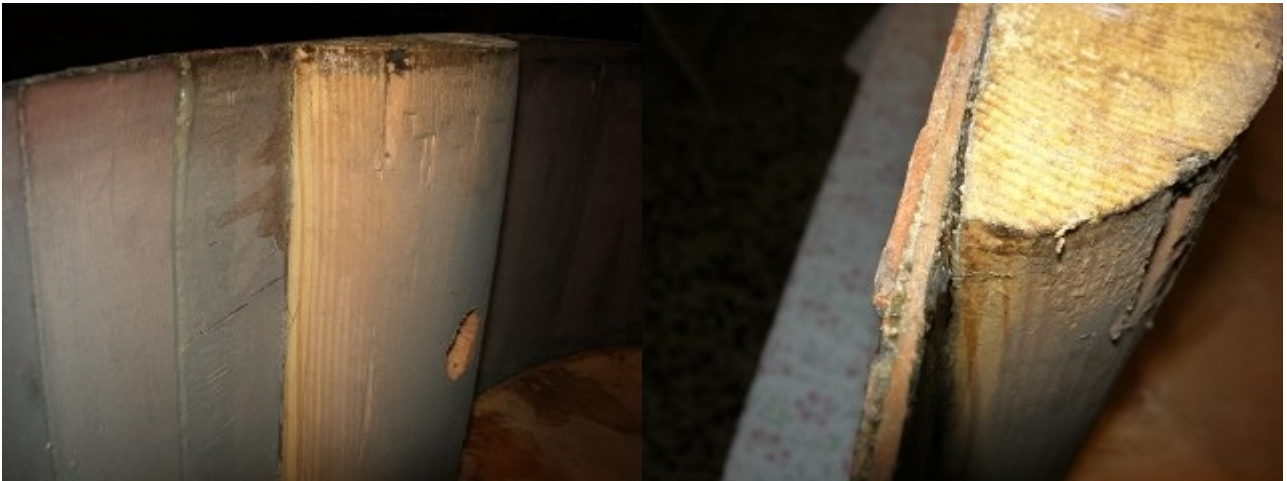
**Figura 32 , Figura 33**

The spruce block is probably not original.

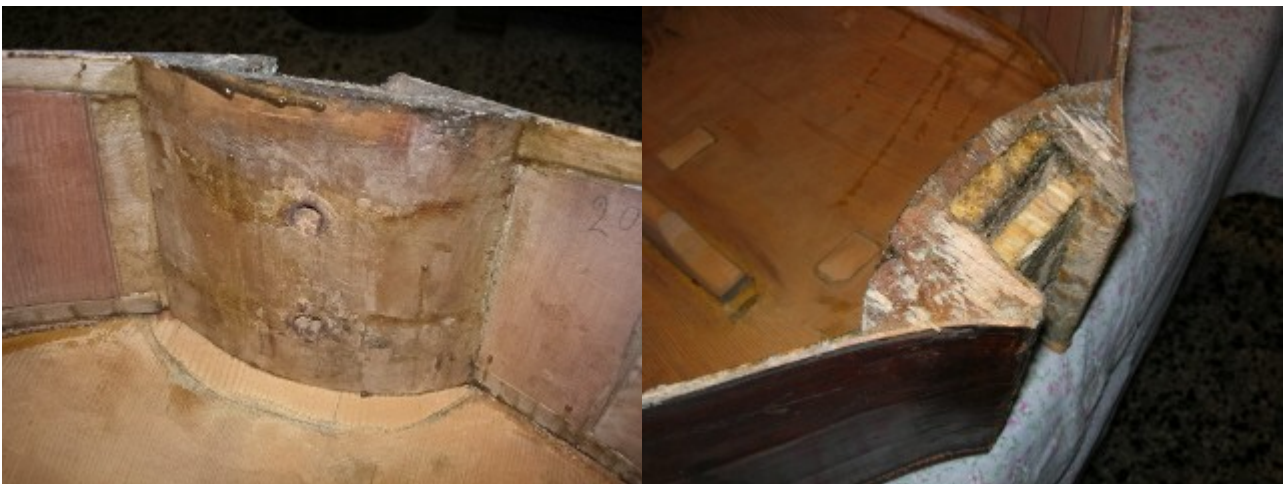
**Figura 34 , Figura 35**

The neck block was made with poplar, like the corner blocks, and shows two holes and two different wedges, probably to adjust the neck angle

My guess is that before the 1965 restoration another neck (original or not ) was screwed to the block to strengthen the joint.

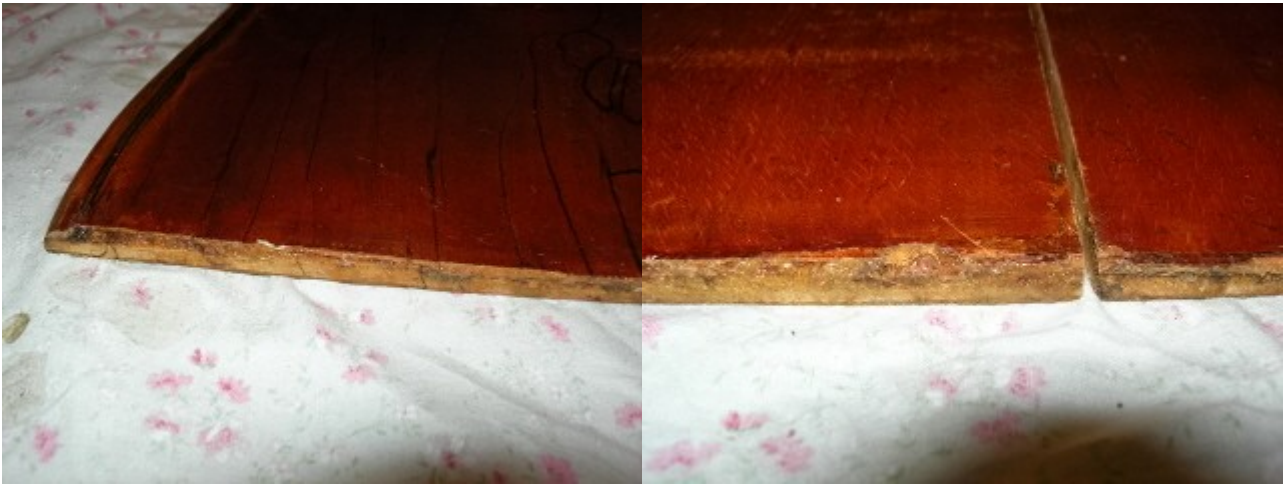
**Figura 41, Figura 42**

The broken bend was repaired with a poorly done replacement and with filler.

Firstly I repair separately the two parts of the back above and under the broken bend.

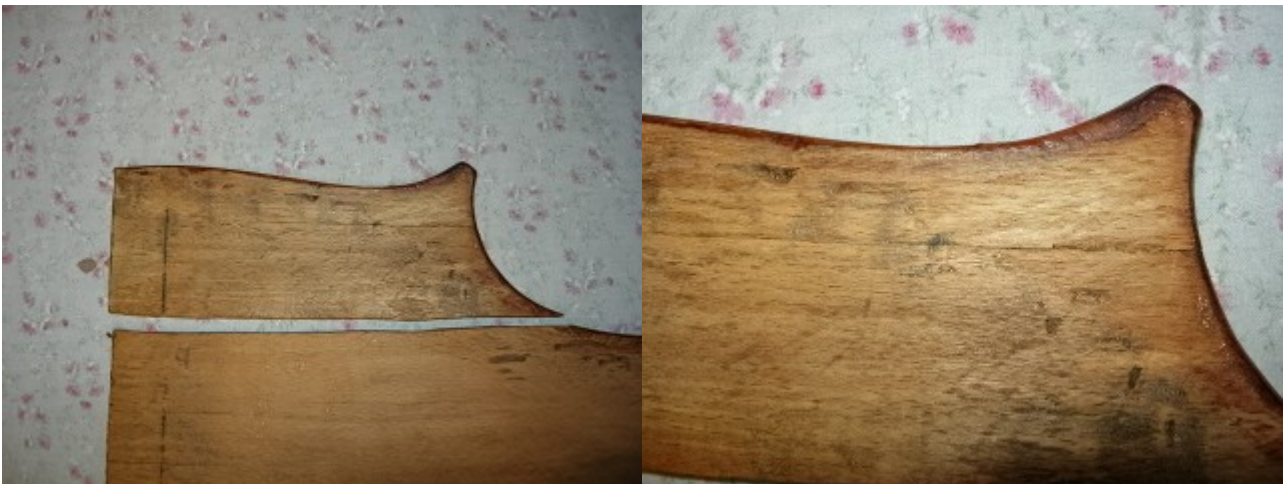
**Figura 43, Figura 44**

On the lower part the central joint, the two cracks near the G side upper corner,

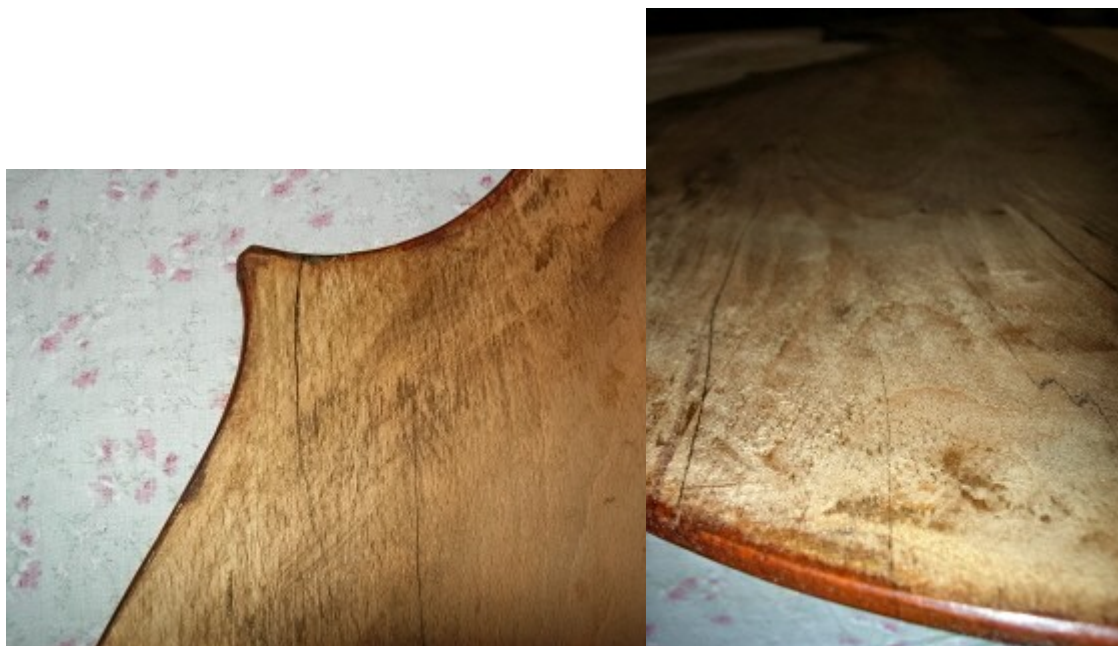
**Figura 45, Figura 46**

and, on the E side, the cracks at the lower corner, at the lower bout “slab” of the beechn, the knot near the upper corner

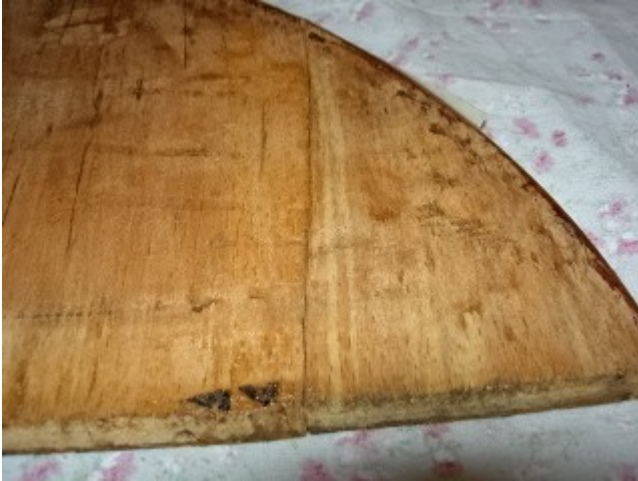
**Figura 48**

On the upper part, the crack at the G side,

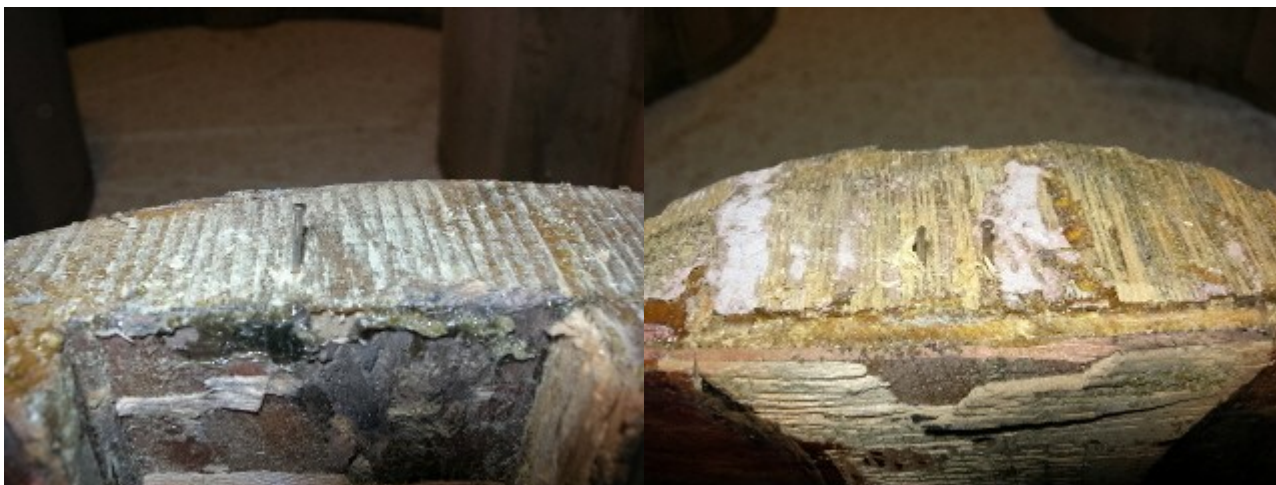
Figura 60, Figura 61

There are centring nails (!) at the upper and lower blocks

I remove the spruce doubling, gluing the blocks where needed.

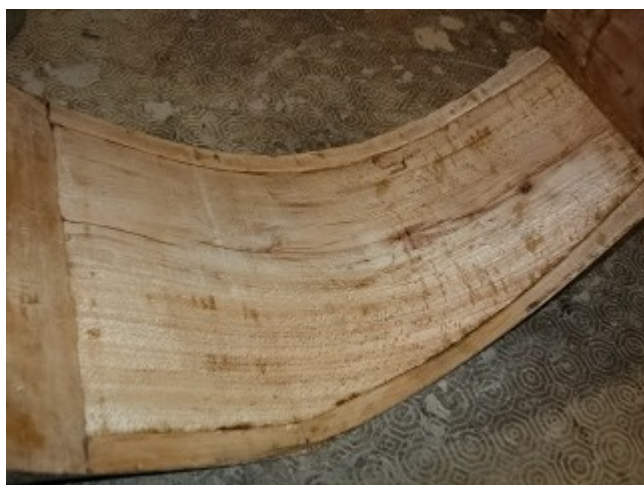
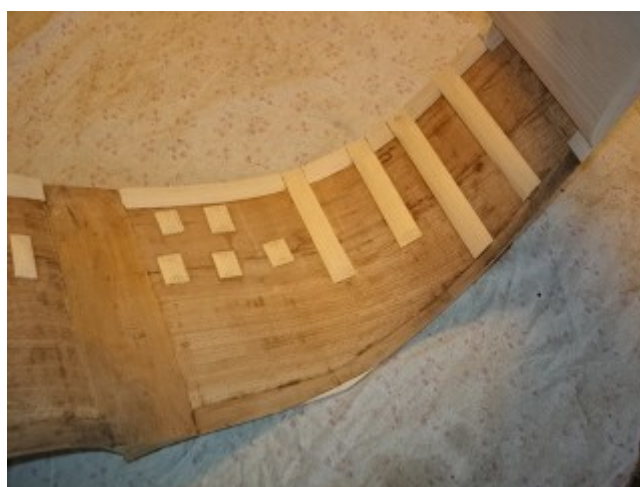
The E side upper rib has a long crack at the beech slab. There are also some small cracks and a xilofages attack near the front gluing joint. The related lining has to be replaced to repair the rib, while the back one has a lack near the bend.

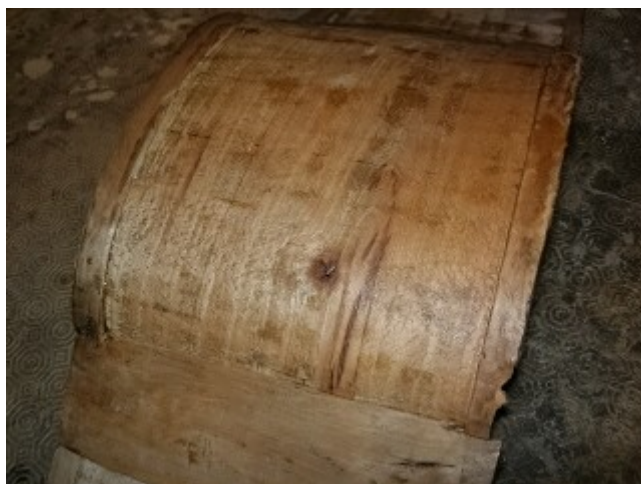
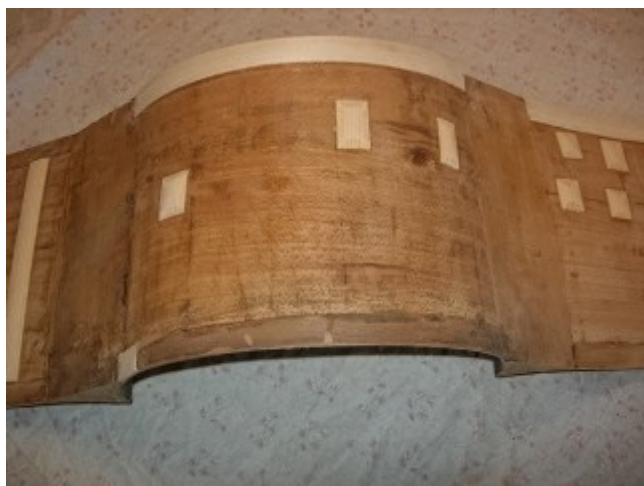
The E side C rib has a crack at the beech slab and a woodworm lack near the upper corner. Here too the front lining, partially worm eaten, has to be replaced.

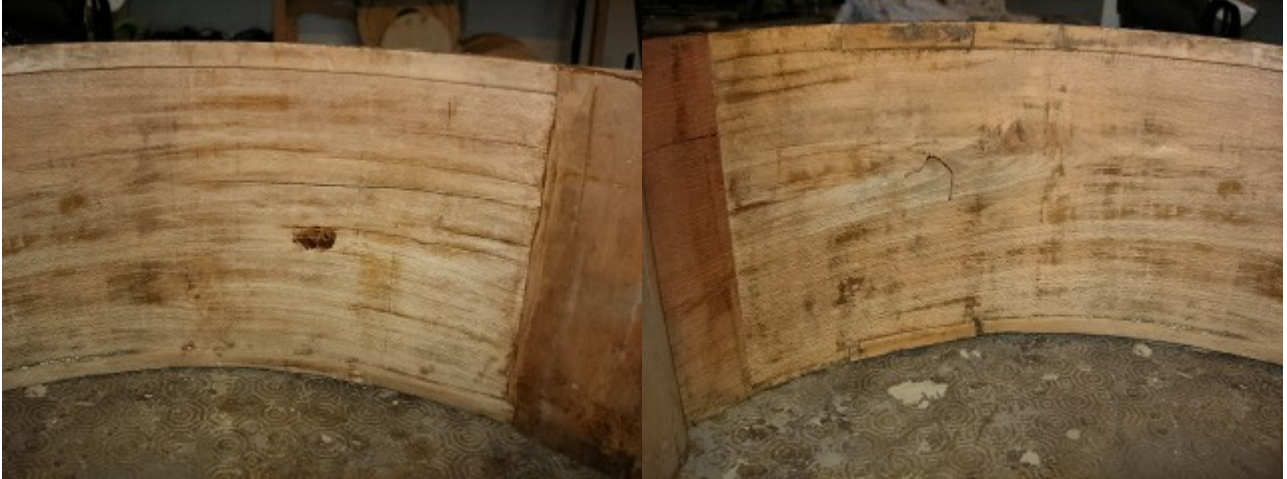
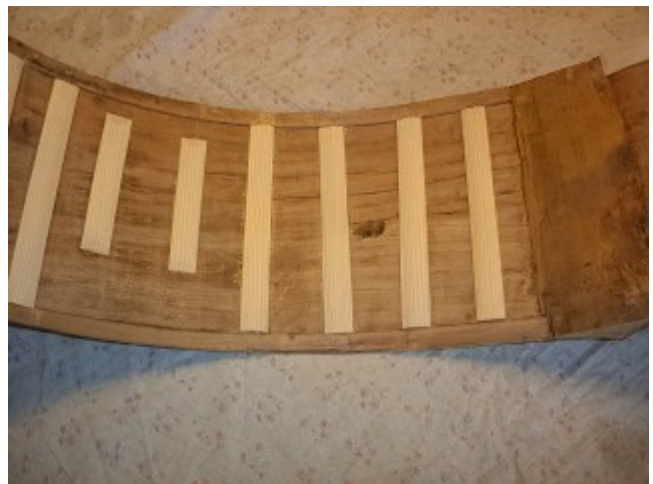
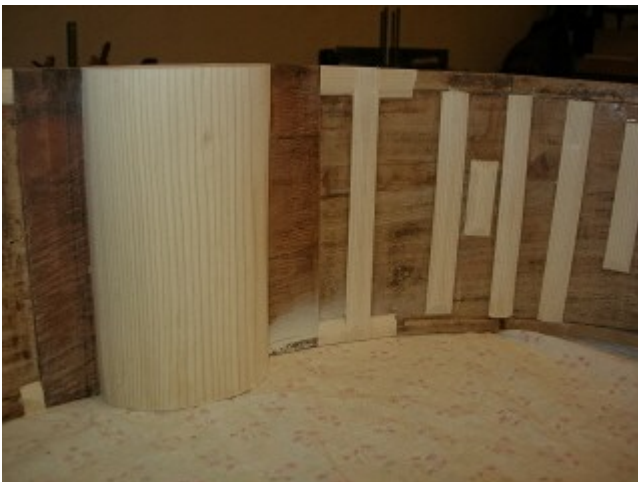
The E side lower rib has two series of cracks, near the corner block and near the lower block, while elsewhere it is in better conditions. I see a xilofages attack near the lower block too.

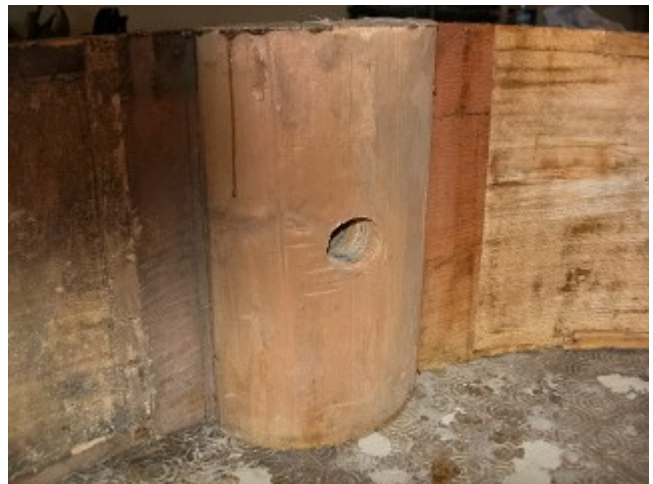
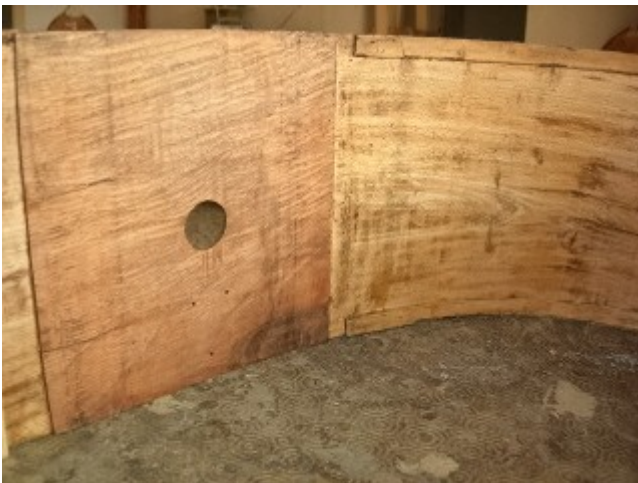
At the lower block a rib sector was replaced, and the joint reinforced with a walnut doubling.

It is strong enough, so I leave it to avoid damages during the removal. I replaced the block, not original, poorly done and partially unglued.

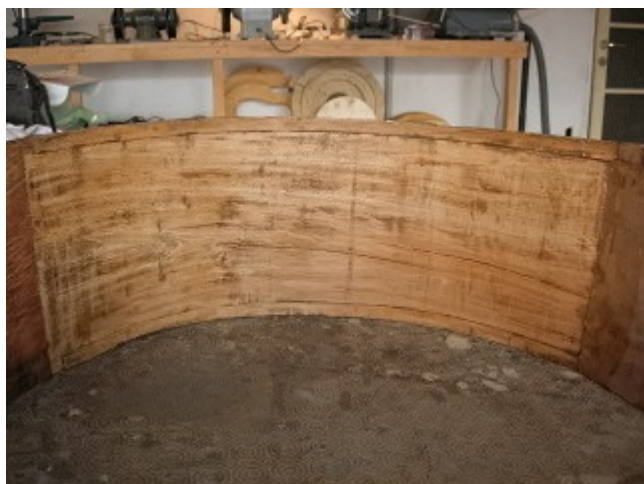
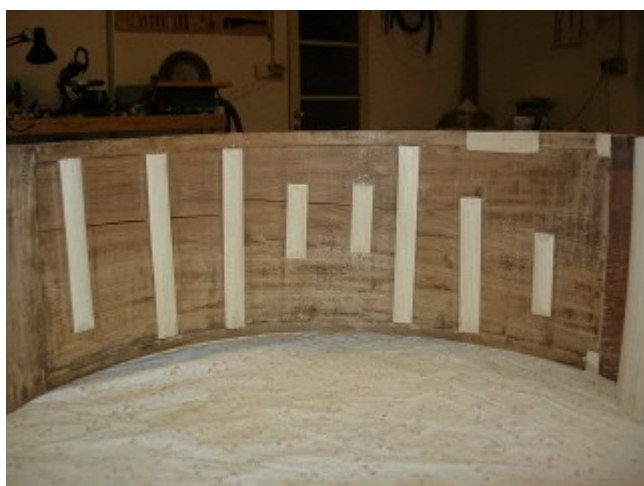
The G side lower rib has three long cracks along the beech slab, and some smaller ones towards the front joint.

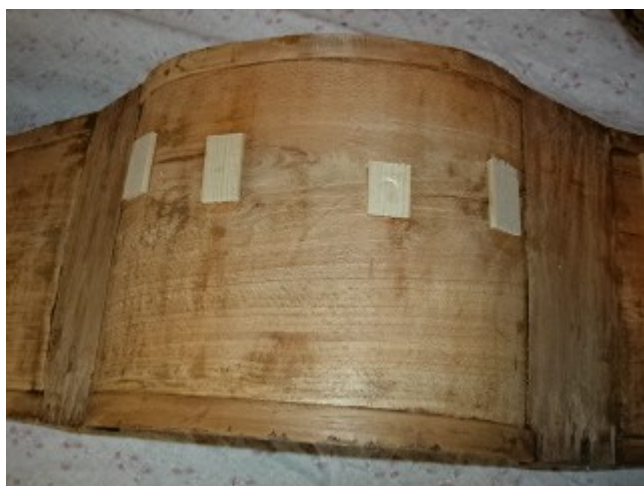
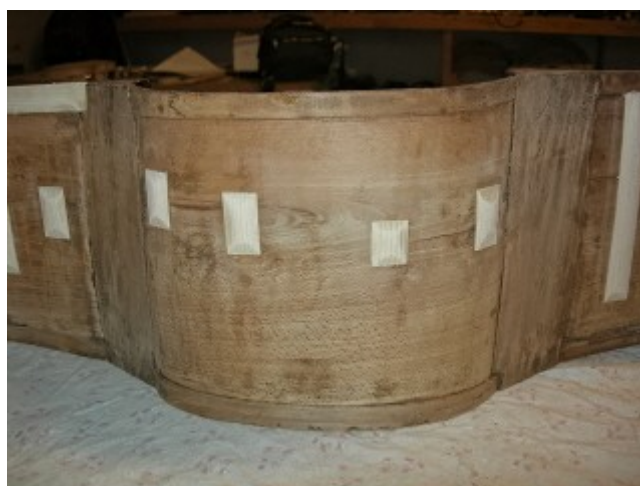
The G side C rib has two cracks at the beech slab.

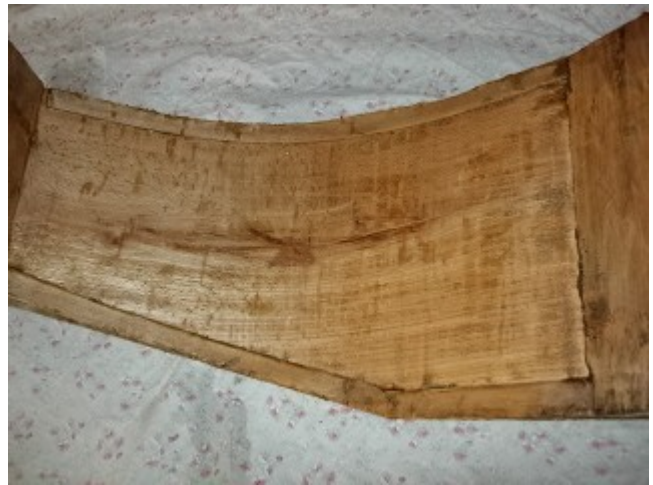
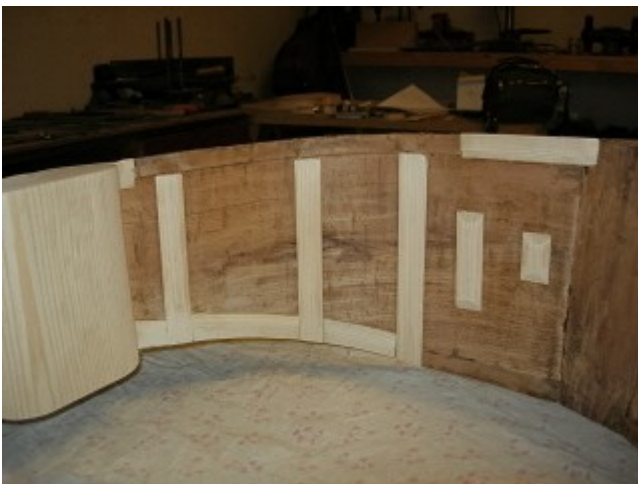
The G side upper rib has a long crack at the beech slab and some smaller ones near it.

There is a crack near the neck block too, where the rib is partially unglued. The back lining has a lack near the bend, where the rib is cracked and deformed.

Between the bend and the block I replace the lining to repair the crack and correct the deformation. The neck block is fragile for the two holes, the wedges and the deep mortise. I replace it too

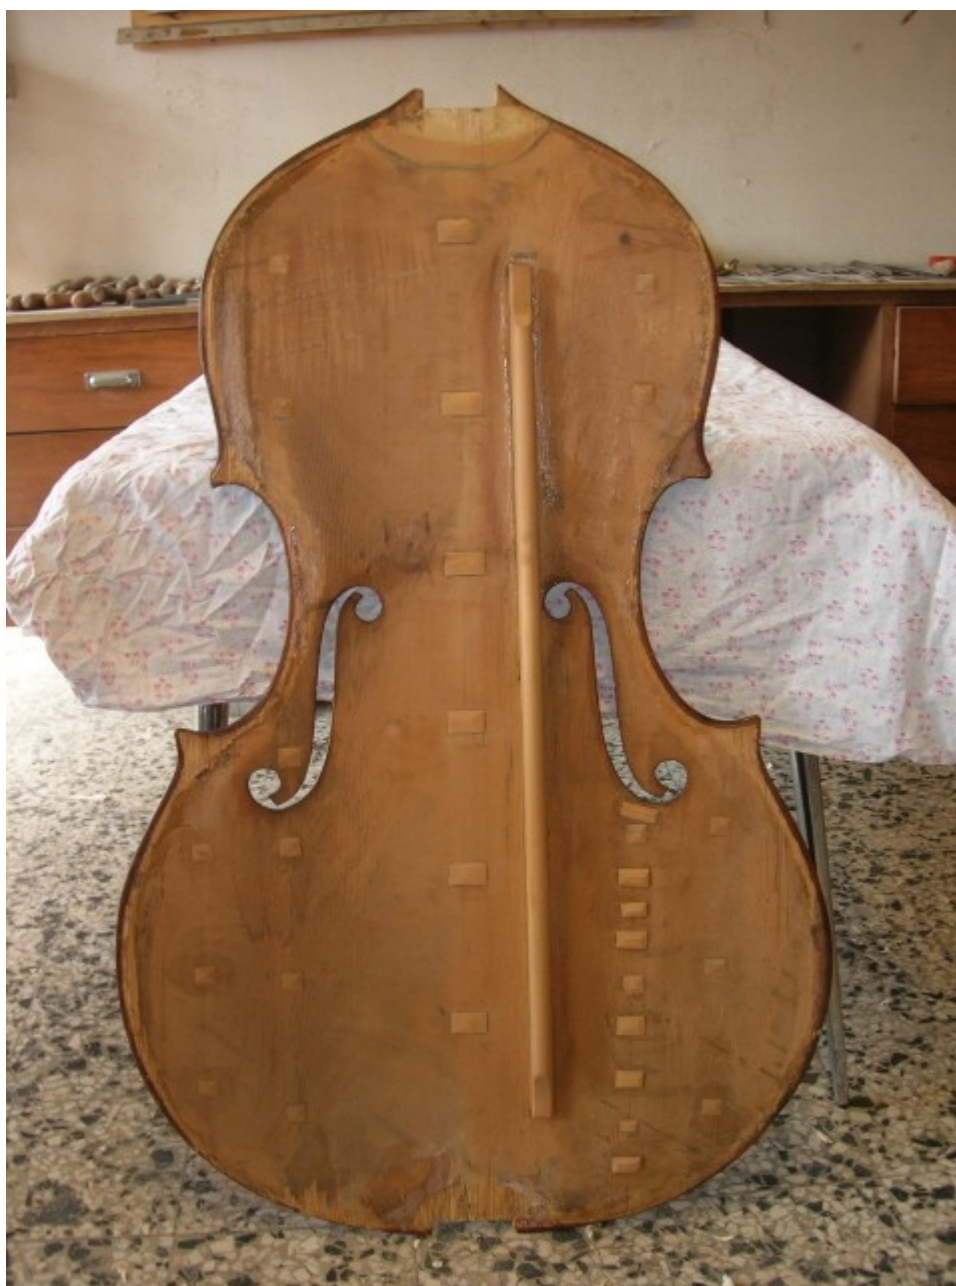
**Figura 85**

There is no soundpost crack; the joints are well glued, except the one from the E side F hole to the lower edge; there is a small crack near the neck block, G side, and similar others at the lower block.

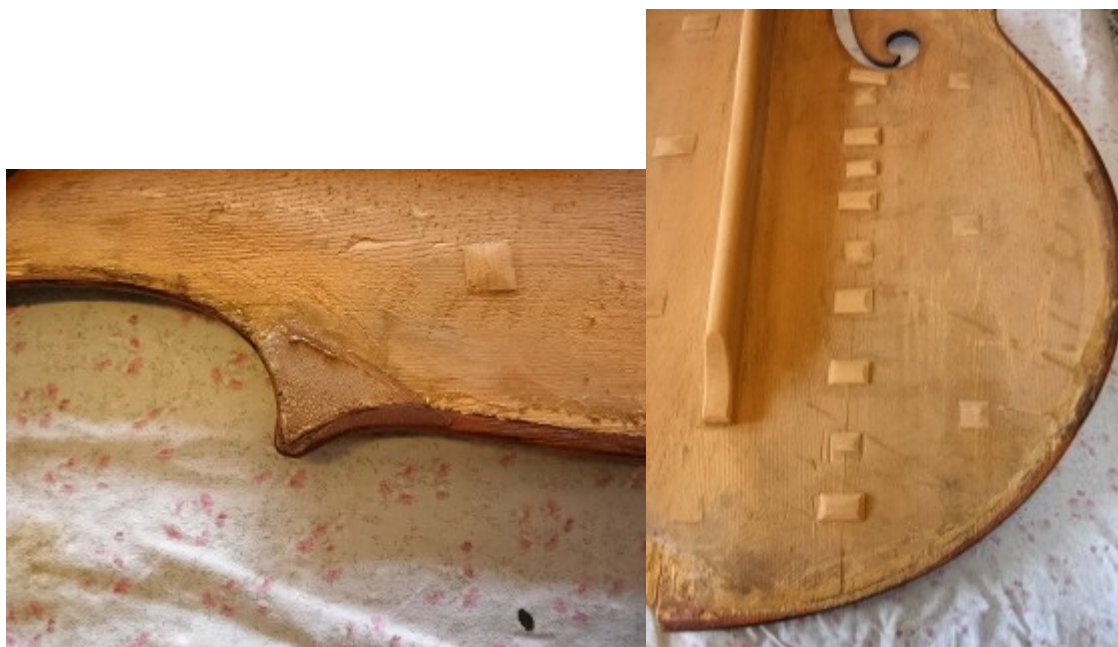
**Figura 87, Figura 88**

walnut at the E side upper corner and lower maximum width;

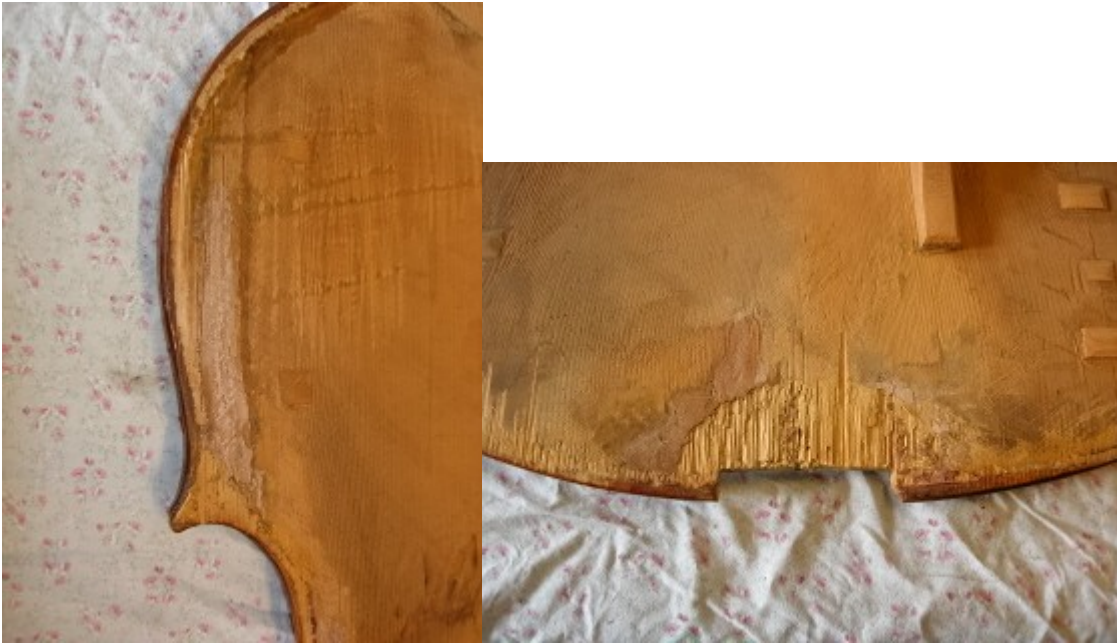
**Figura 89, Figura 90**

filler (!) at the G side upper corner and at the lower block joint.

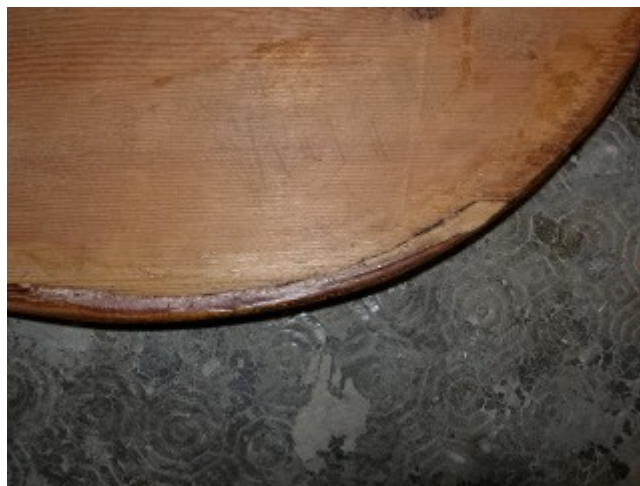
**Figura 91**

The E side shoulder has an undoubled replacement of the edge.

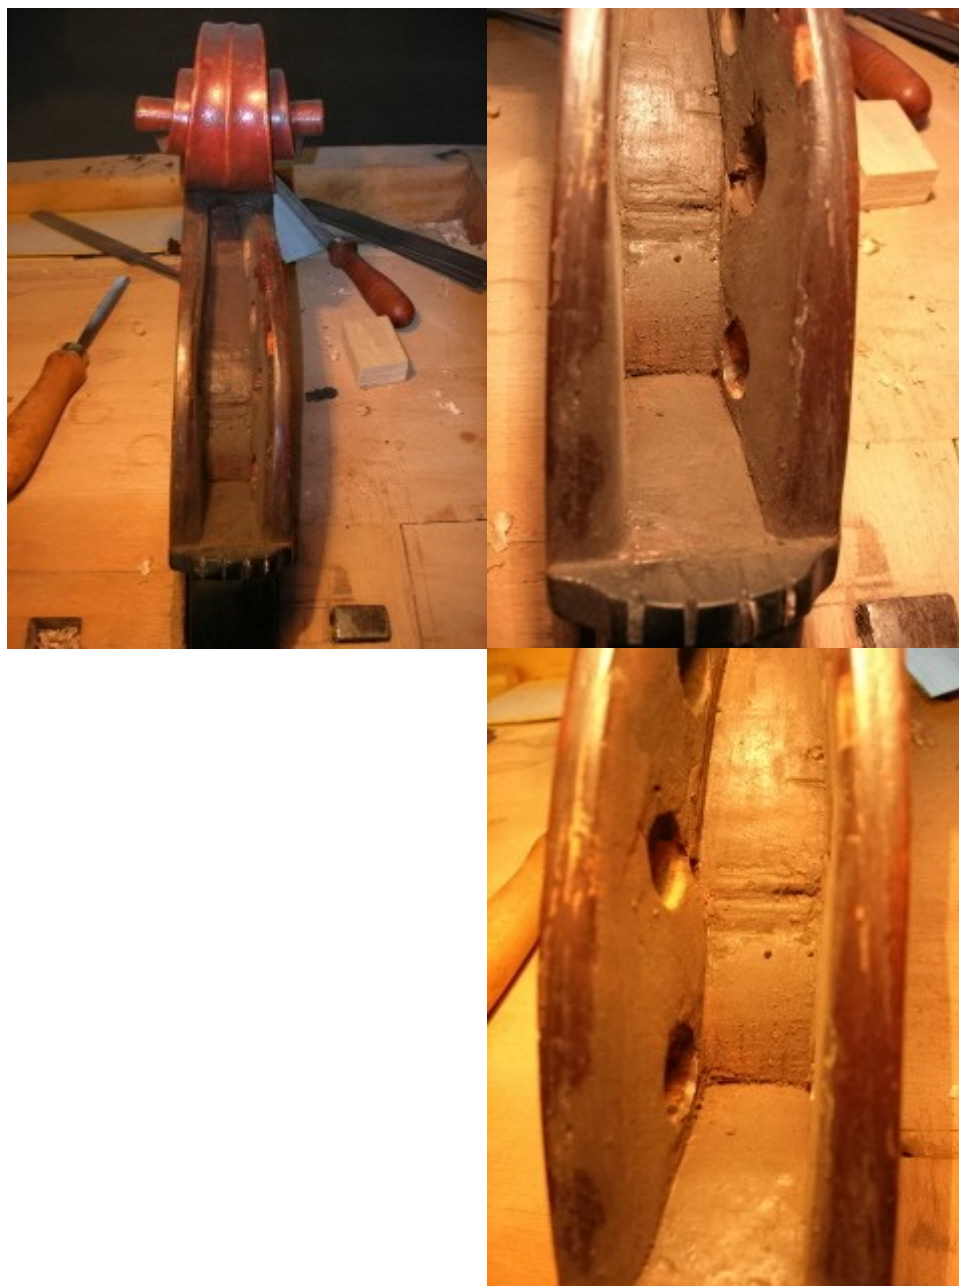
Figura 107, Figura 108, Figura 109

As said, the instrument has an Eb neck graft.

The graft is partly unglued and finished with filler.

I make a new D neck graft for playability and for the previous poor woodwork..
