Giuseppe Cazzaniga, Liutaio

Restoration of a Brescian style double bass

The instrument is property of Maestro Ezio Pederzani

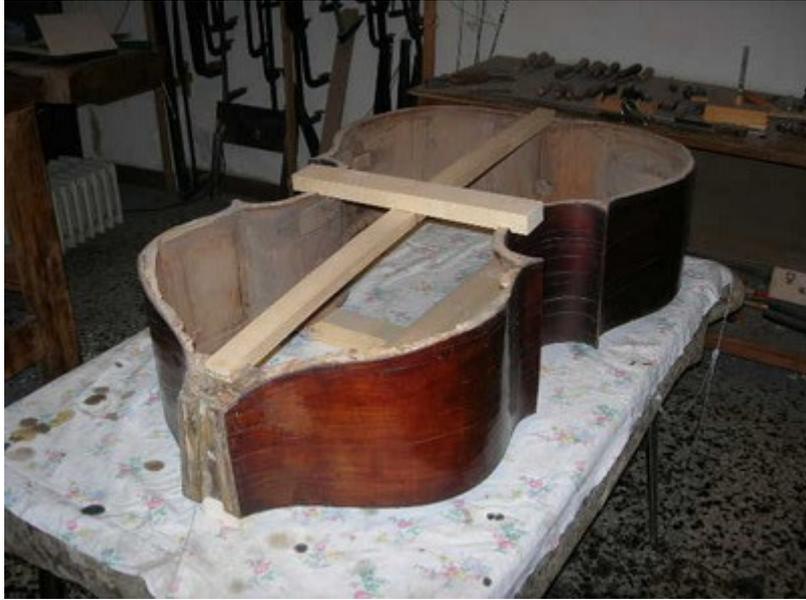
The ribs are made in cherry wood, and have an average thickness of 2 millimetres; cracks are present all over.

Old restorations, which are very heavy, are made in spruce, linden, and ash.

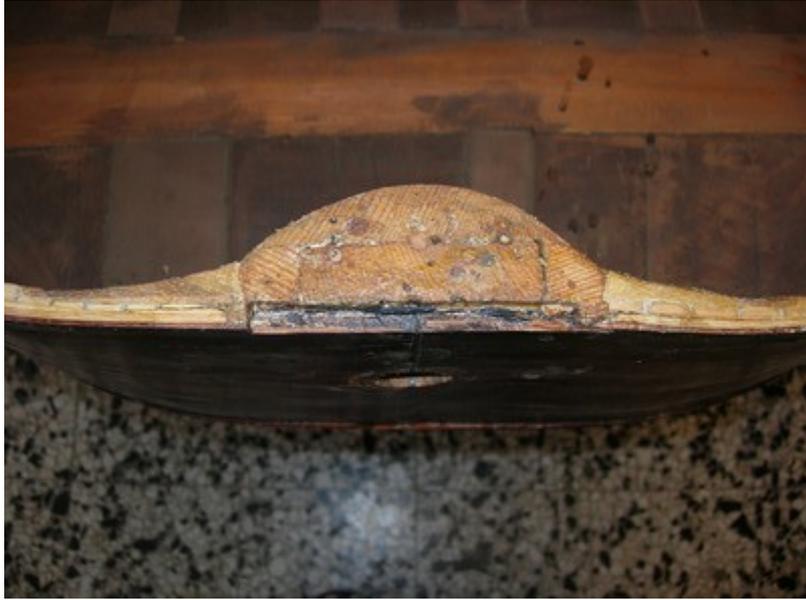
The upper rib on the E side has been repaired with three large ash doublings with transversal fiber, and some splints.

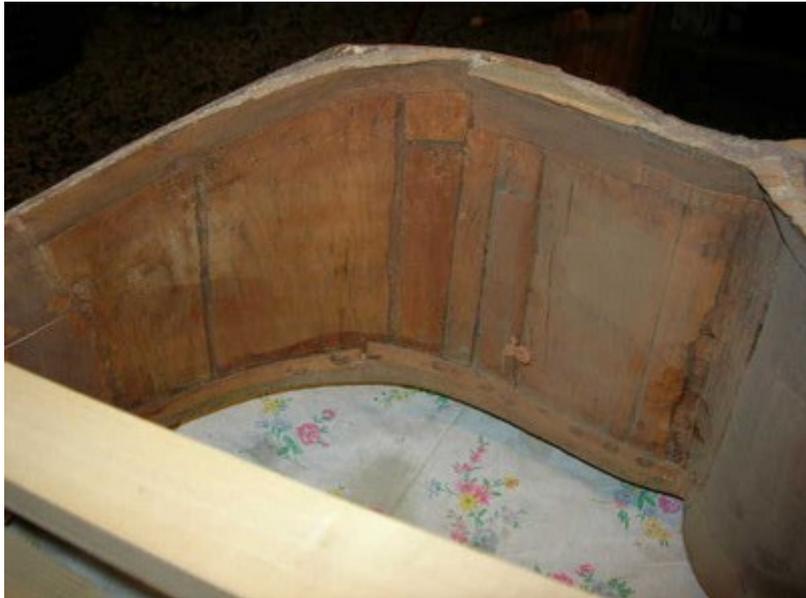
The rib shows a large number of cracks on the entire surface, and worm damages on the back side between the corner and the middle, which have been filled.

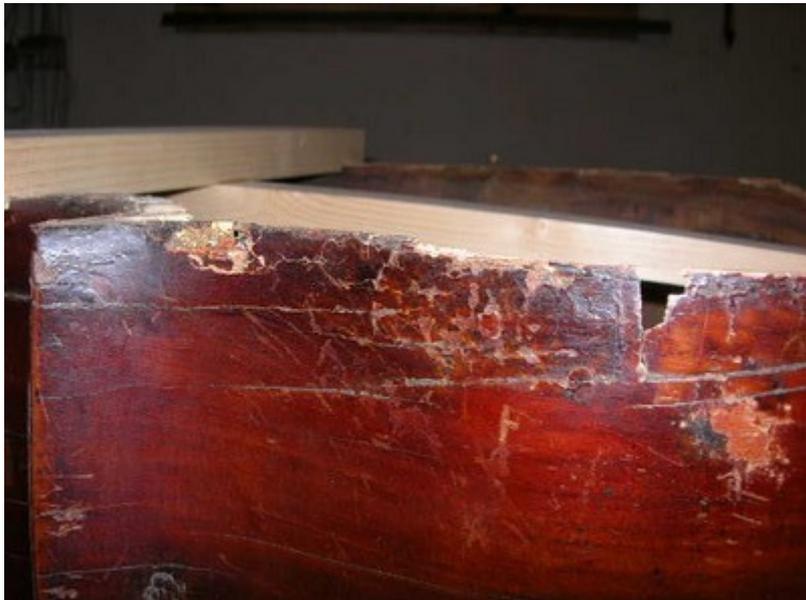
The average thickness of the rib is 2 millimetres, but drops to 1,2 near the maximum upper width of the body

I clean the rib of all the restorations and take the linings off. I then glue a set of 1,7 millimetres thick poplar splints.

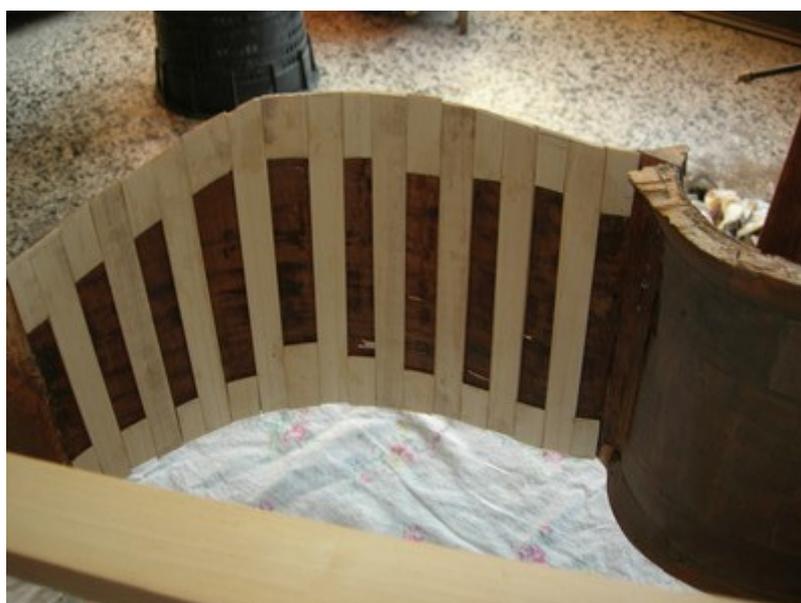
The upper rib of the G side shows many cracks as well, repaired with a large ash doubling and other small ones, with transversal fiber.

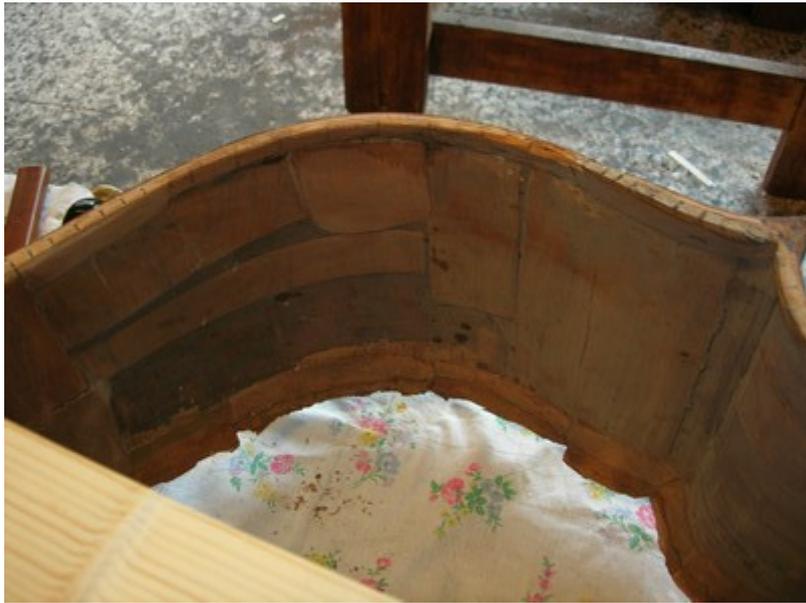
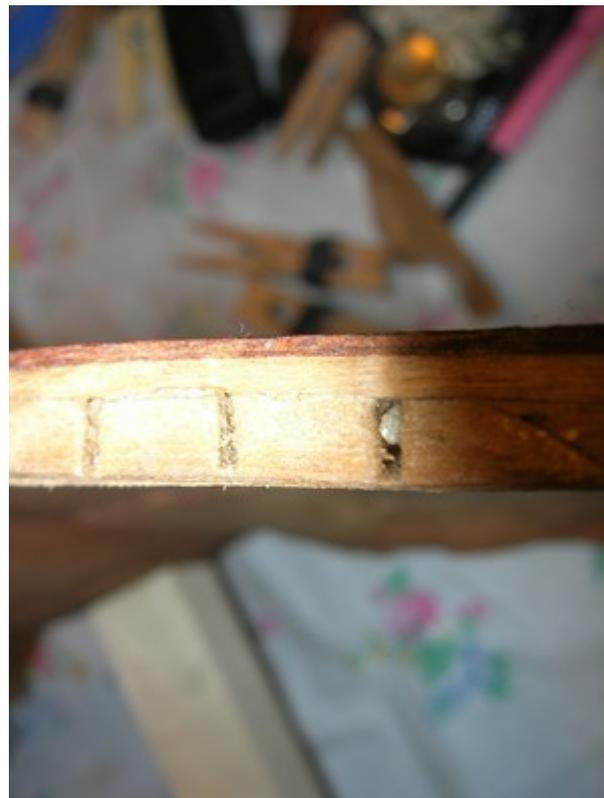
The lining on the belly side, in linden wood, is cut and bent. This overlaps a second one, maybe in poplar.

I remove all repairs and linings from the rib.

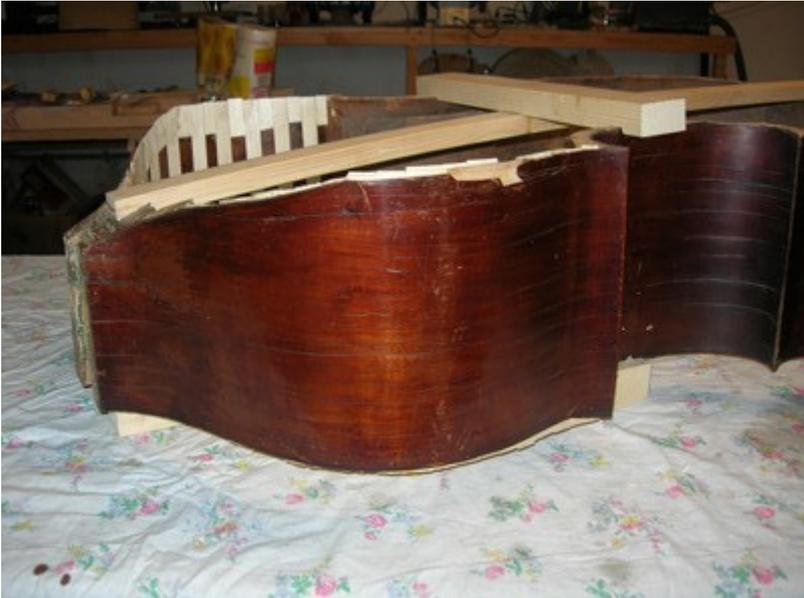
The lower rib on the E side shows cracks on the entire surface, repaired with ash doublings, that cover the whole rib towards the lower block.

There are three spruce splints as well, two of them covering the ash doubling.

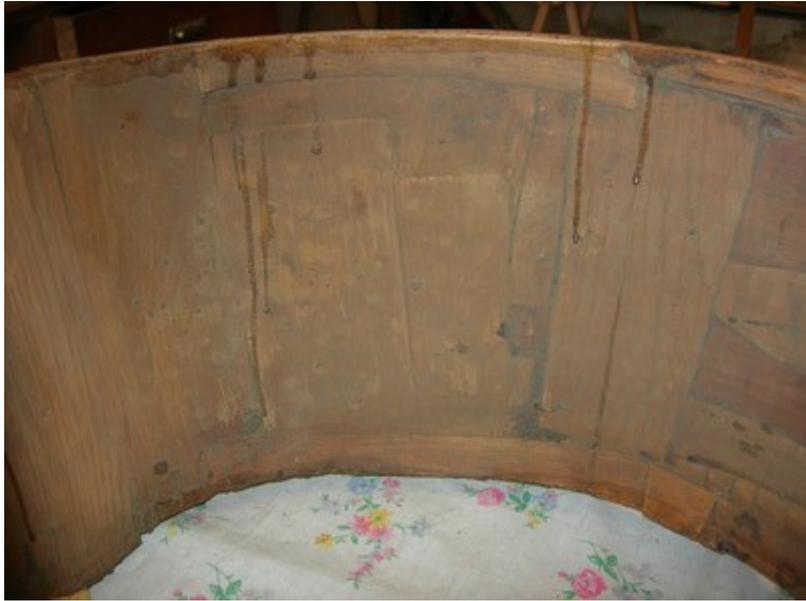
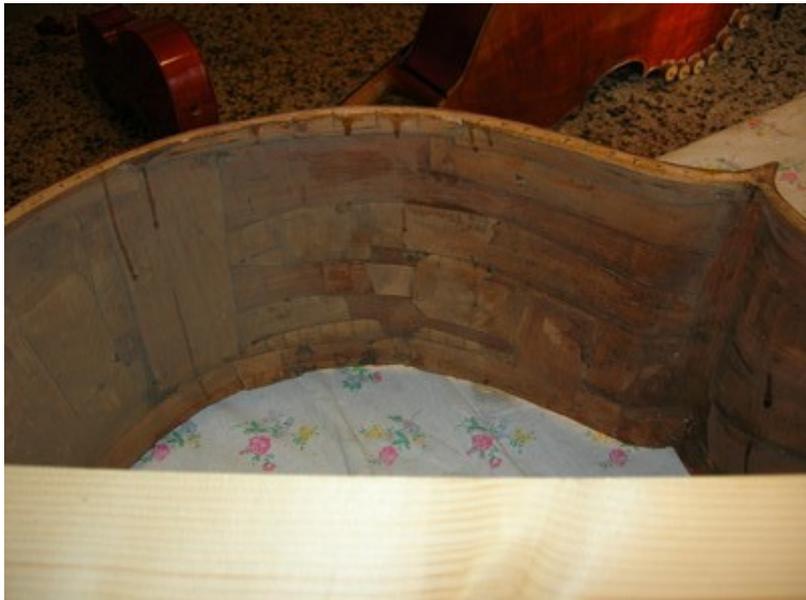
The linden wood lining on the belly side is cut and bent, and covers a second one with continuous fiber.

The one on the back side shows reinforcements cut to shape.

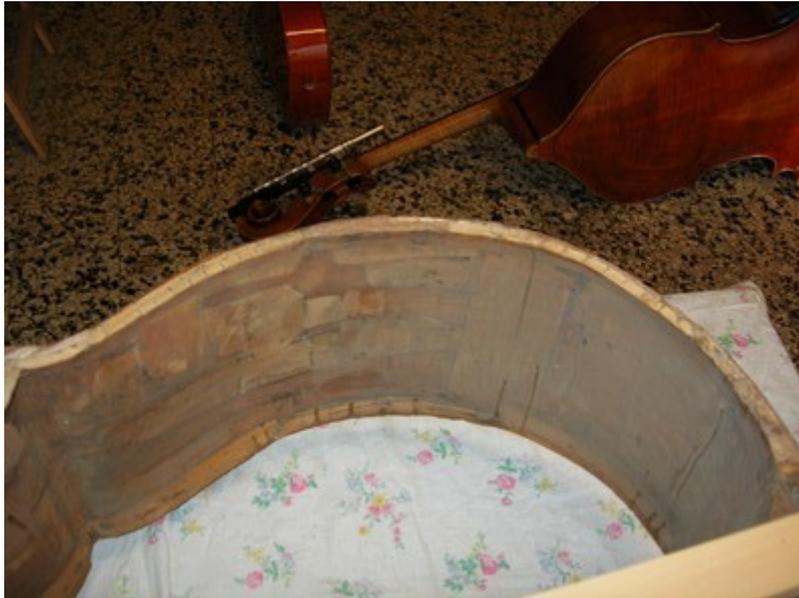
The lower corner on the back side has been replaced.

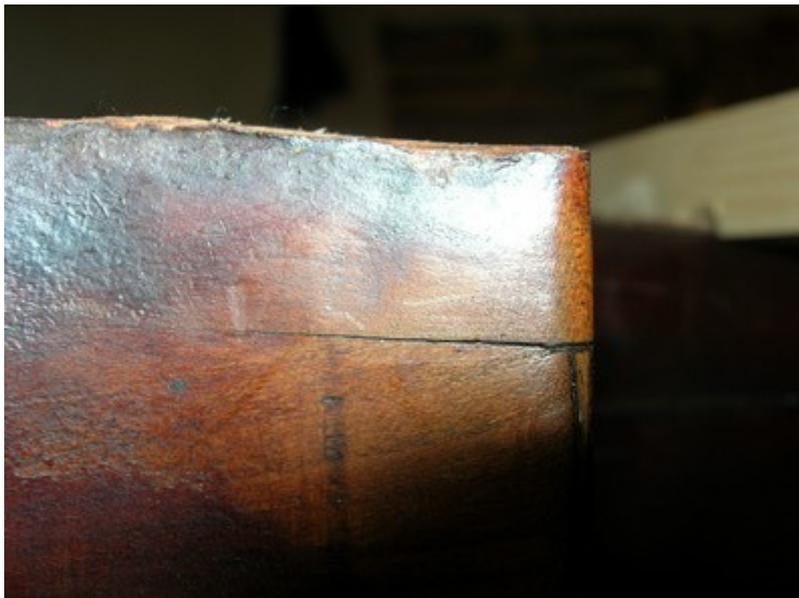
There is a small replacement in the center of the rib as well.

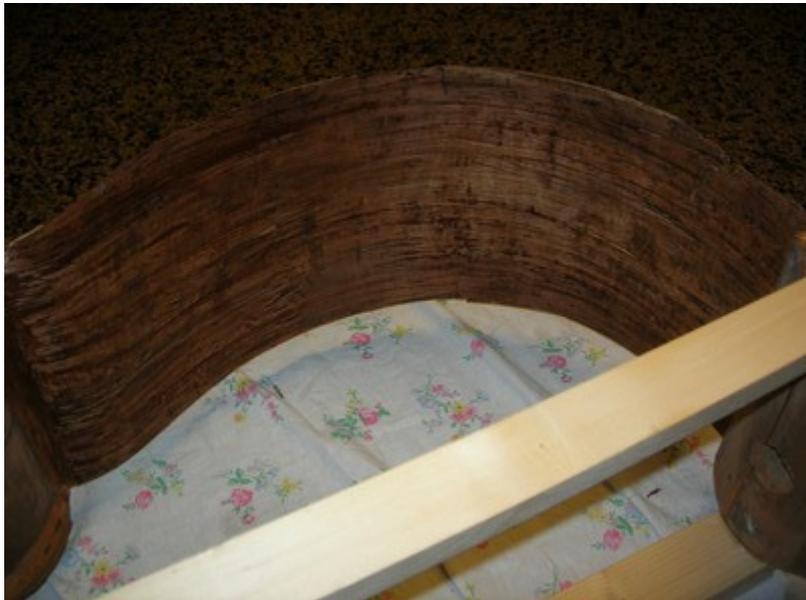
The average thickness is 2 millimetres (1,8 - 2,1 millimetres)

During the cleaning process two missing parts can be seen along the glueing surface on the back side, at the lower block and towards the corner.

The missing parts were filled with wood and filler.

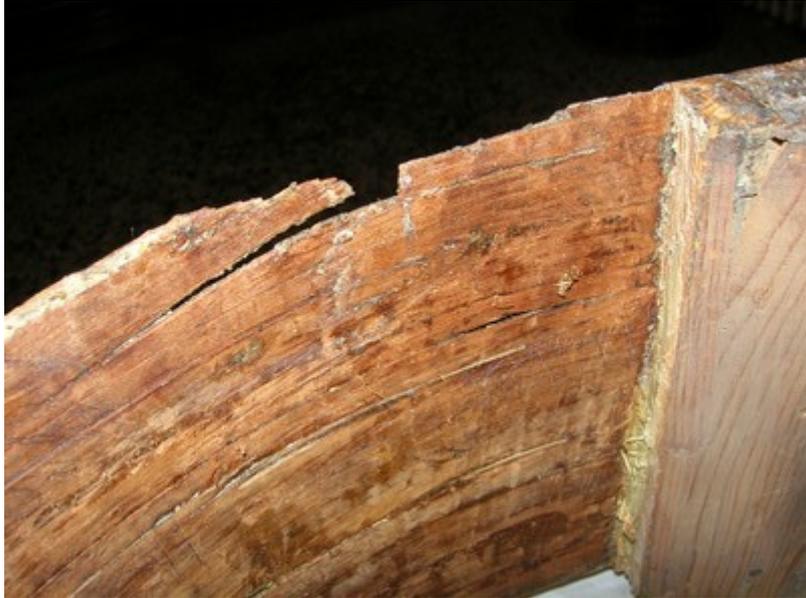
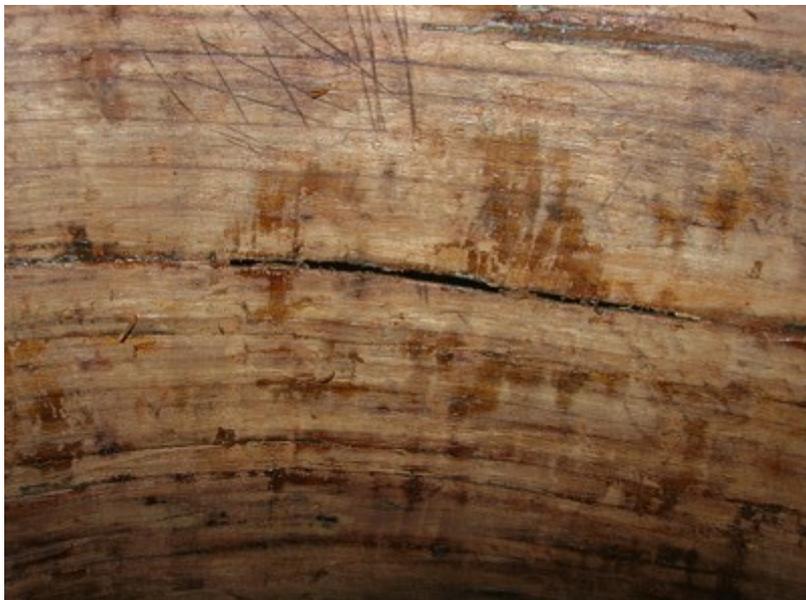
The glueing surface between ribs and back has been lowered, probably during the replacement of the lower edge of the back.

In order to rebuild the missing section, I glue a set of poplar splints longer than the current height of the rib.

I then glue the doublings between the splints.

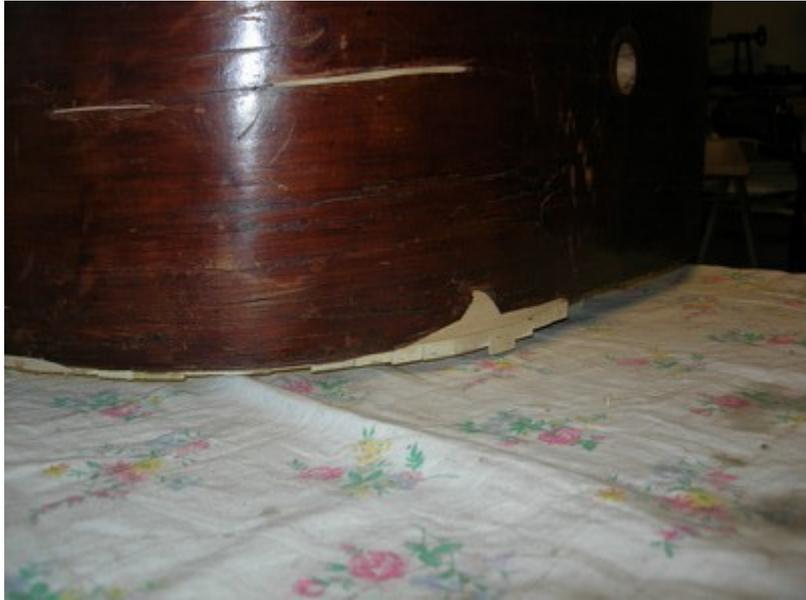
The lower rib on the G side shows many cracks, repaired with ash doublings and with three large splints of linden wood.

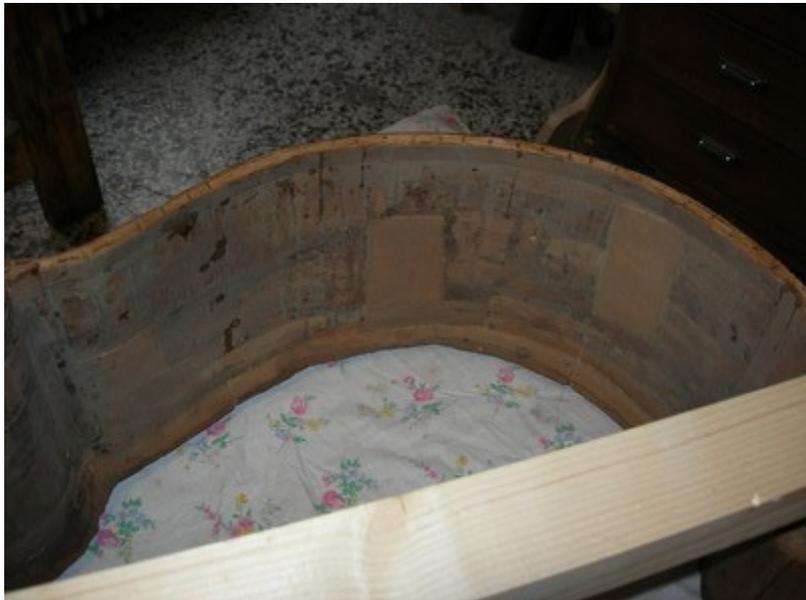
Here too, the linings on both the back and front side are cut and bent, and are covering another set of linings with continuous fiber; on the back side the lining is partially cut to shape.

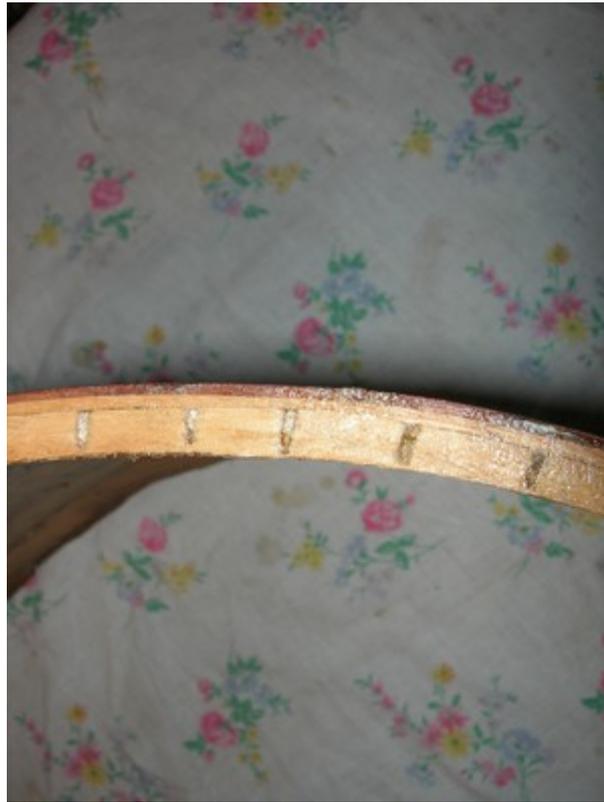
A part of the rib on the back side is missing and filled with putty.

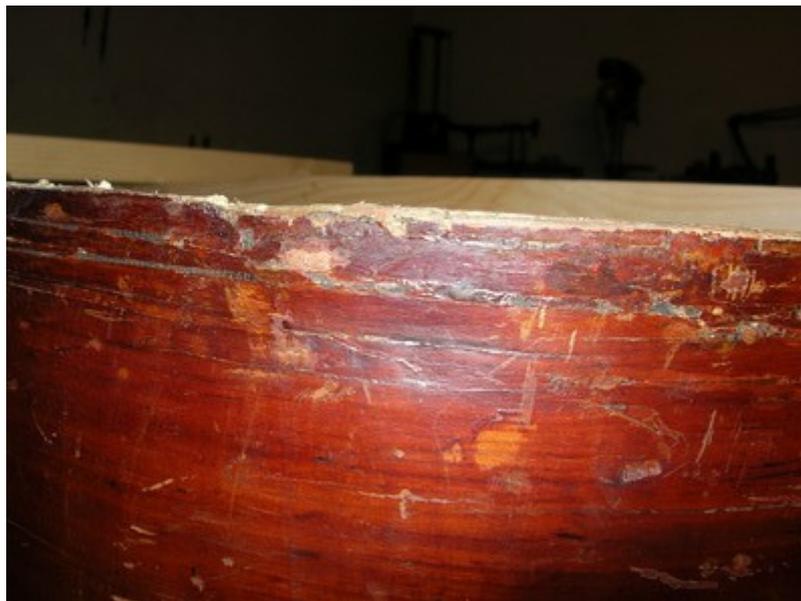
The glueing surface of the back to the ribs next to the lower block has been lowered.
Once the rib is cleaned, I make the poplar splints higher than the rib, to rebuild the missing part.

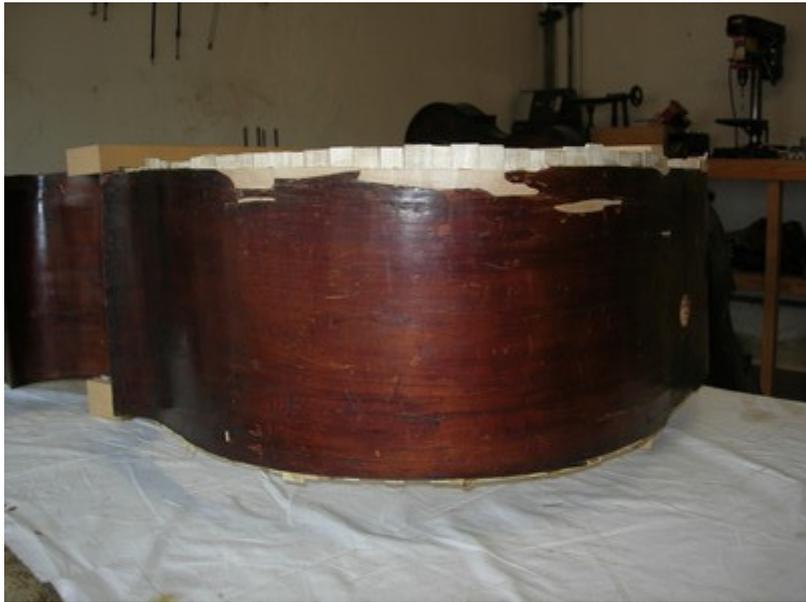
The upper block might be partially original. It is currently made of four different layers of wood, two side grafts, wedges and fillings.

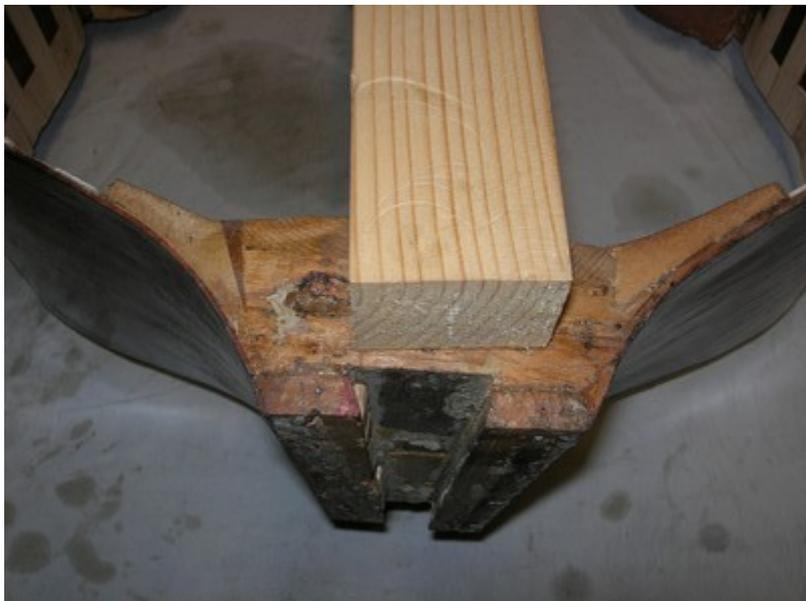
The external layer is screwed to the inner ones, and is not original. It is made of walnut, and forms the cheeks of the dovetail neck fitting.

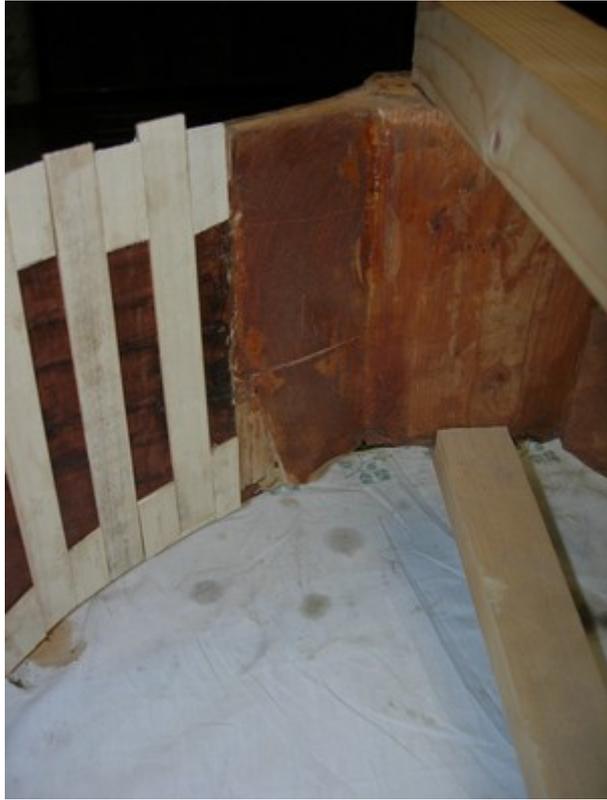
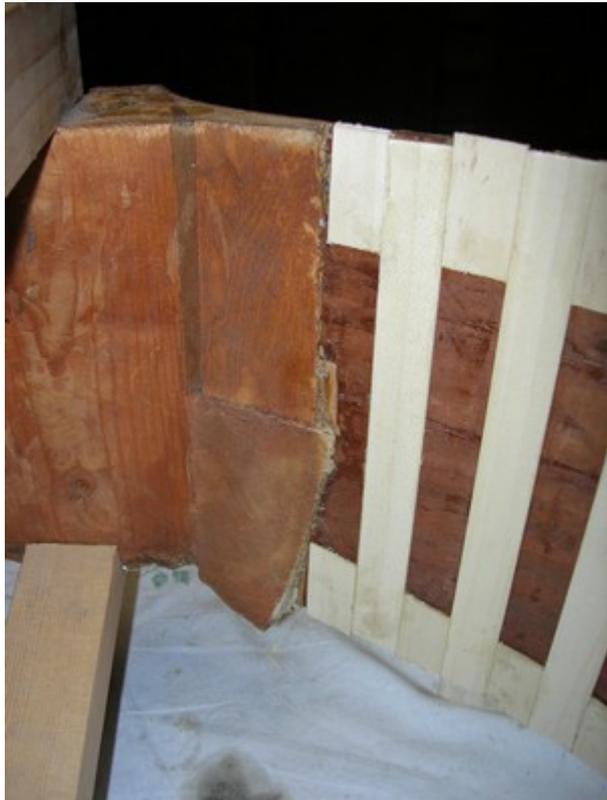
On the sides of this are two grafts, both in two pieces, that were probably made to widen the shoulders on the belly side, while tightening the back, as can be seen from the back's purfling and the front additions.

An hypothesis is that the original form had the front of the same width of the back, and that the neck was glued to the block without the dovetail joint, and the last part of the ribs glued to the neck's sides.

I decide to replace the block because of the bad condition it's in, having different woods, wedges, worm holes and side grafts, and for the necessity of remaking the neck's fitting.

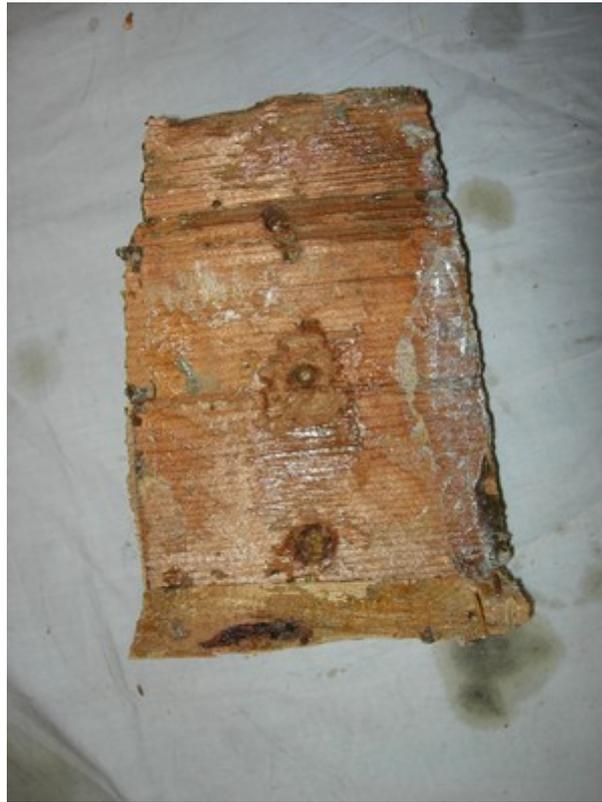
The two middle layers of the block, with the fiber running perpendicularly to how it is commonly used, are glued to the ribs by the endgrain, and have three holes.

I figured that the inner layer was newer than the middle ones. It is possible that at some time a neck was nailed or screwed to the middle layers.

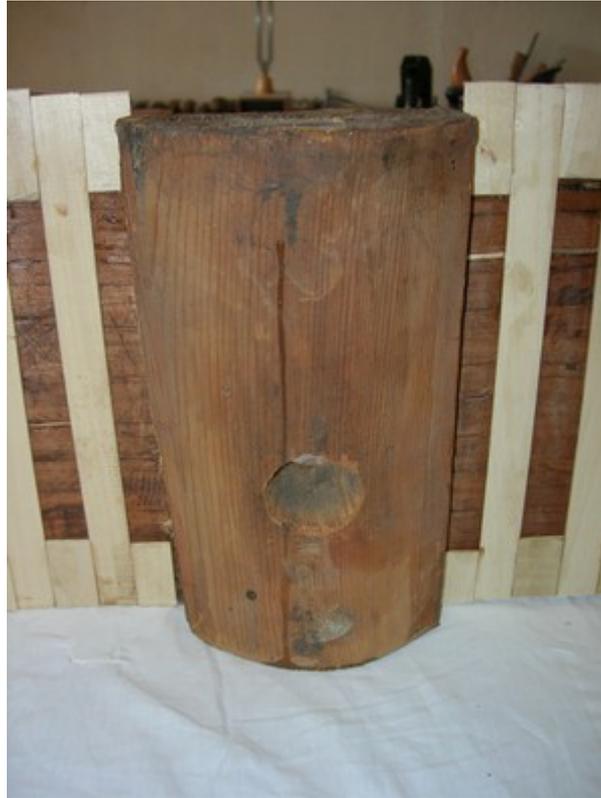
The endpin hole is off center in respect to the height of the ribs

If the hypothesis is that the instrument was played with the back edge resting on the floor, maybe with a protective "clog", it would make sense to think that an end button was used rather than an endpin, and would have been placed more towards the top, so it would not touch the floor.

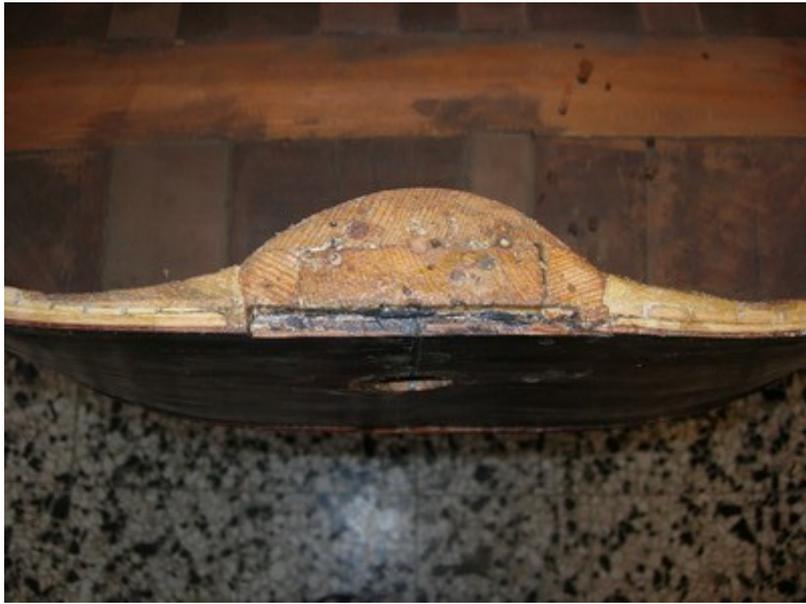
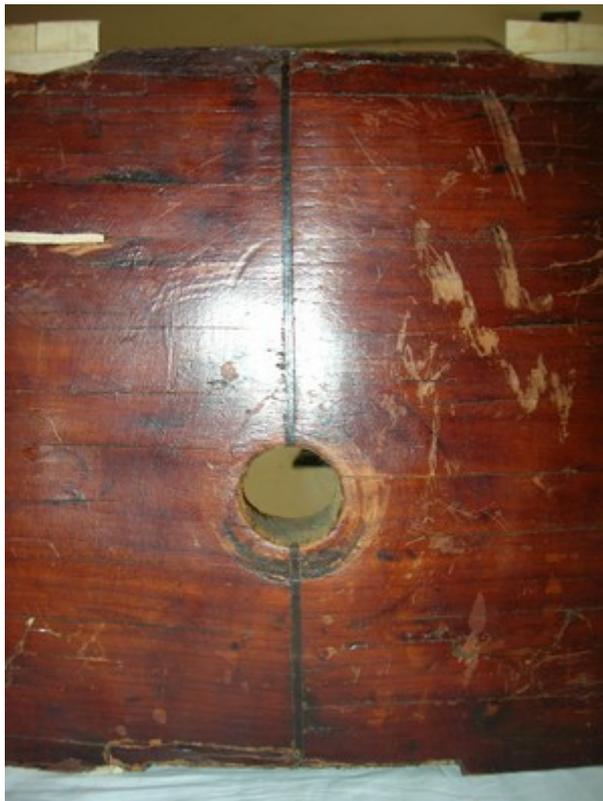
The block's glueing surface to the back is splintered and shows fillings.

An ebony inlay at the lower ribs' joint suggest that the block has been detached and reglued , maybe to shorten the ribs

The block has been cut on the sides in order to put two lateral reinforcements in linden wood.

I decide to make a new block, for solidity, and to have one of the right height.
Since the lower surface is completely flat, the replacement does not need a counterform.
I remove the block.

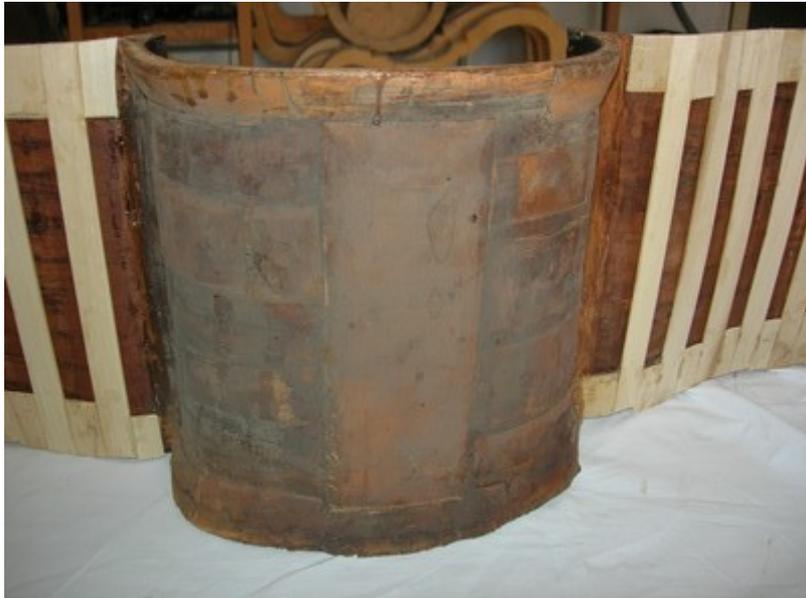
The G side C bout has been repaired with some ash doublings and a large spruce splint in the middle.

Covering two straight fiber linings, there are others in linden wood; the top one is cut and bent, the back one cut to shape.

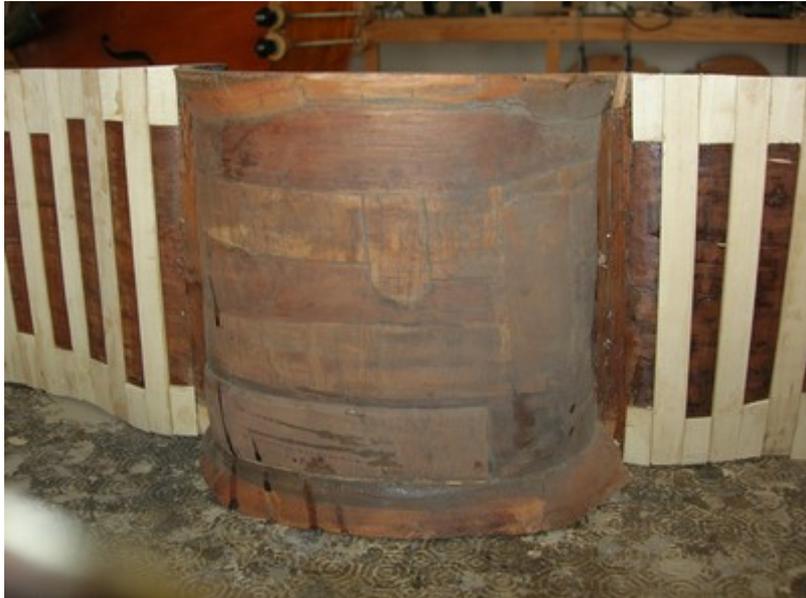
The very cracked E side C bout has been repaired with ash doublings and two linden splints.

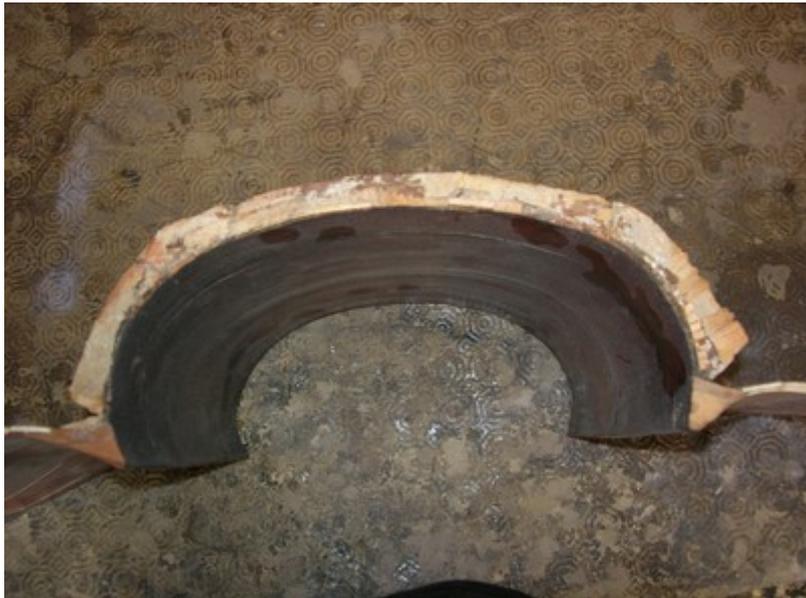
On the back side the covering one is in three pieces, cut to shape.

The back corners have been replaced. Here too, it is possible that the blocks were lower than the ribs.

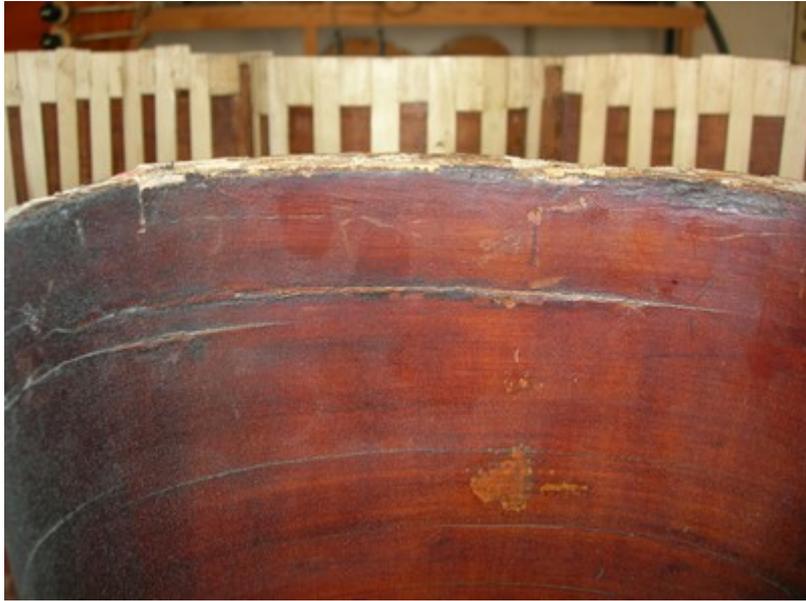
In proximity to the glueing surface on the back side, there is a rectangular replacement, and part of the edge is missing and filled.

At about 35 millimetres from the edge there is a reconstruction meant to fill a crack.
