Giuseppe Cazzaniga, Liutaio

Bernareggio, July 2009 - June 2012

Restoration of a Brescian style double bass

The instrument is property of Maestro Ezio Pederzani

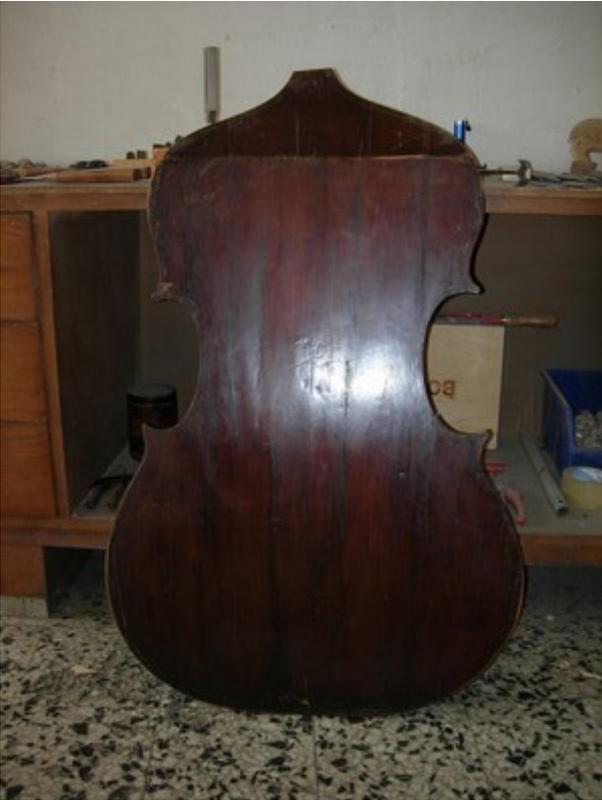
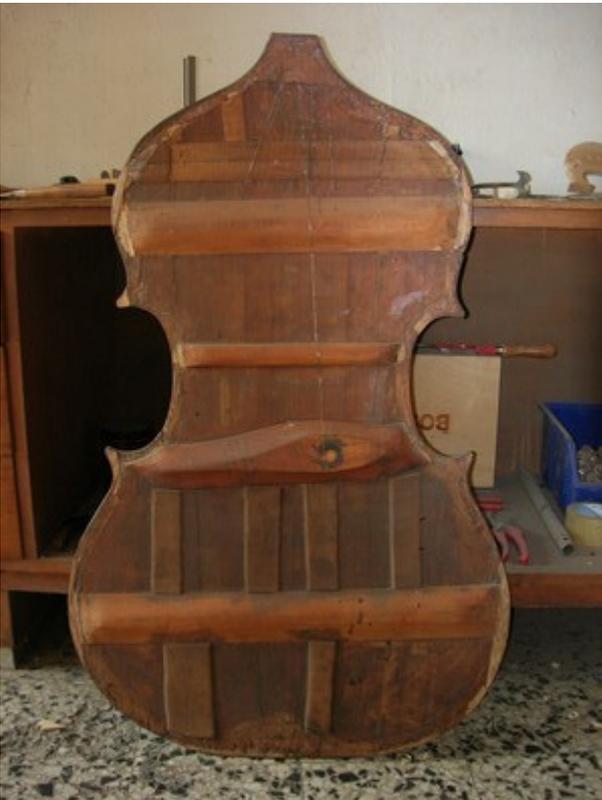
The back is made from cherry wood, in two pieces, cracks are present over the entire surface, the button is missing.

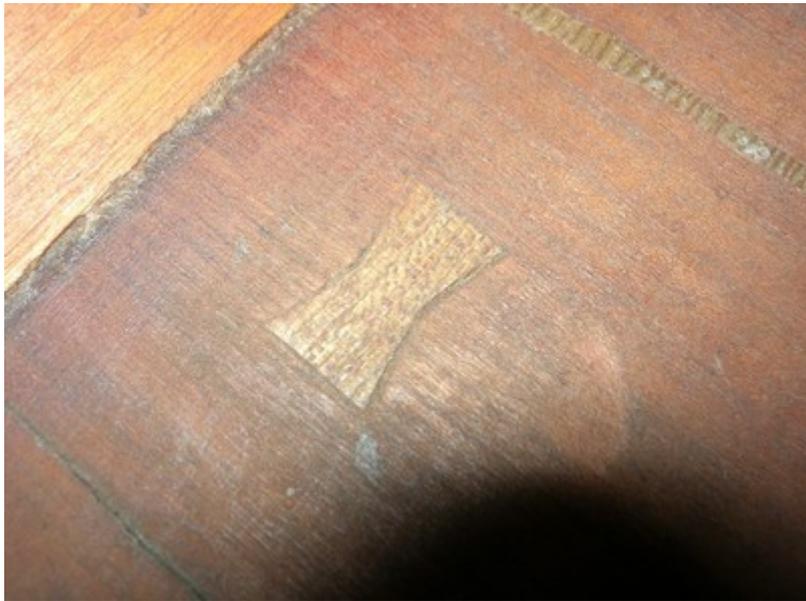
The joint was reinforced, I believe at the time of construction, with butterfly maple inserts.

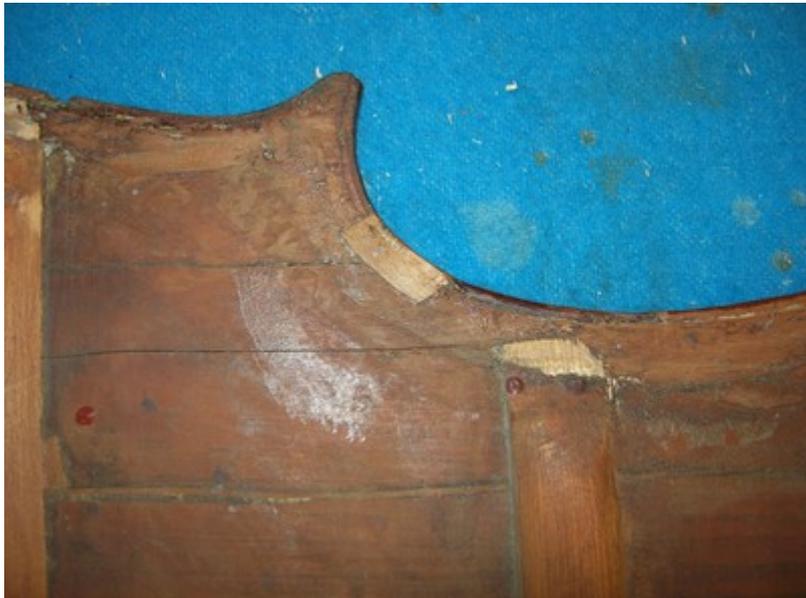
A remade section is also present at the treble C bout.

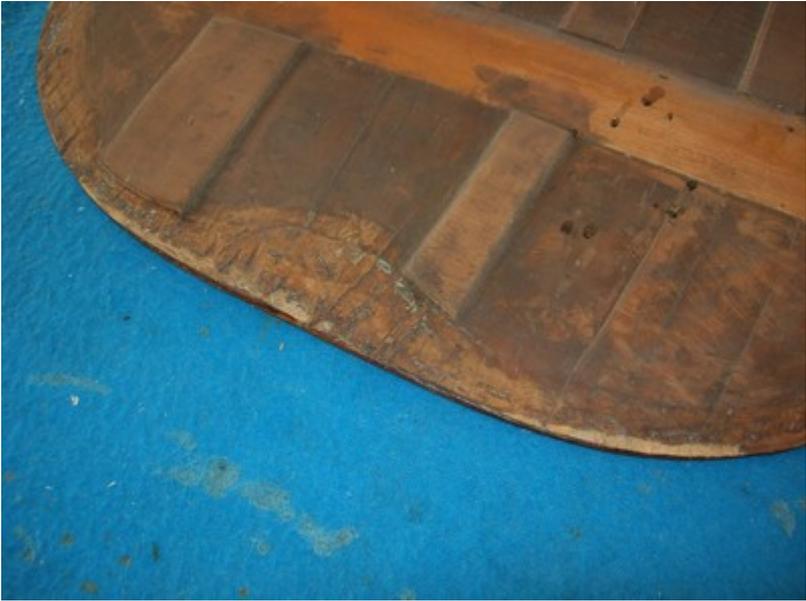
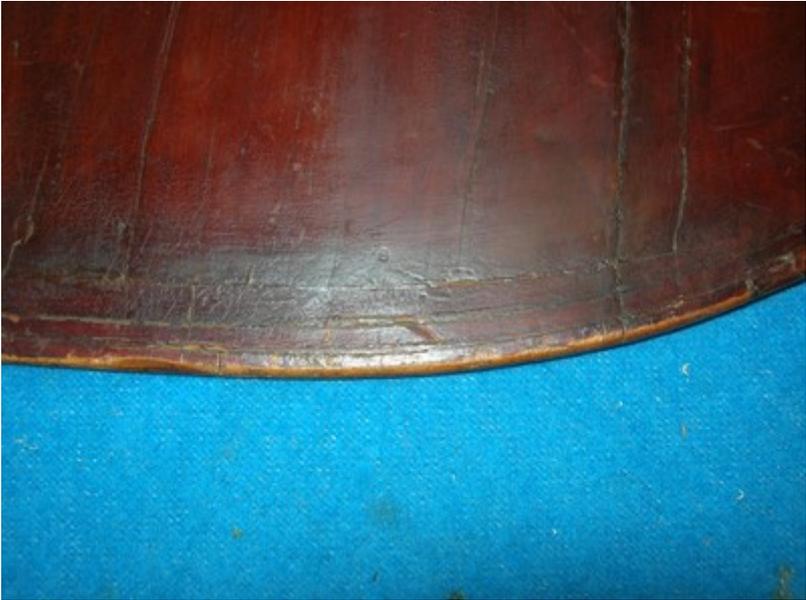
The lower edge, adjacent to and under the block has been remade, maybe to repair the damage caused by playing the instrument without an endpin.

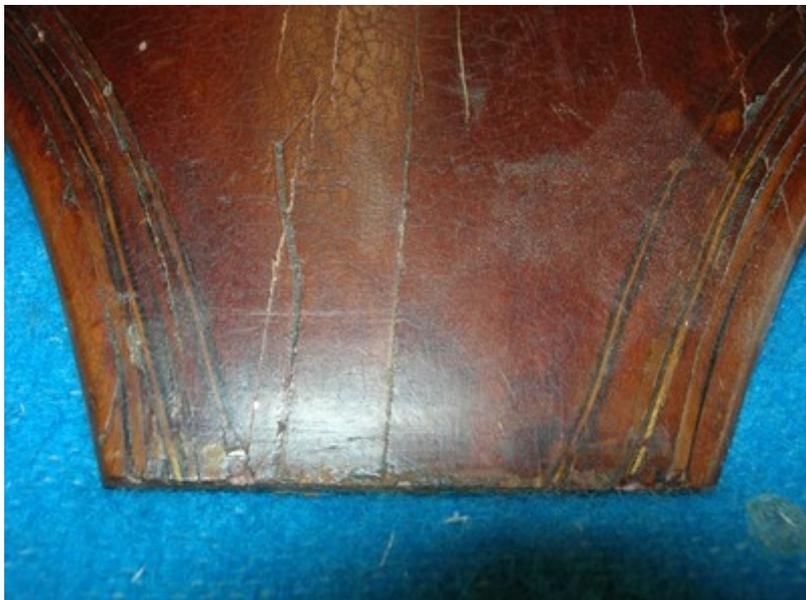
In the upper section, near the upper block, the presence of wider purfling may show that the profile has been reduced in width

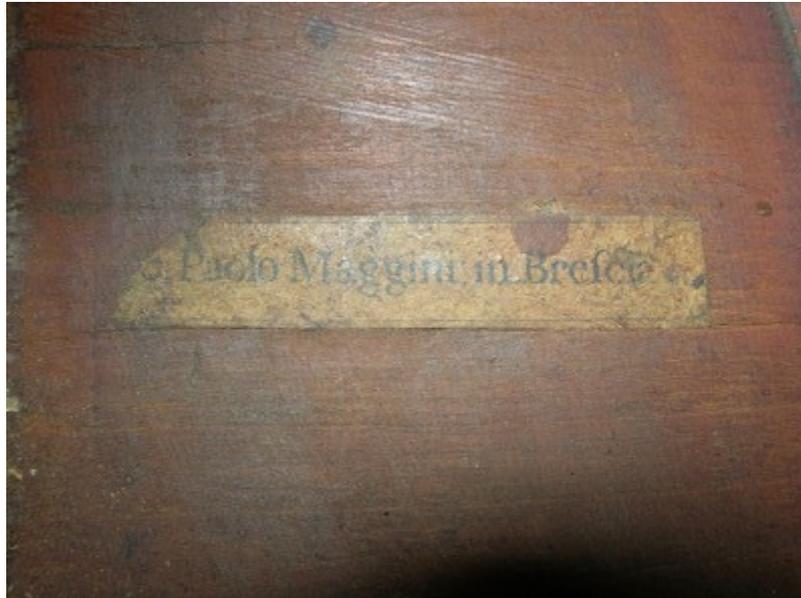
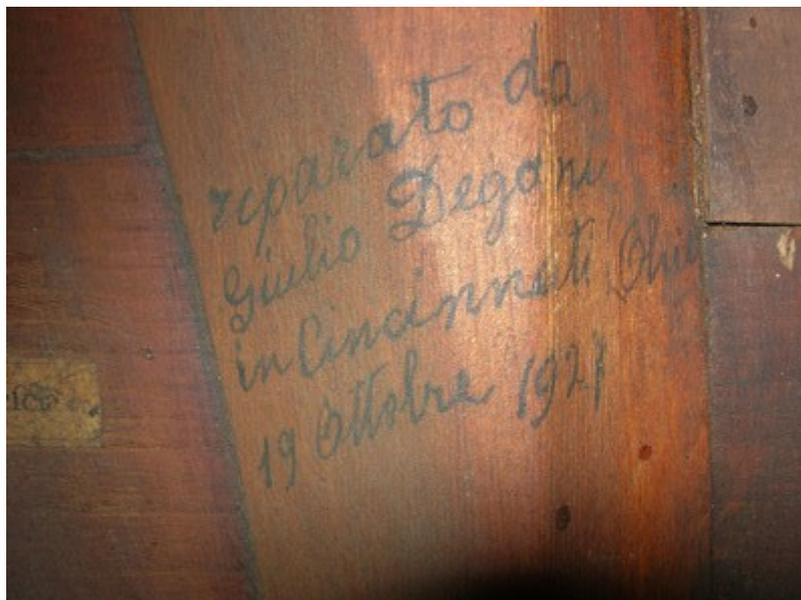
There is a label reading "...o. Paolo Maggini in Brescia ", as well as a pencil writing reading " riparato da Giulio Degani in Cincinnati Ohio 19 ottobre 1927 " .

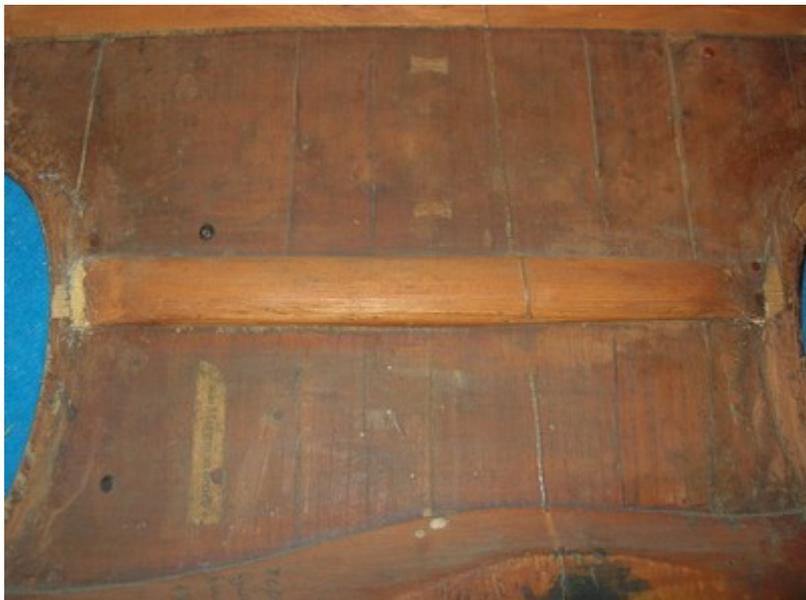
The small bar is from a different maker and seem to have been replaced more recently.

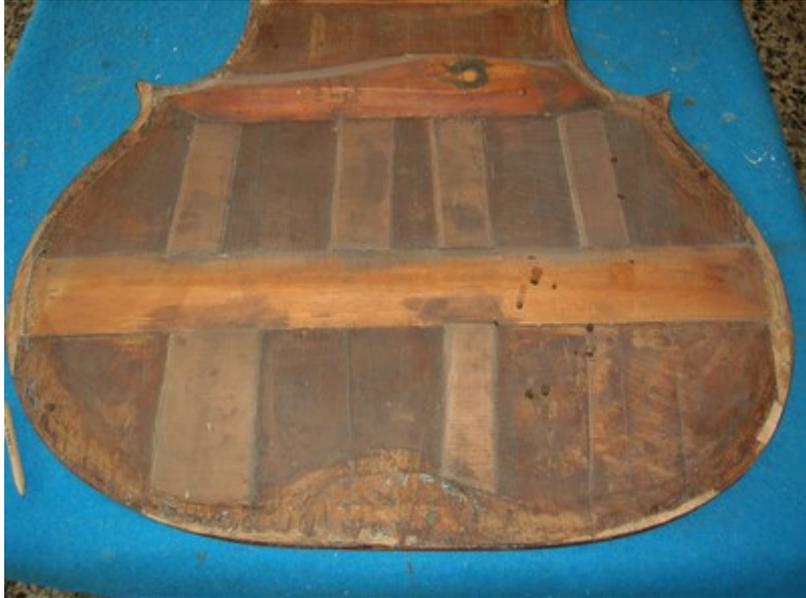
In the lower part there are several rectangular reinforcements, placed along repaired cracks. those above the lower bar are in walnut, and those below in spruce.

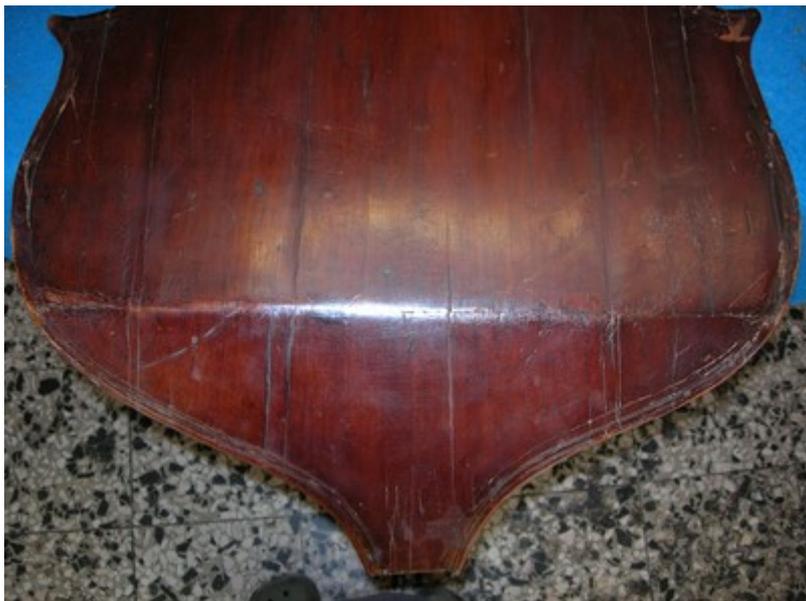
The bend, placed fairly high, has been broken, and there is some filler from the outside. Inside it has been reinforced with a strip of walnut, with grain parallel to that of the back.

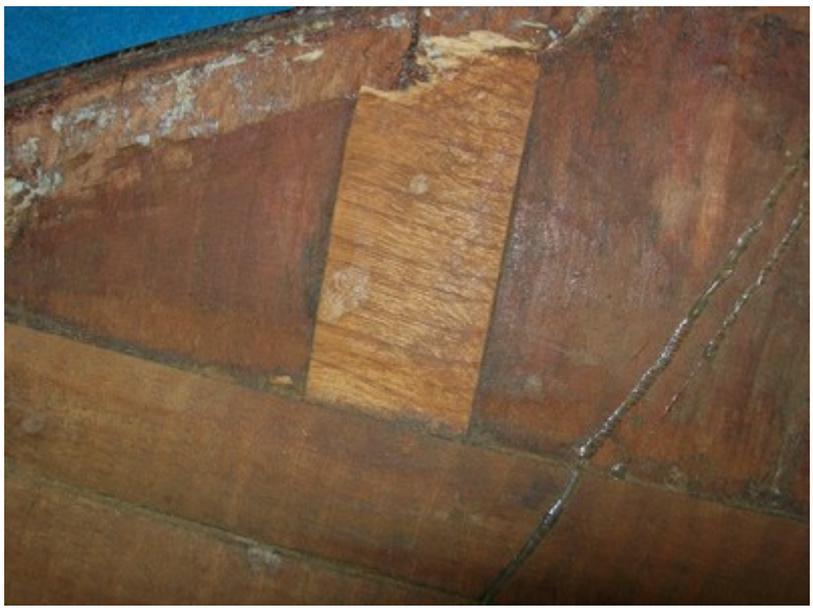
There are additional reinforcements, maybe in ash, along two cracks on the bass side, as well as two others smaller in size on the treble side.

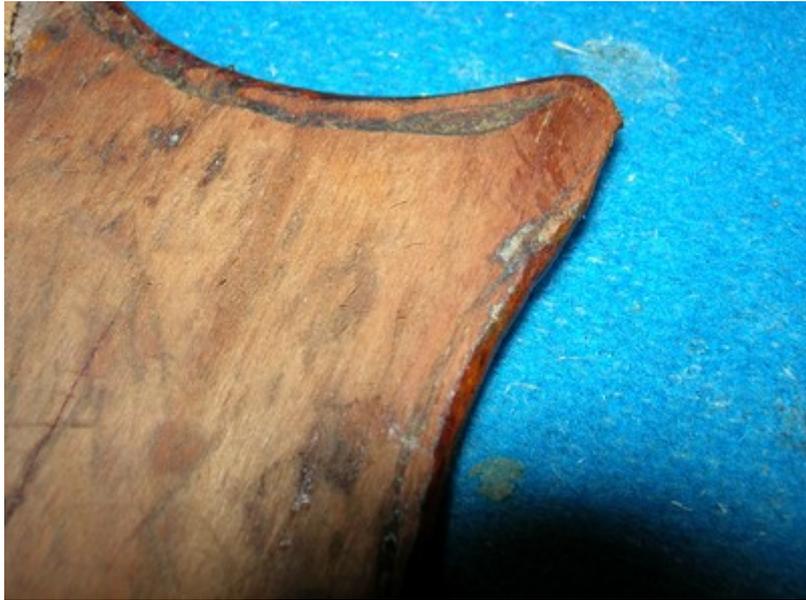
It is now possible to see the profile of the ribs, traced with a scribe roughly 4 millimetres from the border.

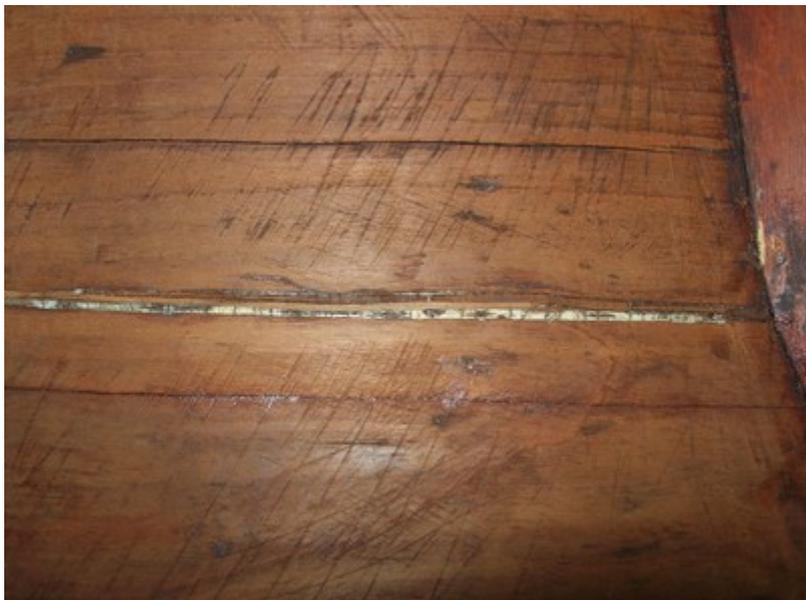
Some of the cracks have been filled with strips of walnut, and one was filled with white putty.

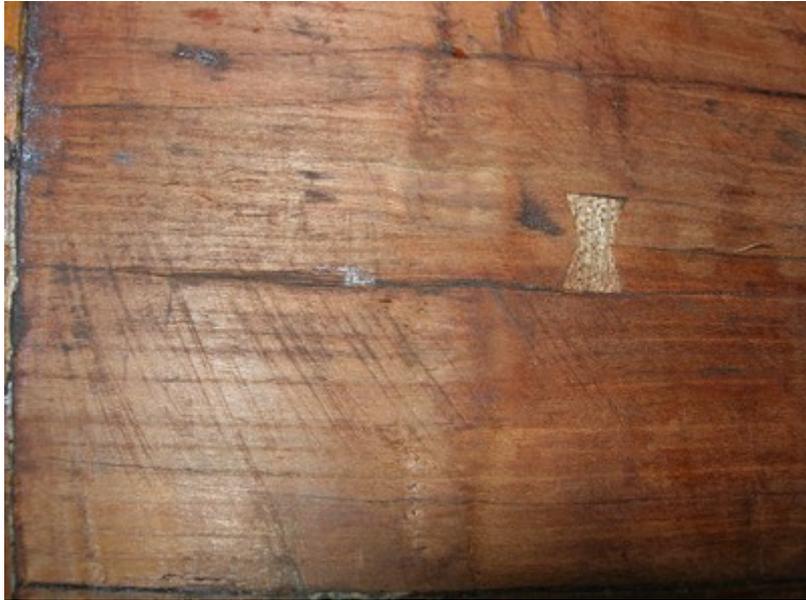
There are marks from a scraper or a small plane present on the entire surface.  
Under the reinforcements there are scribe marks.

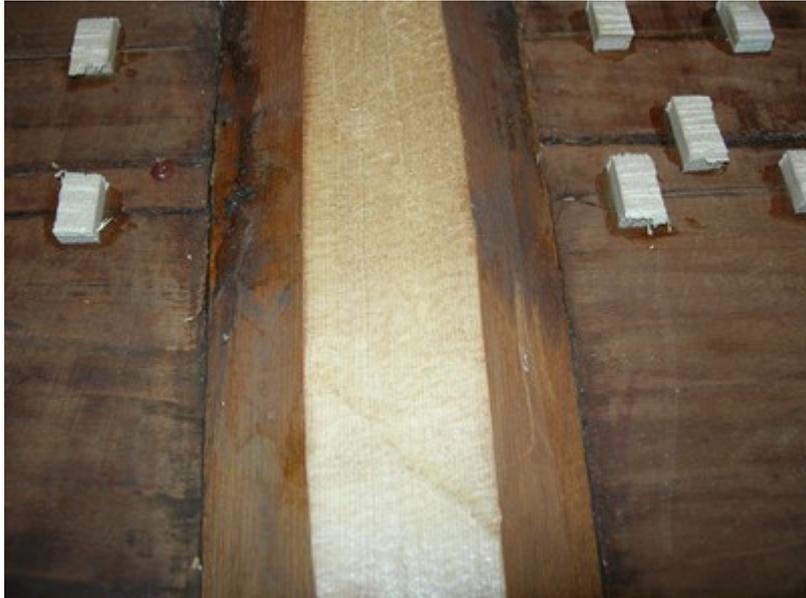
The spruce with which the lower bar was made is fairly hard and rigid.

The glueing surface of the back to the lower bar was scratched with a scribe. Similar to the surface under the walnut and spruce reinforcements along the cracks.

I choose to remove the bars with a plane and gouge, and then cleaning the glueing surfaces with hot water; this way avoid the possibility of causing further damage to the back while unsticking the bars.

None of the bars is original, their excessive weight and rigidity could have caused some of the damage the back has suffered, the removal is necessary to repair the cracks under the bars.

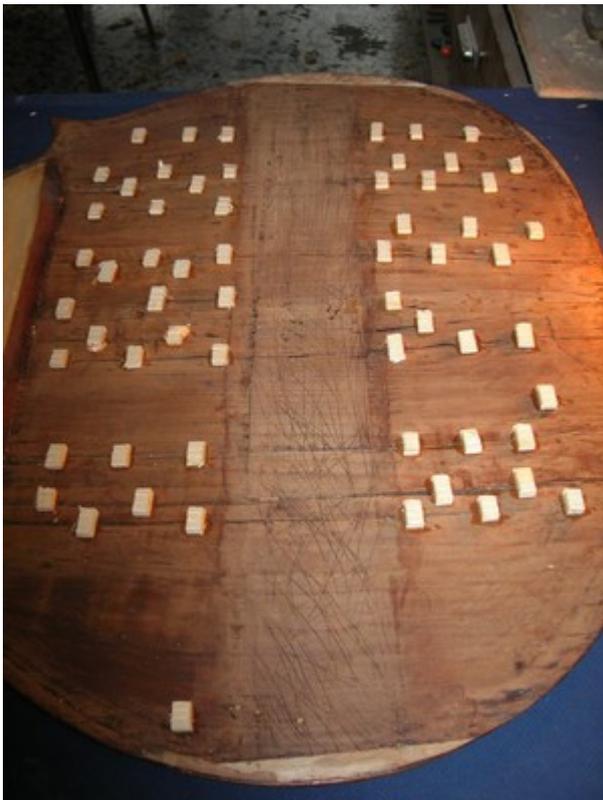
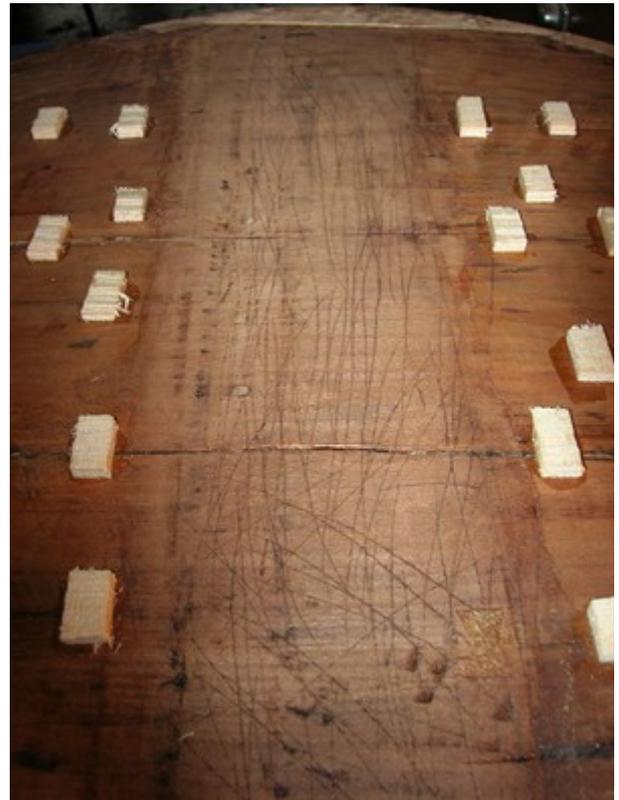
There are also several round pins, maybe placed from the outside during a bad repair to a previous smaller bar, whose position is still visible on the surface of the back

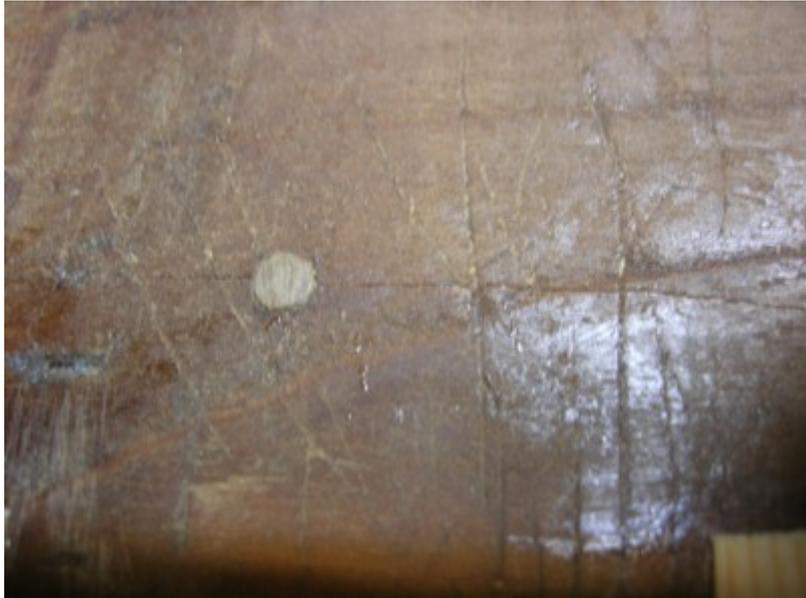
The next crack, near the bend, was caused by one of the walnut pins under the upper bar.

I remove the pin and repair the crack.

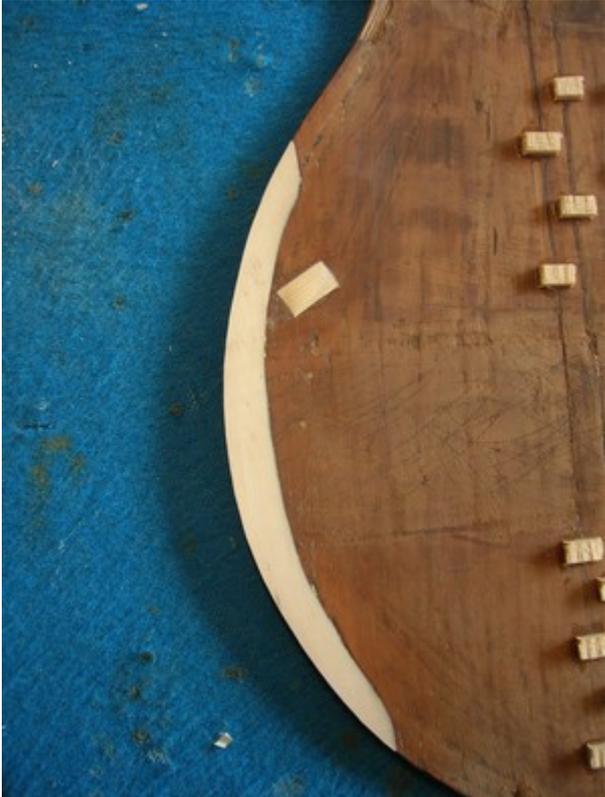
The next crack, in the lower section on the bass side, was repaired with several slivers of walnut and with putty. It reopened.

I remove the temporary cleats, open the crack, remove the slivers and repair the crack, rebuilding the missing part in white maple.
