Giuseppe Cazzaniga, Liutaio

Bernareggio, July 2009 - June 2012

Restoration of a Brescian style double bass

The instrument is property of Maestro Ezio Pederzani.

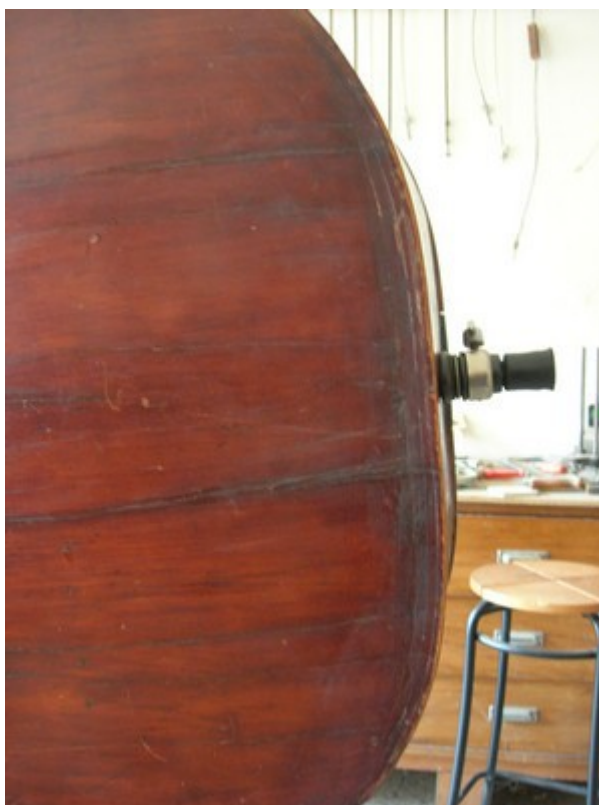
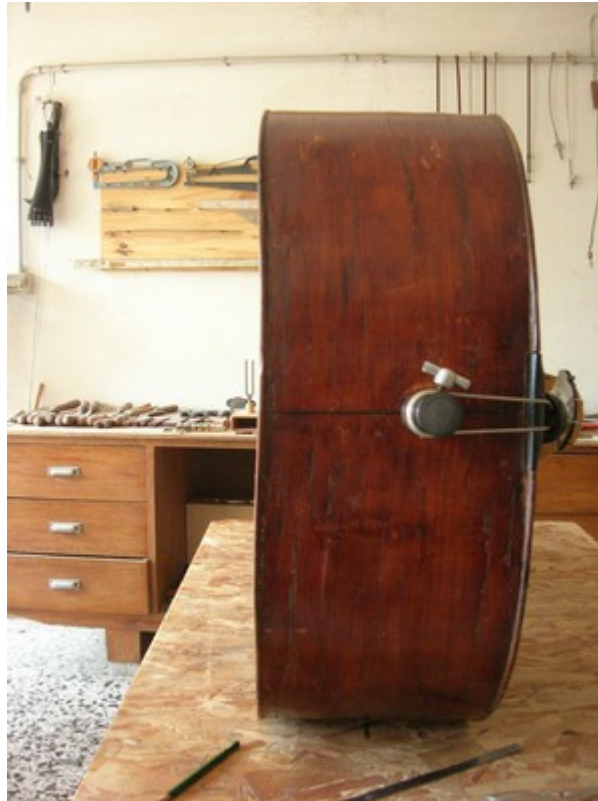
The lower curves of the back have been modified, next to and on the sides of the lower block, for a length of about 45 centimetres, with a replacement of the edge and purfle, of a maximum width of 20 millimetres

The glueing surface of the ribs to the back in this area has been lowered by 5 millimetres
The endpin hole is not in the middle point of the ribs' height but more towards the top.

It is possible that the ribs and lower block have been planed down, and the lower part of the back rebuild, to repair the damages caused by resting the back edge of the instrument on the floor while playing, or because of the removal of a "clog" used for the same reason, and that in the beginning there was an end button instead of an endpin.

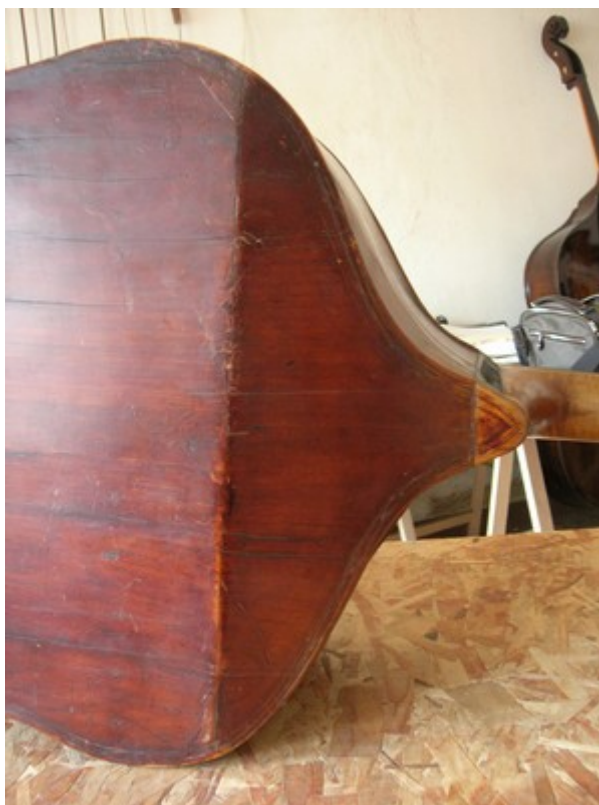
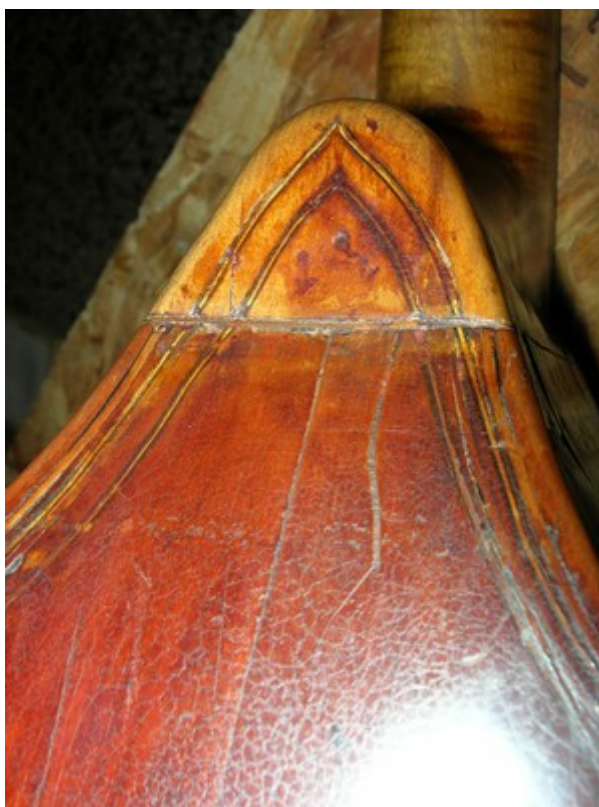
The width of the back has been decreased, as proved by the old purfling beside more recent ones, from the back button to the maximum width of the upper bouts.

The width of this reduction is of about 5 millimetres per side. The back button has been cut transversely and rebuild.

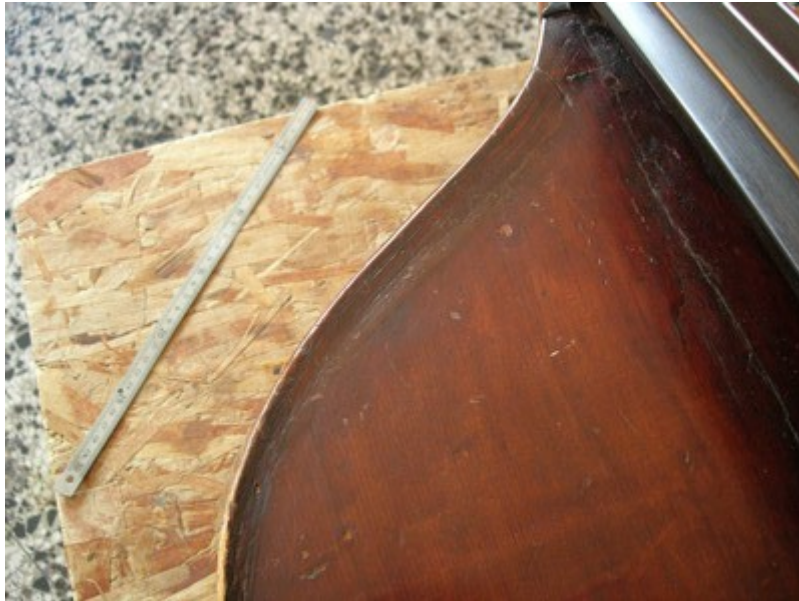
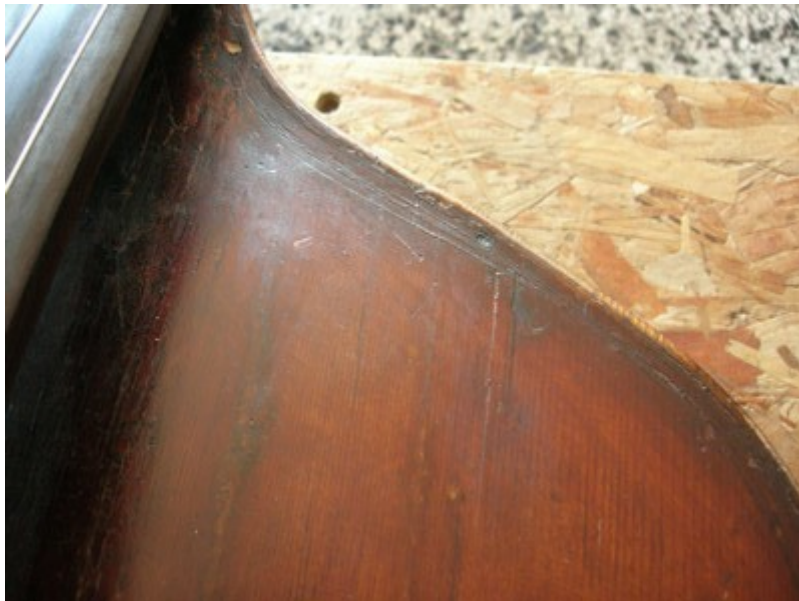
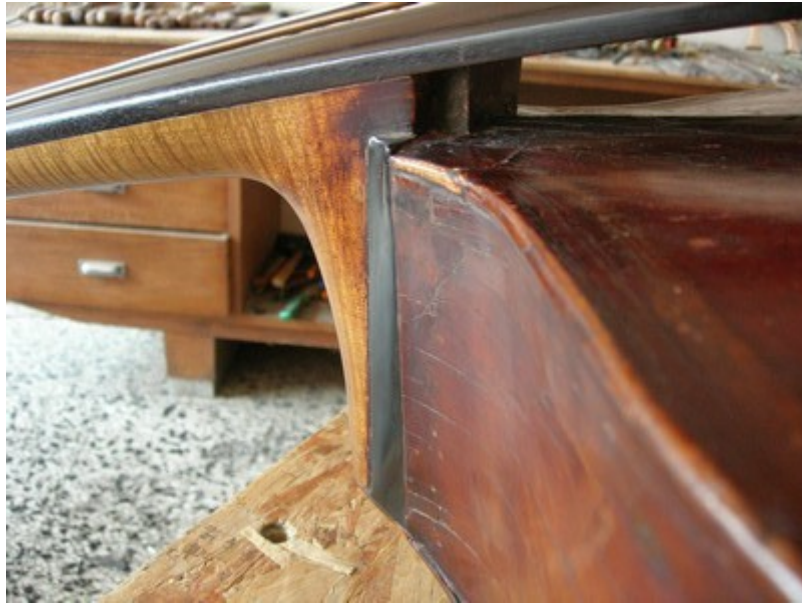
In the same area the top has been widened with two additions of the edge and purfling.

On the G side, the addition has a maximum width of 17 millimetres and a length of about 180 millimetres.

On the E side the addition is much longer, of about 300 millimetres, and the maximum width is of about 22 millimetres.

The two additions, and some fillings as well, cover the highest point of the top.

On the neck's sides, to complete the body's outline, there are two ebony columns.

It seems that the upper part of the body has been modified to bend the shoulders ribs, by widening the top plate and tightening the back.

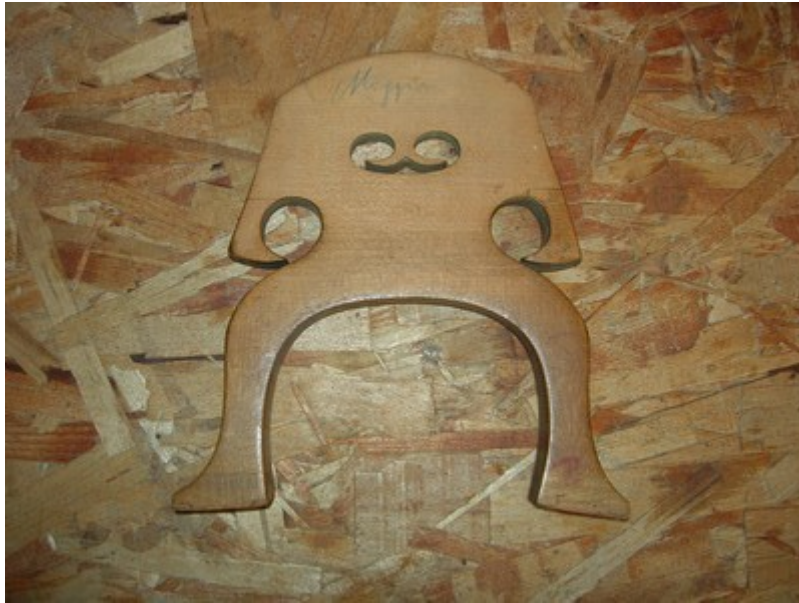
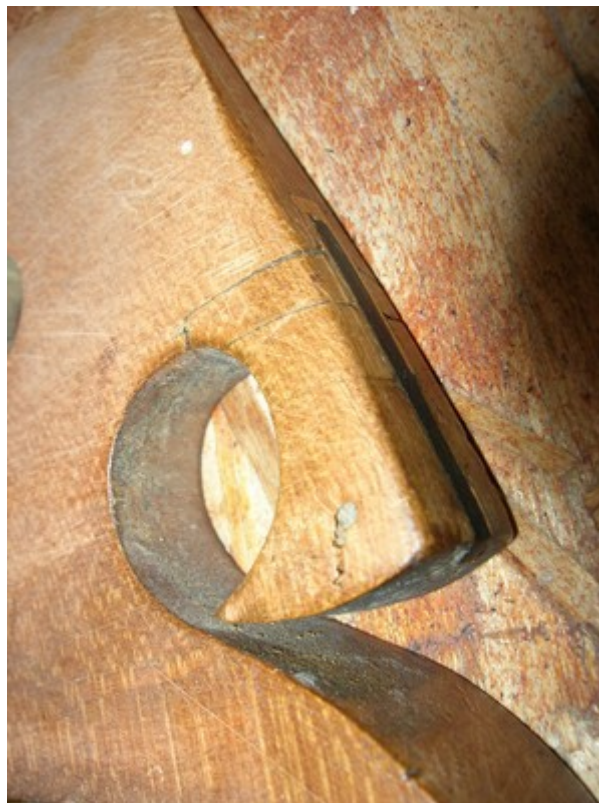
The bridge is deformed and has been repaired on the E side with an ebony plate, where it was fractured and eaten by woodworms.

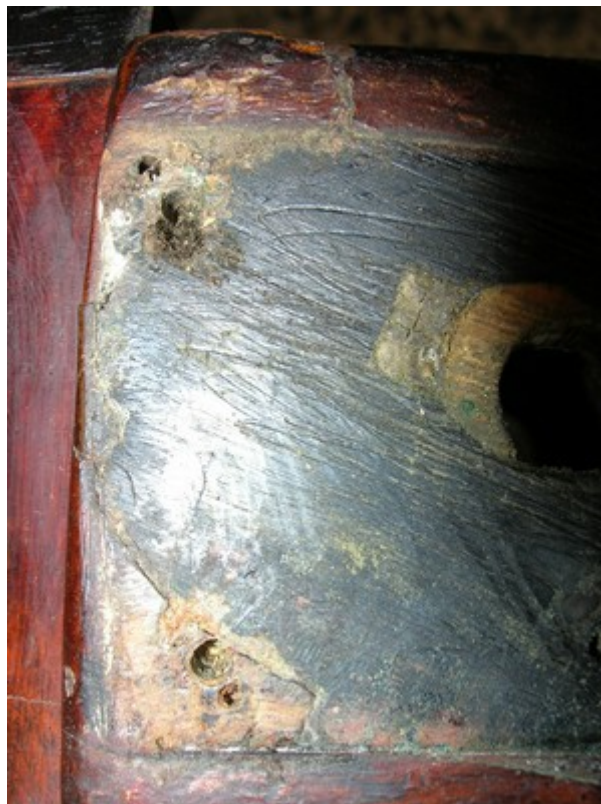
Under the plates there are two ebony and filler replacements, where a previous set of tuning machines for four strings were inlaid in the pegbox.

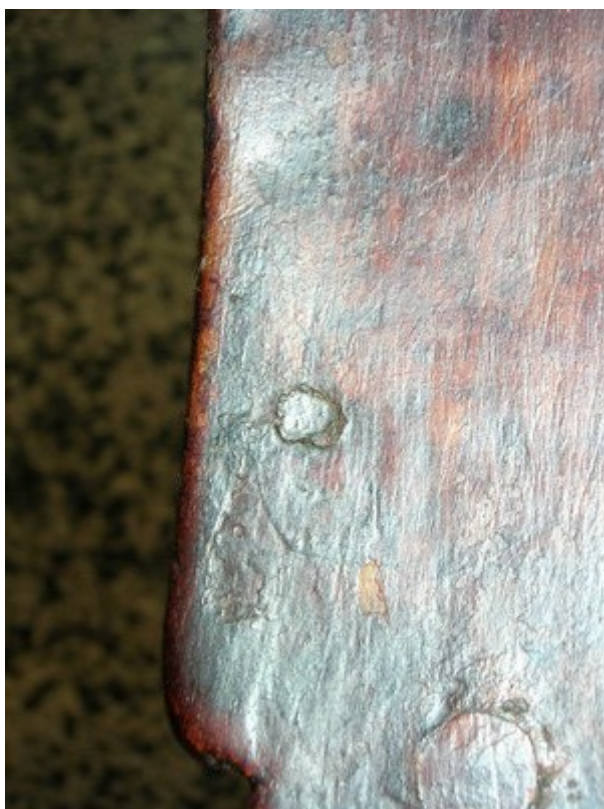
On the back of the pegbox it is possible to see three filled holes, that might be left from a previous set of three machines with retaining pins.

I will be able to get better informations on the previous stringing when I will repair the pegbox by removing the ebony and filler from the walls in order to make new additions.

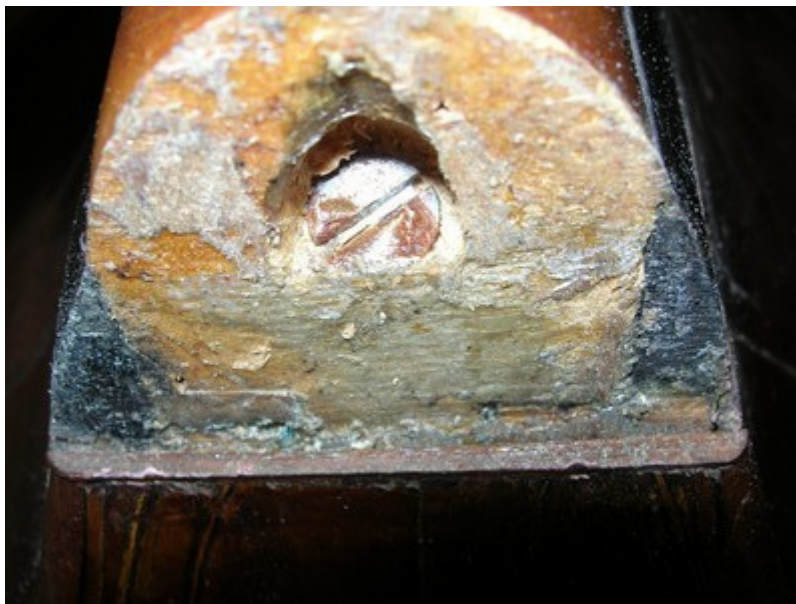
Under the non original back button there is a metal screw inserted diagonally between neck and upper block

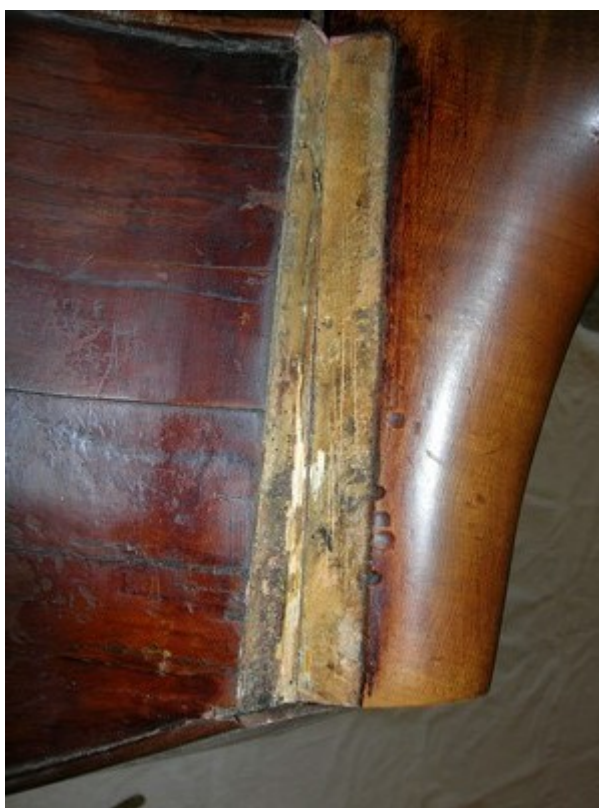
On the G side a wedge has been inserted to block the dovetailed neck fitting.

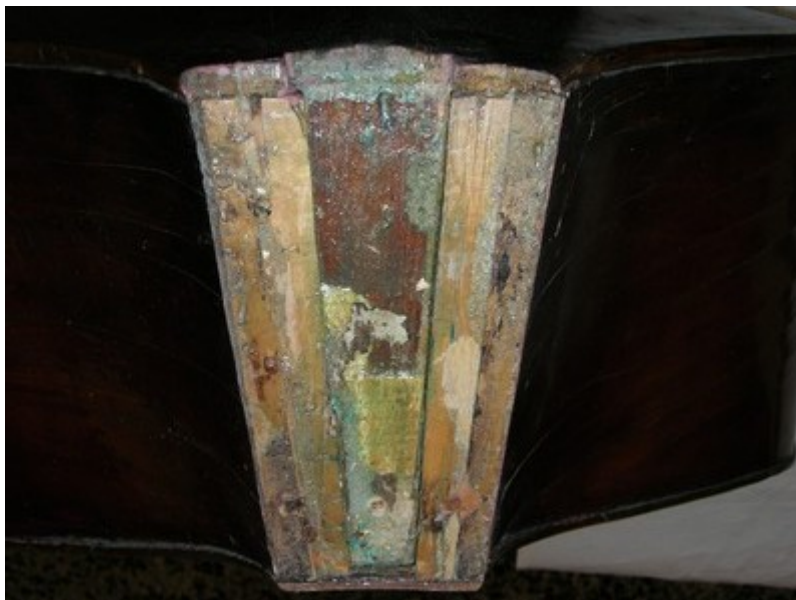
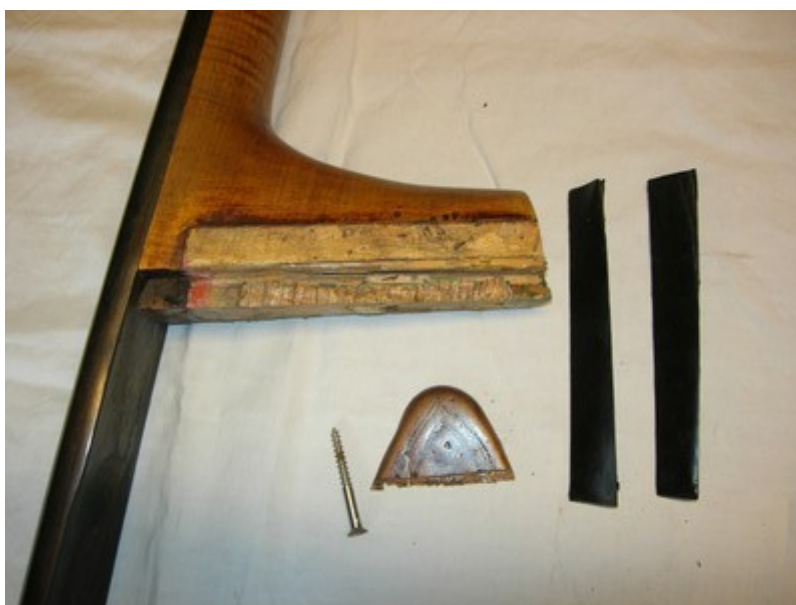
Various replacements are glued to the upper block both on the sides and back of the dovetail, with different woods (walnut, maple, spruce). There are three screws as well.

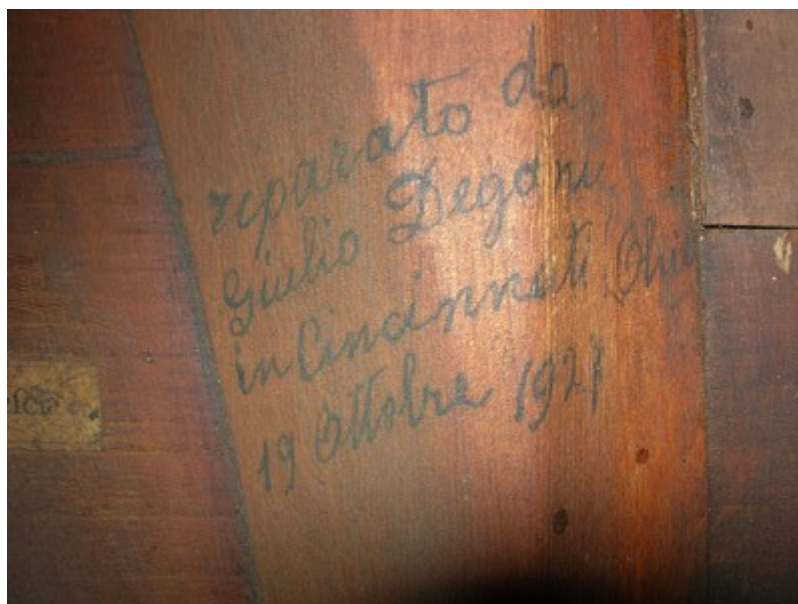
“ Riparato da Giulio Degani in Cincinnati Ohio 19 Ottobre 1927 “.
