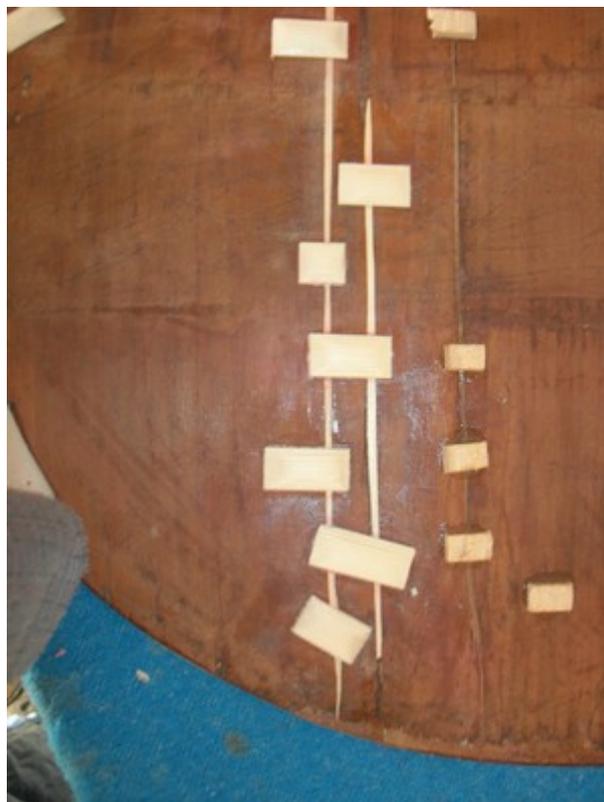
The next two cracks, above and below the lower bar, have been repaired with slivers of walnut and putty, and are partially open.

I first repair the lower crack.

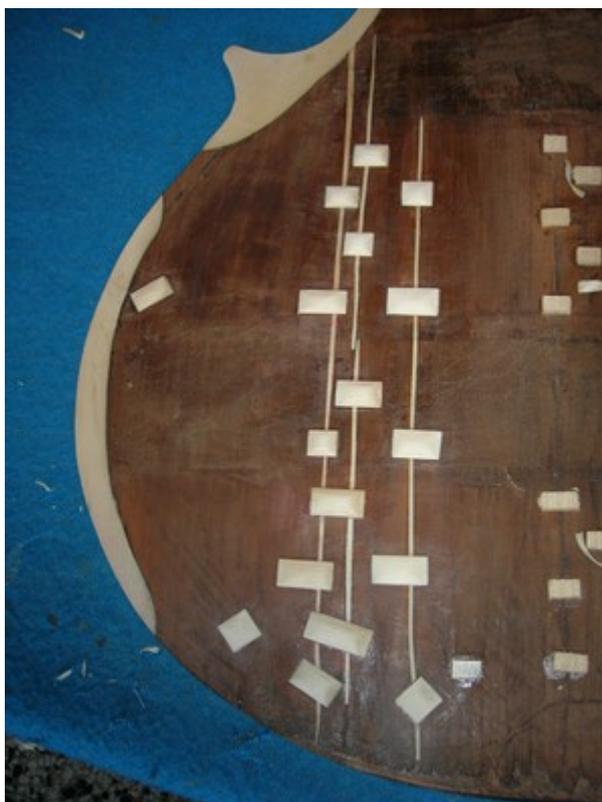
The next crack, on the lower bass side, has been repaired with a sliver of walnut.

From the outside the sliver is well glued and the crack is level, inside the sides of the crack are slightly offset, and the sliver shows gaps.

I work from the inside, without touching the outer surface, inserting a new sliver into the back, which enters halfway into the thickness.

The offset sides of the crack inside do not merit a doubling, and the crack can be reinforced with the adjustment of the cleats.

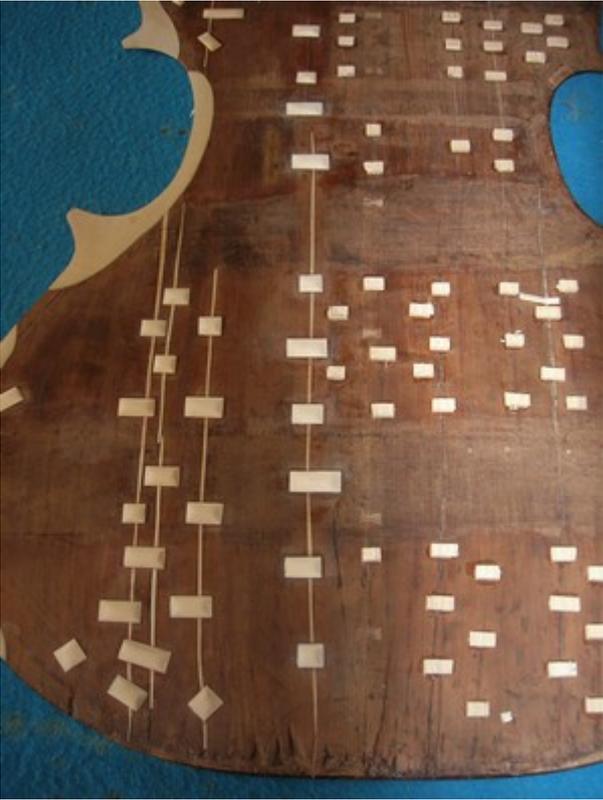
The next crack runs from the glueing surface of the lower block to the center of the instrument. The sides are partially offset, and it has been filled with strips of walnut and putty. I reopen the crack, remove the fillers and close the crack with a new sliver.

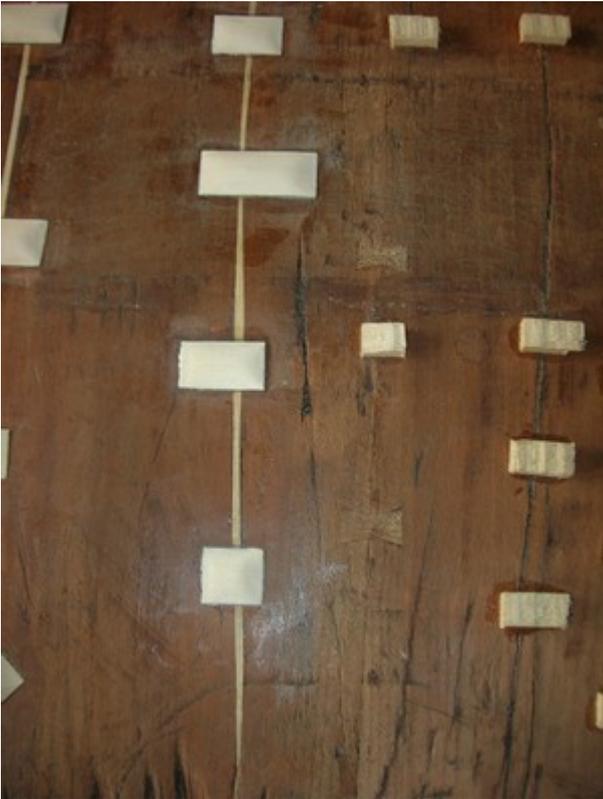
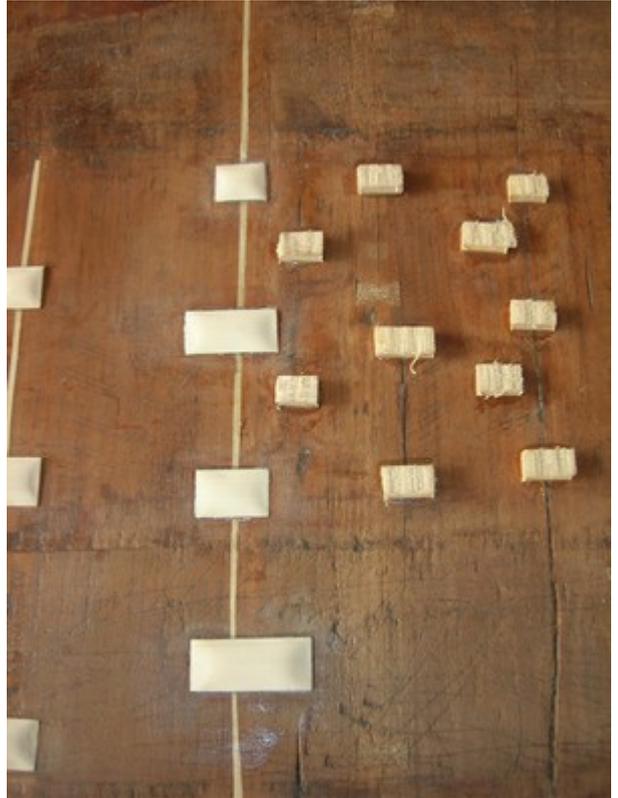
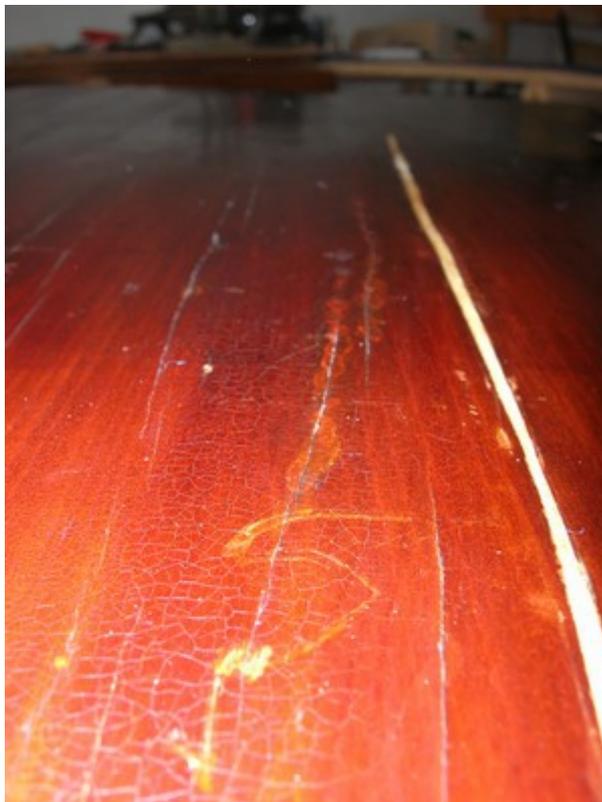
Continuing towards the central joint, in the lower section there are three small cracks, the first between the lower block and the lower bar, the second under the bar, and the third above it.

The first is well glued and level, but has a gap filled with glue on the inside; the second and third are partially open and offset, with brownish retouches to the varnish.

I remove the temporary cleats and repair the cracks, inserting maple into the gaps.

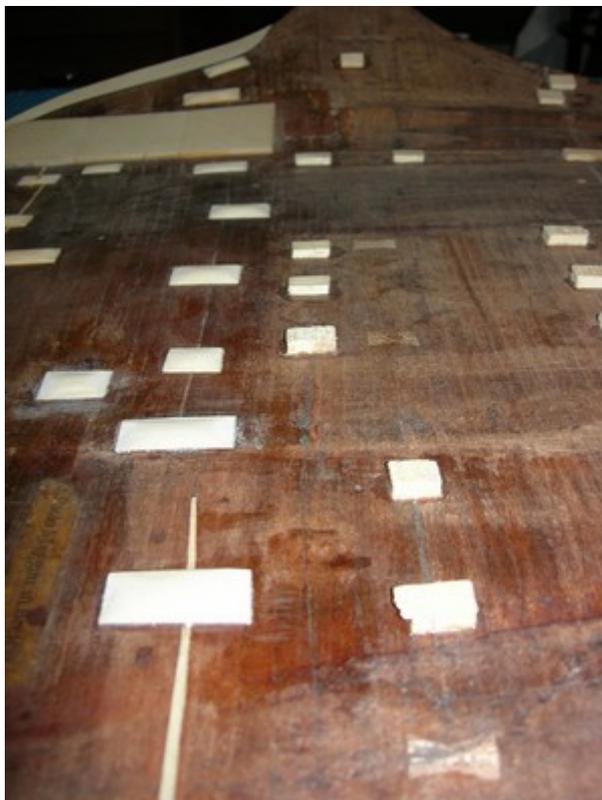
In the upper section, between the bend and the soundpost bar, along the side of the central joint on the bass side, there is a long crack, repaired without filler, partially open and dirty.

I remove the temporary cleats, reopen, clean and glue the crack, reinforcing with cleats.

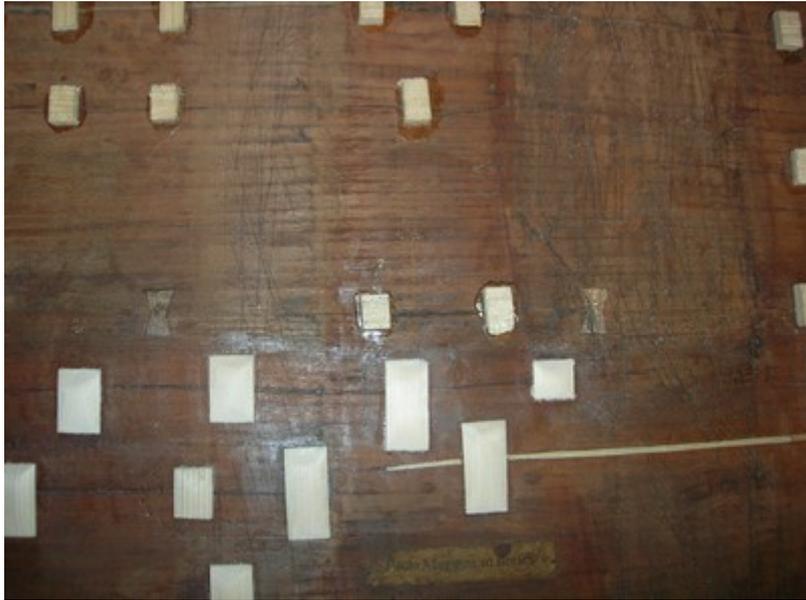
The exception is a short area on top of the soundpost bar, which has been repaired with a walnut shim.

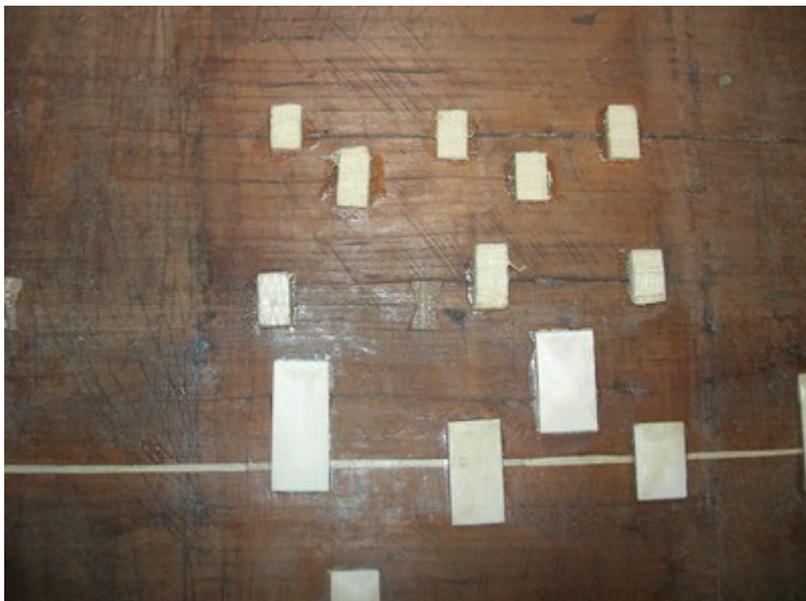
Also, under the soundpost bar, next to one of the butterfly inserts and by this probably caused, there is a crack, repaired with a walnut shim as well.

I reopen and repair the two openings, and reinforce the central joint with cleats

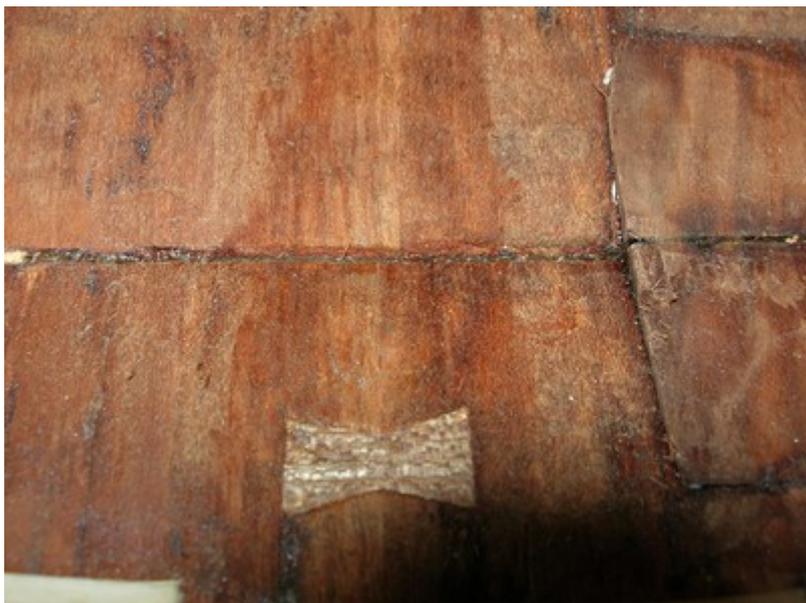
I remove part of the bend reinforcement, uncovering the joint and a butterfly insert.

In this way it can be noticed that the section of the back on the upper side of the bend was shifted of about 2 millimetres towards the treble side, probably during a previous bend repair.

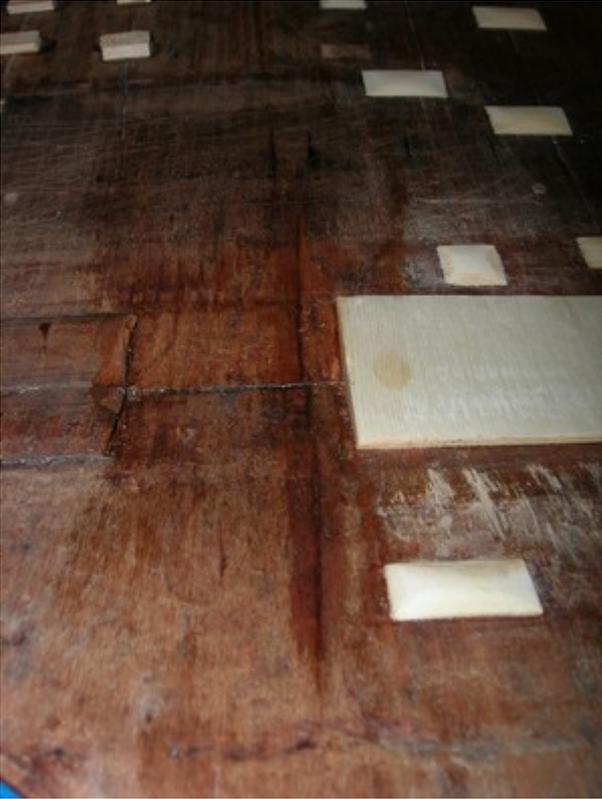
I remove the next section, uncovering a crack that starts at the upper block's glueing surface and continues down to the upper bar, through the bend, where it is open.

I repair the crack and replace another part of the reinforcement.

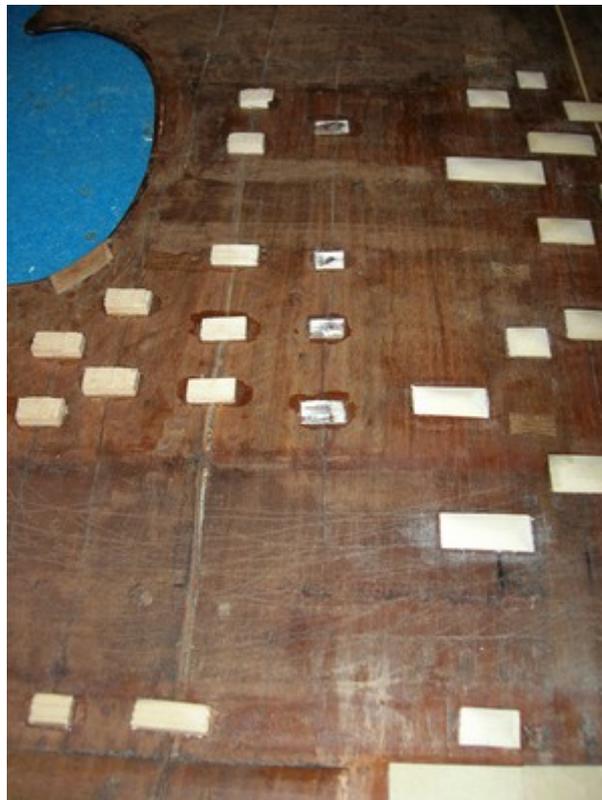
In the area between the upper bar and the soundpost bar, there is a crack repaired with a walnut shim, well glued from the inside, but open and putty filled on the outside.

I remove the temporary cleats, clean and repair.

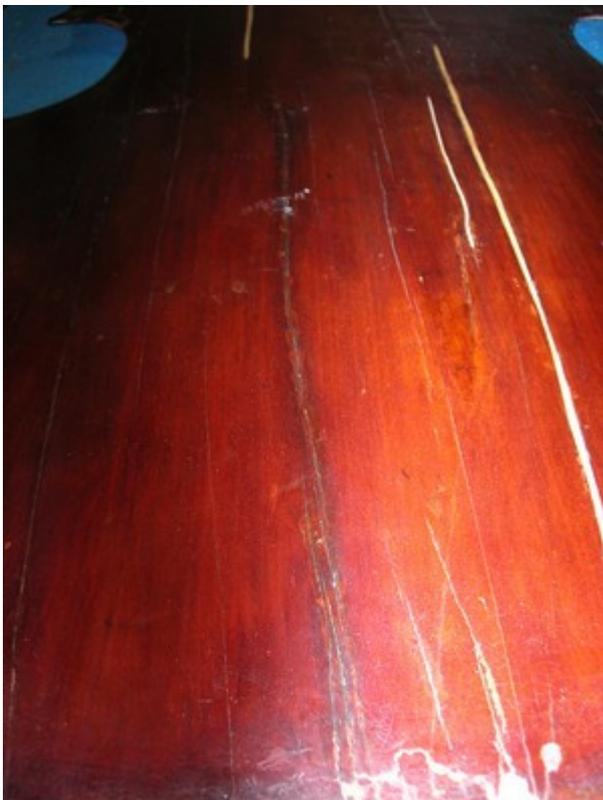
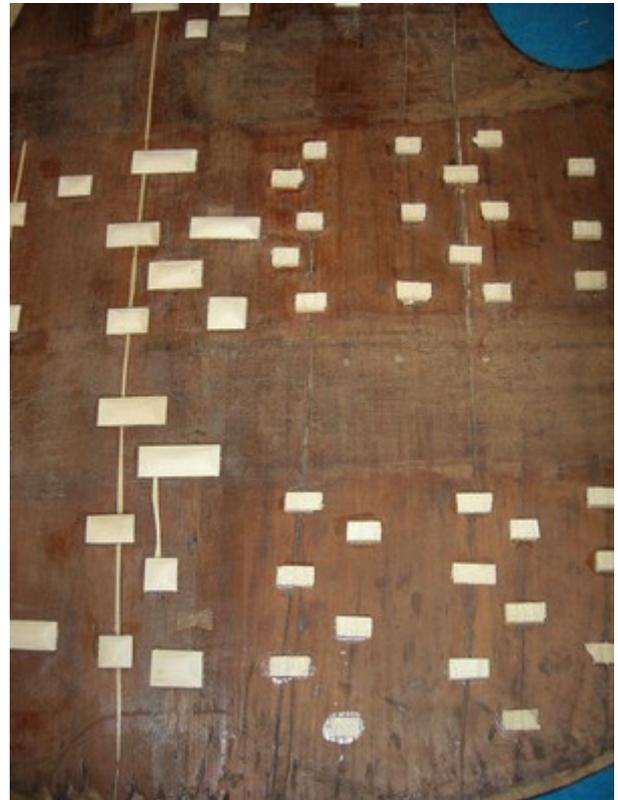
There is another open crack between the soundpost area and the lower edge, repaired with a walnut shim and putty, and two shorter cracks alongside, one right under the soundpost bar, the other at the lower edge.

I remove the temporary cleats, clean and repair.

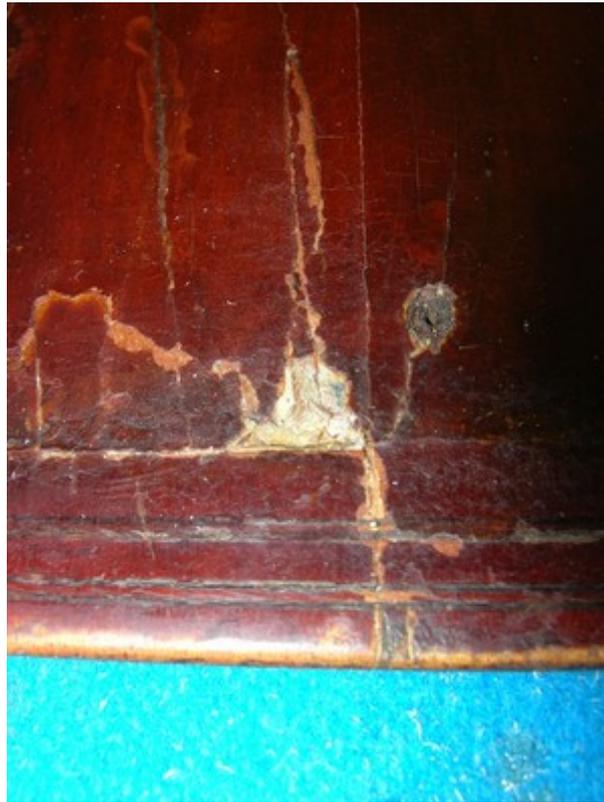
At the glueing surface of the lower block, a broken part has been reglued and a missing part filled.
There is an hole flared on the outside as well.

I remake the missing parts.

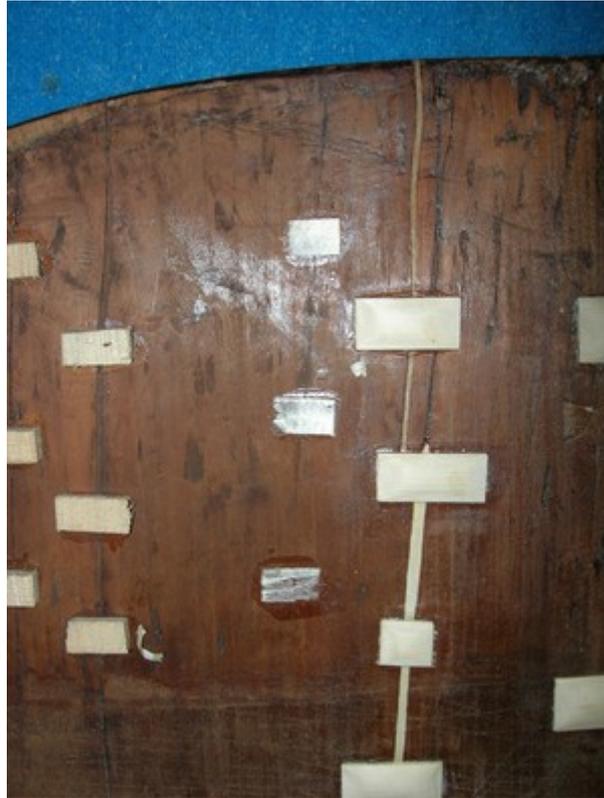
On the side of the block area there is an open crack about 16 centimetres long.

I reopen, clean and repair.

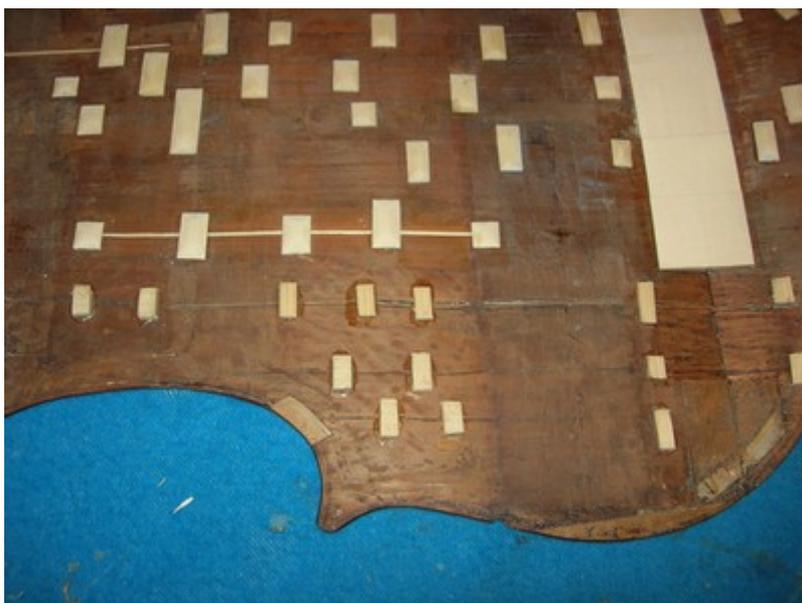
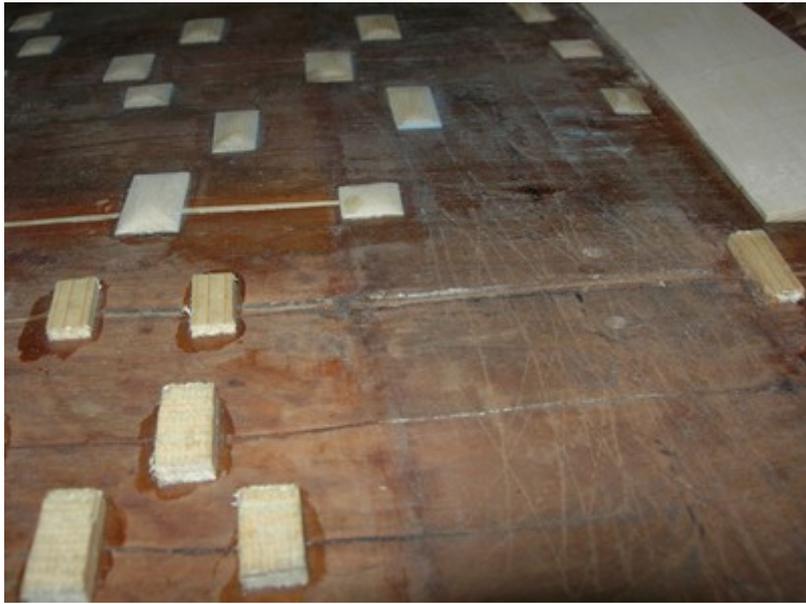
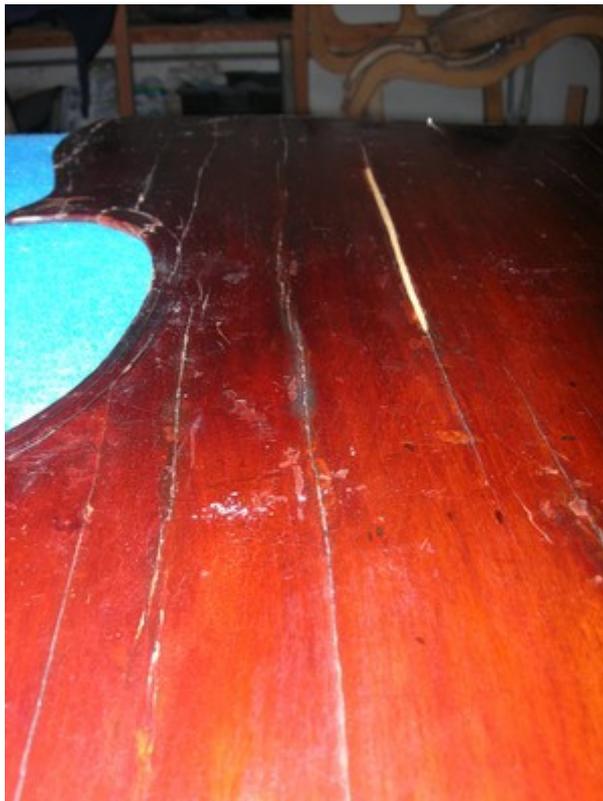
This runs from the upper edge to the lower bar.

The section between the lower bar and the soundpost bar is open but has no filling shims.

From the soundpost bar to the upper edge there are many shims, some side by side, and putty.

Also, the sides of the crack are offset on the inside, while they were smoothed and retouched from the outside, making the joint sunken.

I remove the temporary cleats and clean the crack.

Then repair the lower part with no filling shims, replace the two upper shims and put new cleats.

I pushed both sides of the crack on a flat surface on the outside to eliminate the sinking, while the unlevelling on the inside will remain as it is, with the cleats shaped to follow it.

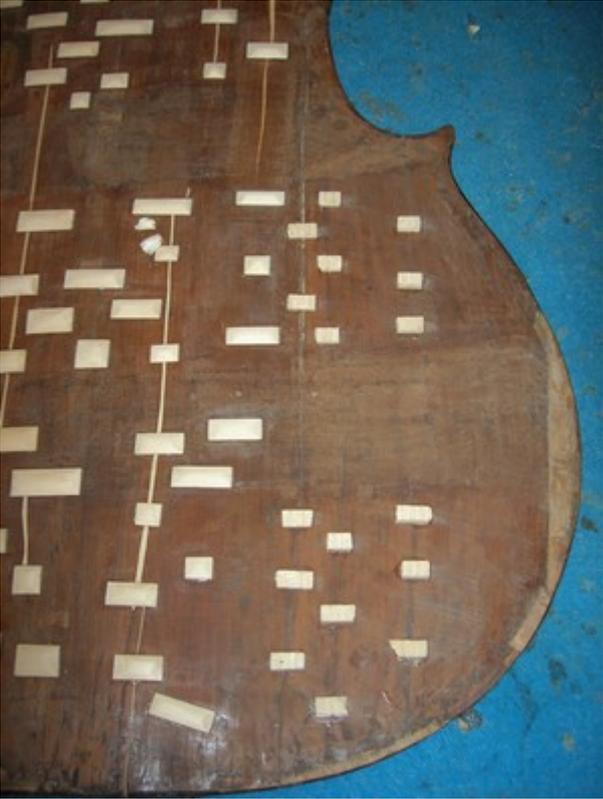
There is a crack in the lower part between the lower edge and the treble C bout, repaired with shims and filler.

I remove the temporary cleats, open, clean, replace the shim and put new cleats.

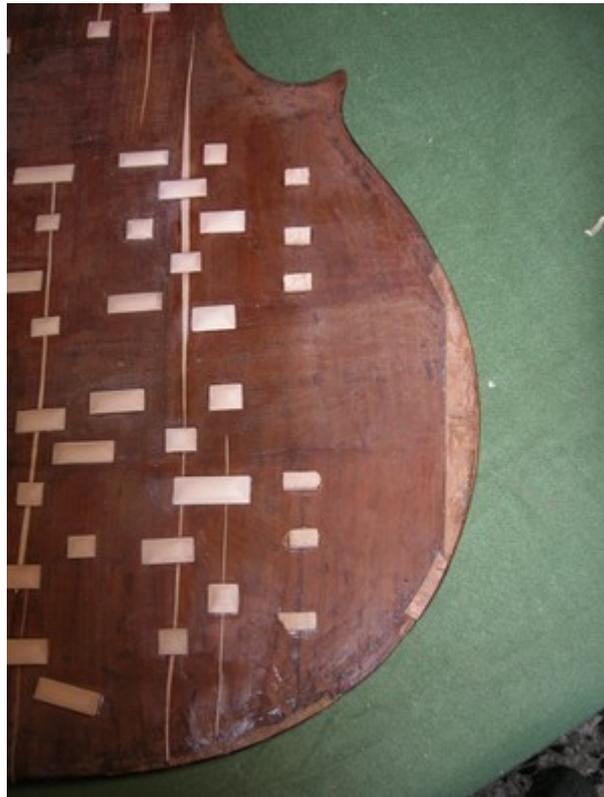
In the lower treble part there is a last crack, between the lower edge and lower corner, properly repaired with a shim, well glued.

I remove the temporary cleats, clean and reinforce with new cleats.

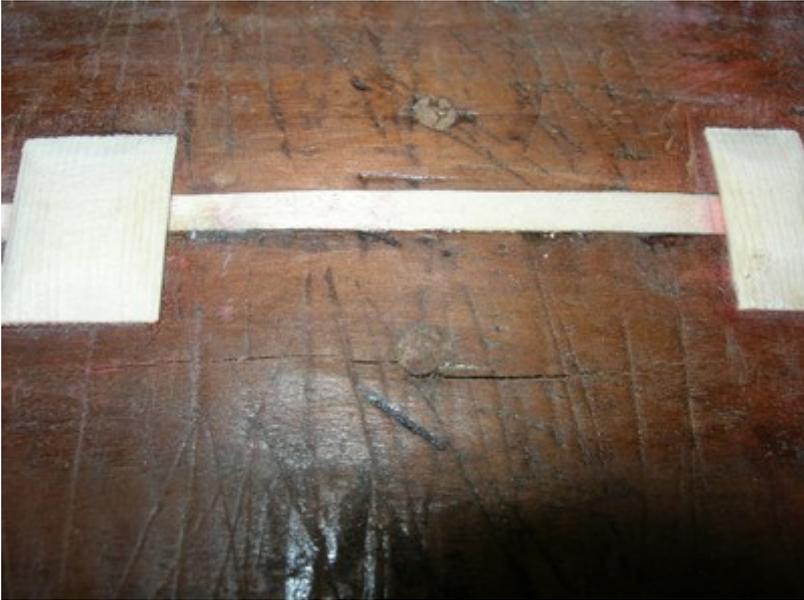
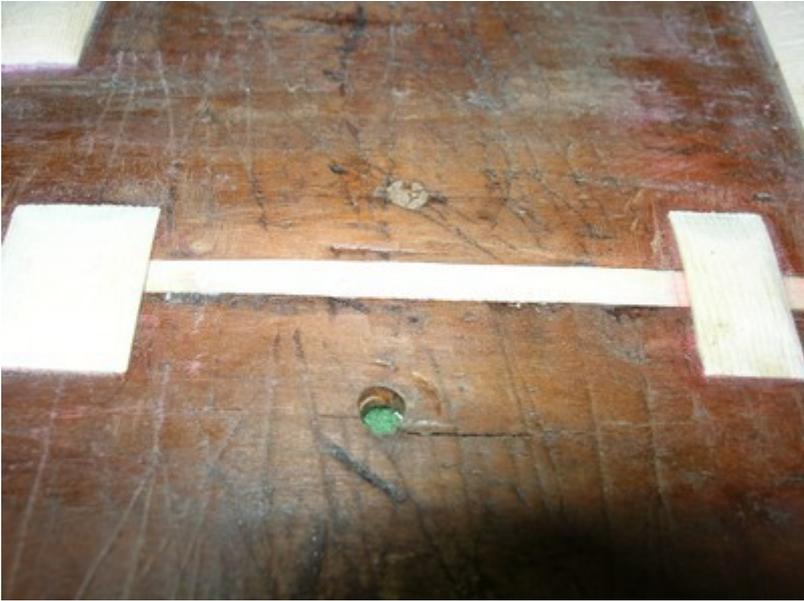
In the upper part I remove a pin in the upper bar glueing surface, which caused a small crack.

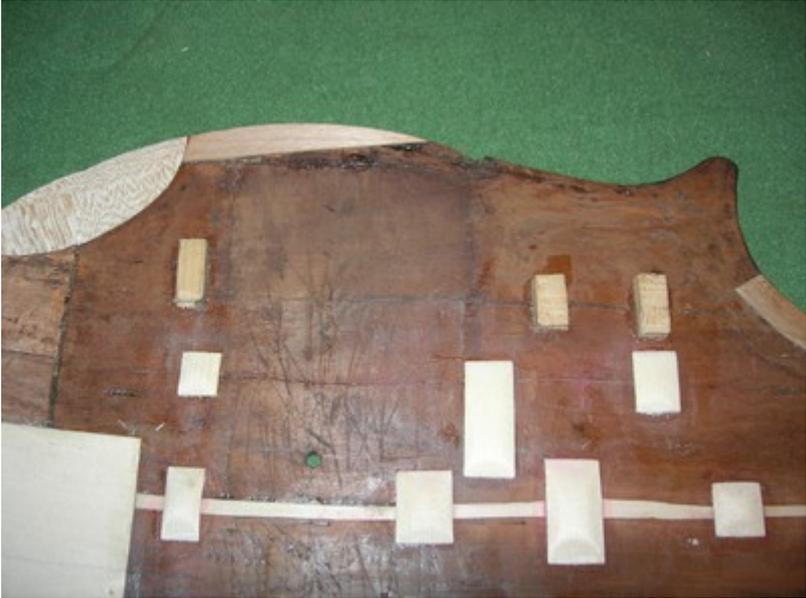
In the upper part, a crack is open from the bend to a reconstruction at the treble C bout. The reconstruction has the grain parallel to the C bout's edge.

It has been repaired from the outside with a walnut shim and filler.

Next to this one, between the bend and the upper bar, a second small crack is open. I clean and repair the two cracks, replacing the shim with a longer one.
