Giuseppe Cazzaniga, Liutaio

Bernareggio, July 2009 - June 2012

Restoration of a Brescian style double bass

The instrument is property of Maestro Ezio Pederzani

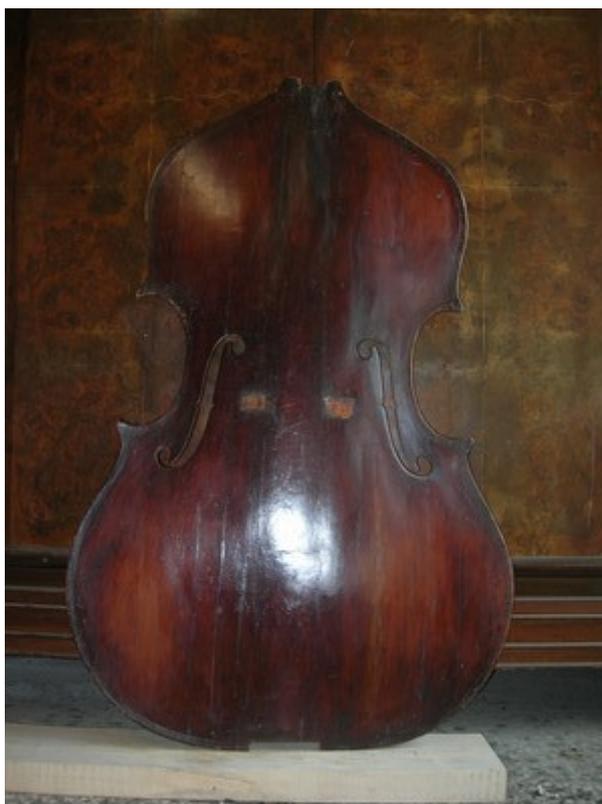
The design of the front is very pleasant, archaic, typical of the Brescian school.

The upper bouts are relatively wide, the C bouts small and round, the f holes very far apart and slanted, with the upper and lower eyes of similar size, the corners long, there is a double purfling, the bridge line is close to the middle point of the top's length. The arching of the upper part of the top is finished with a central crest.

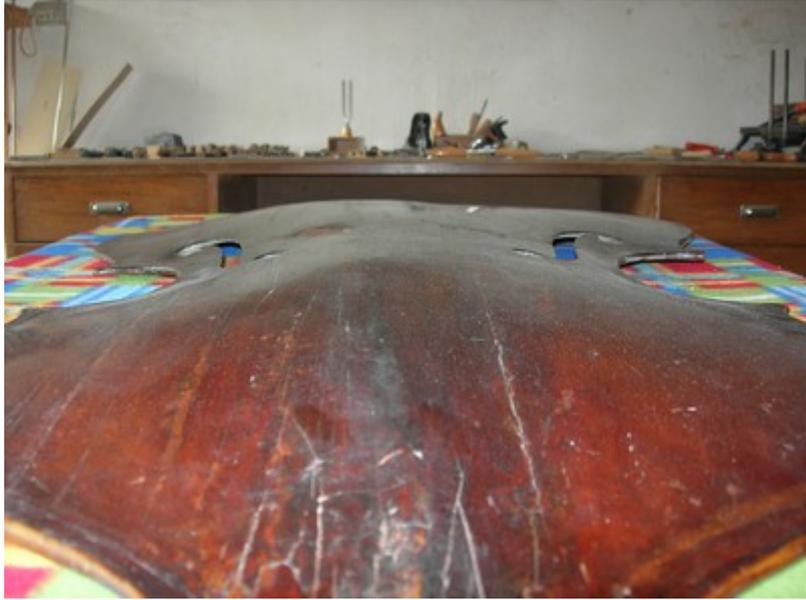
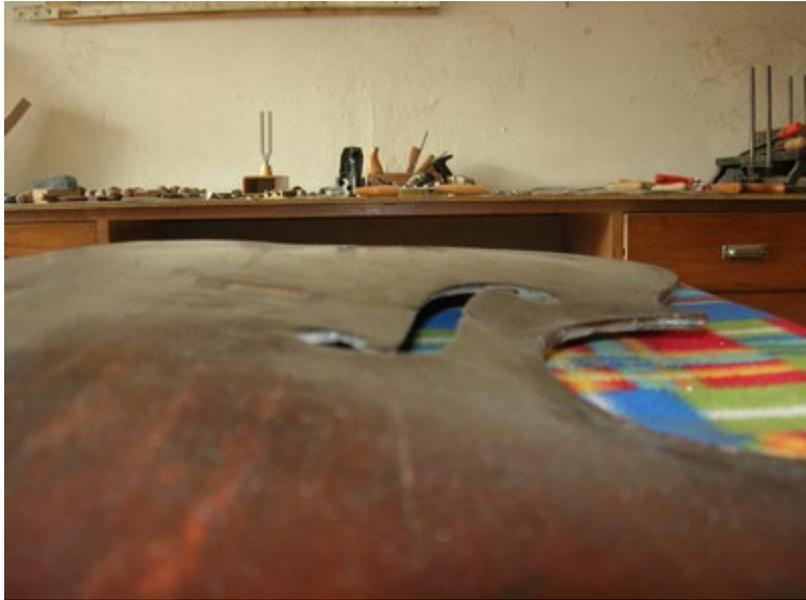
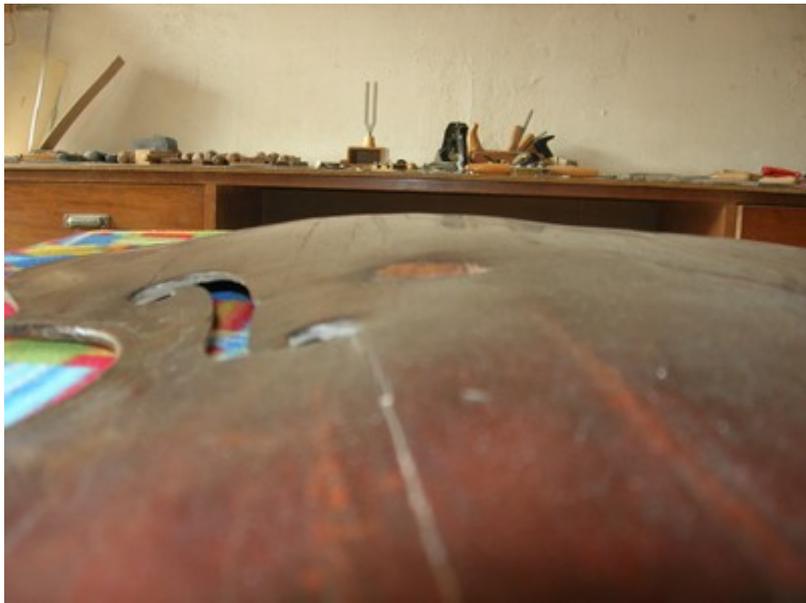
The whole surface on the front is heavily cracked,

It is also very deformed, presenting an extensive weakening of the bass side, a swelling of the lower treble side, cuppings under the bridge's feet, in particular under the G foot

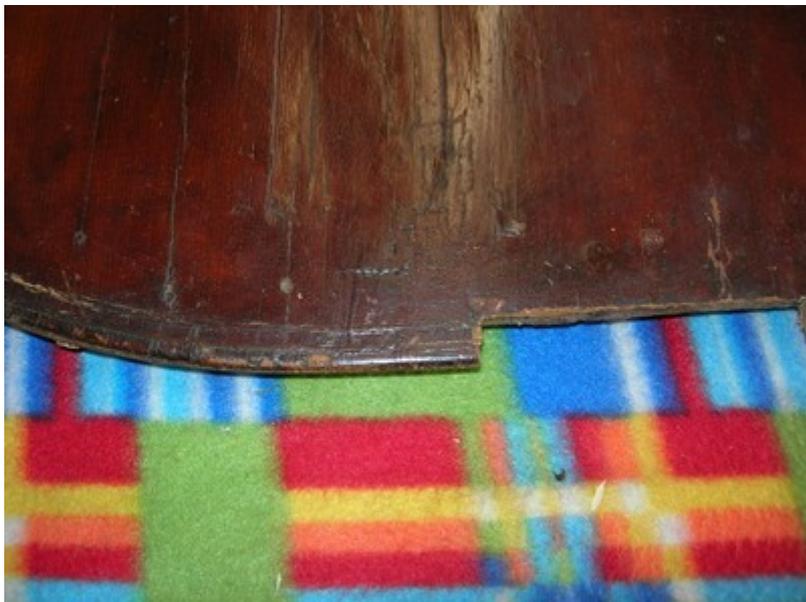
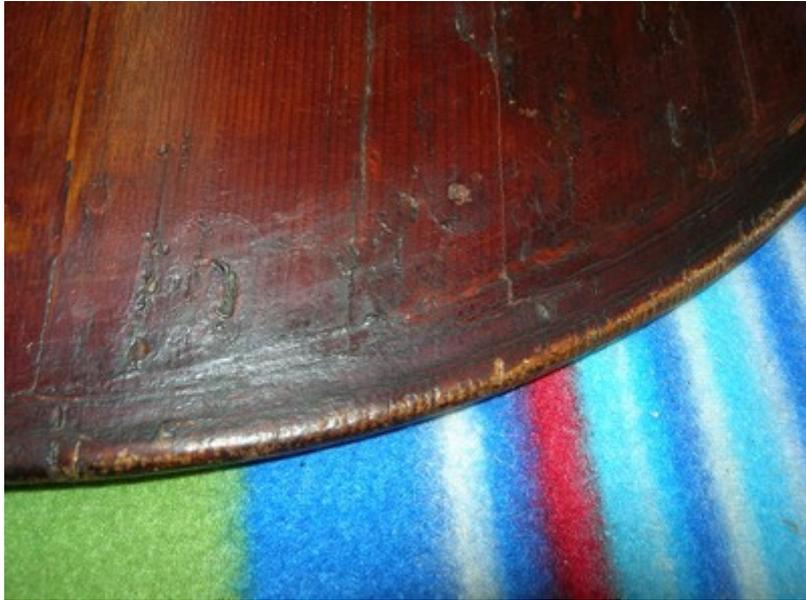
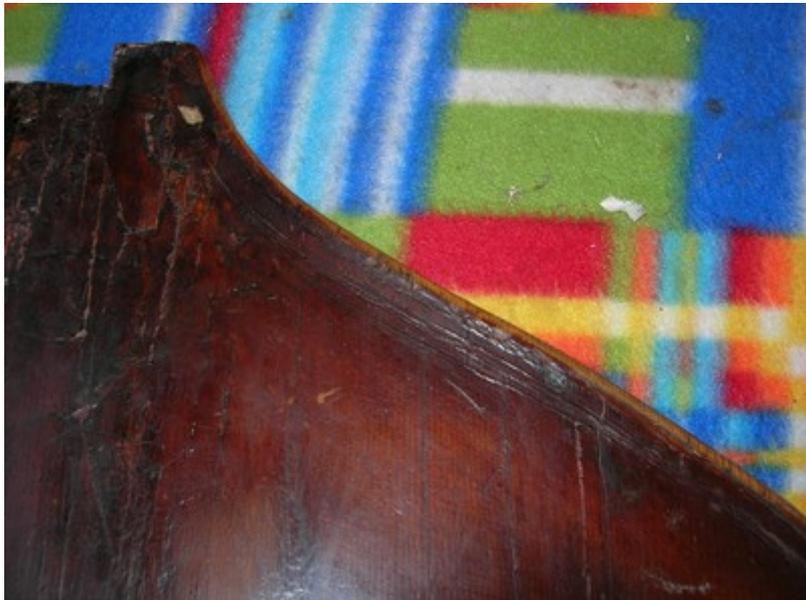
Edge works and and purfling replacements are evident both on the lower and upper block's sides.

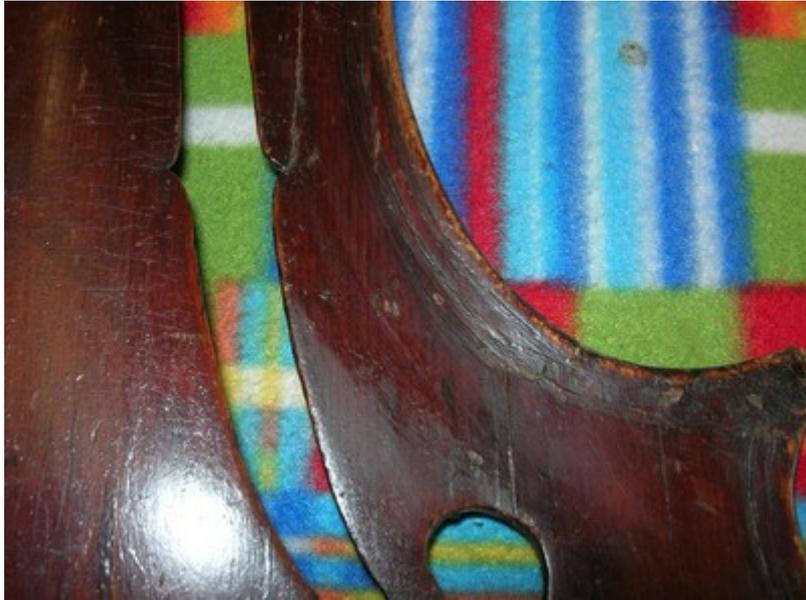
The varnish is dirty, with red brown retouchings and fillings, specially near the bass bar, where there are evident woodworm damages.

There are no open worm holes though.

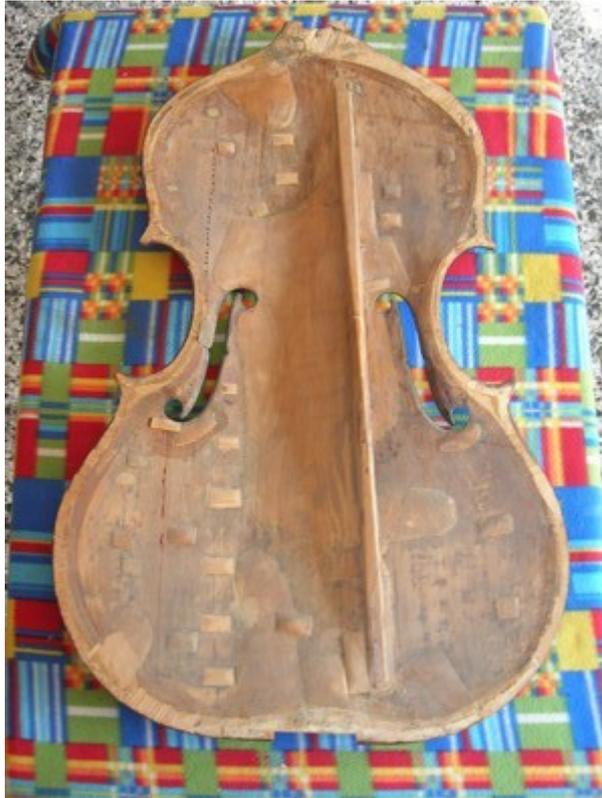
From an inside view, there are repairs by at least three different hands

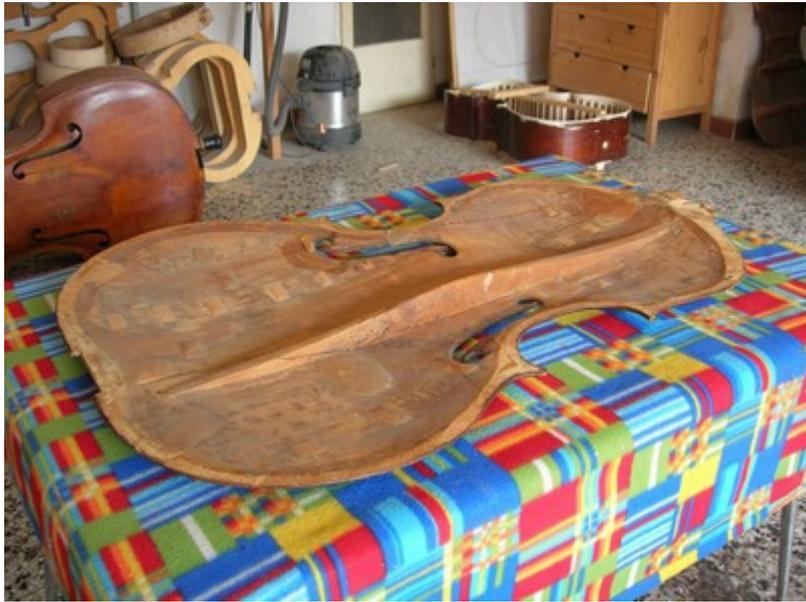
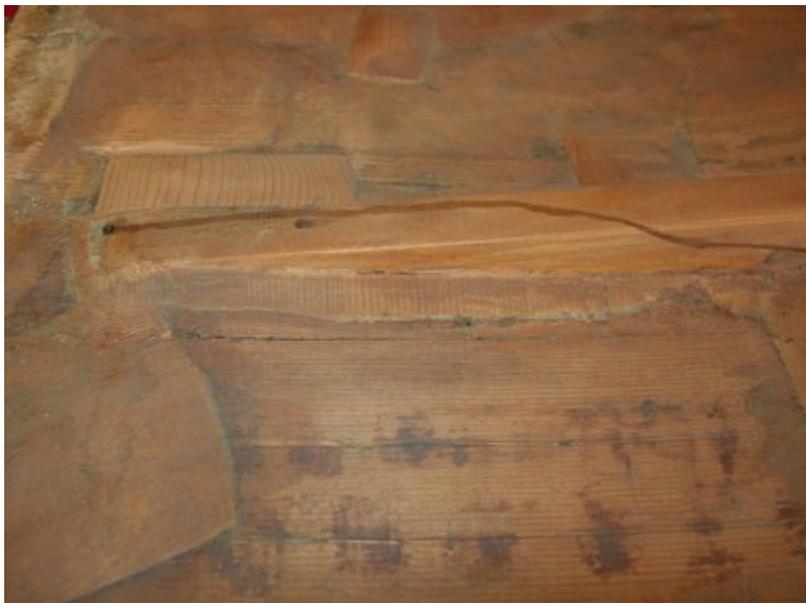
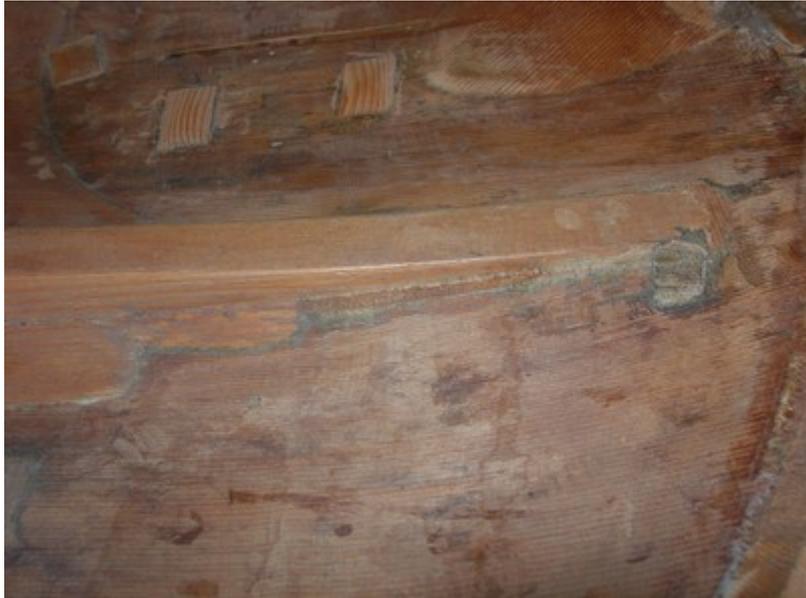
The bass bar, which is very long, conical, well shaped, is glued to a large doubling in the middle part of the top, and to reinforcements with perpendicular fiber at the edges. (the grain of the central doubling which is made of multiple pieces, goes in various directions).

The thickness of the non doubled parts, without considering irregularities, shows a thick area near the edge, ranging from 4,5 to 6 millimetres, up to 7,5 in the C bouts area, and a relatively thick area at the edges of the bass bar, between 6 and 7 millimetres, while thin areas can be found between the bass bar and the edges, till a minimum of 2,8 millimetres.

The edge of the f holes has been bevelled from the inside, so that from the outside it shows a thickness more or less regular and of an average of about 4 millimetres.

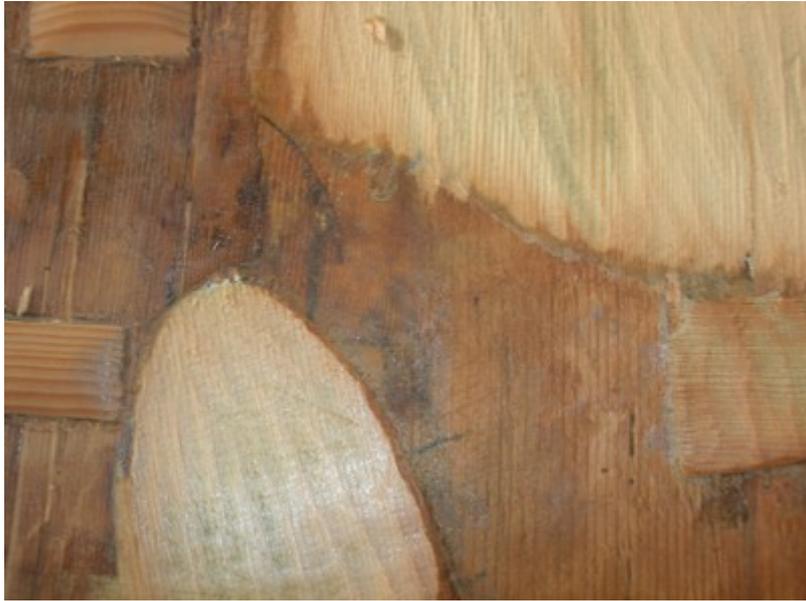
While doing this, I notice that the edge doublings and their extensions toward the inside are older than the ones in the middle of the front, where the wood used seems less oxidized.

There is a second doubling in the lower center of the top, older than the one covering it.

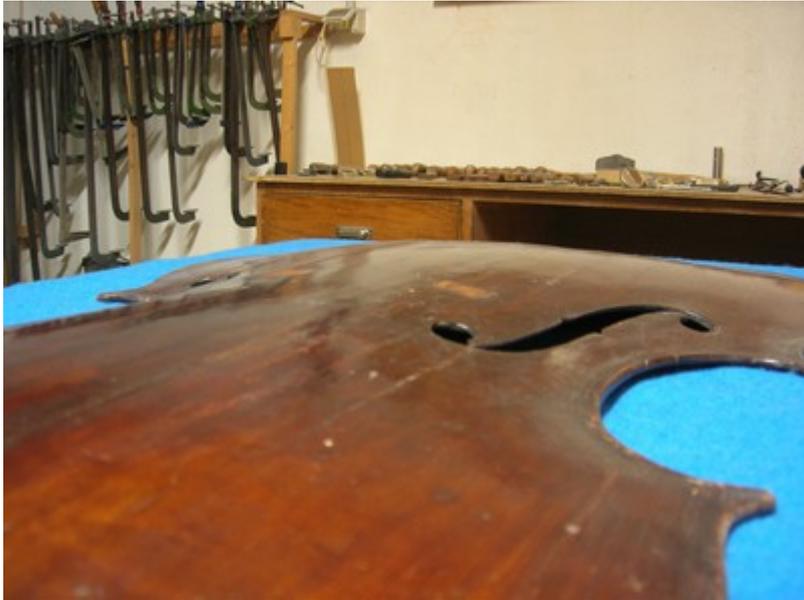
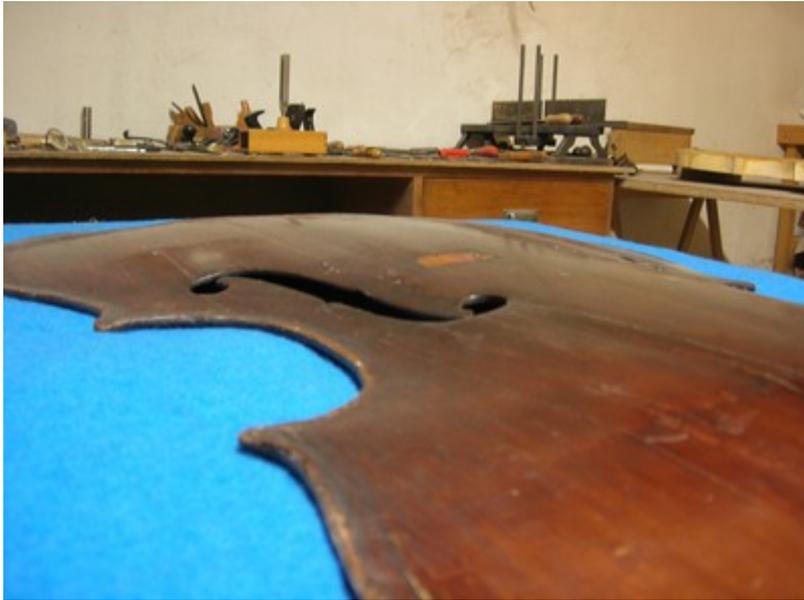
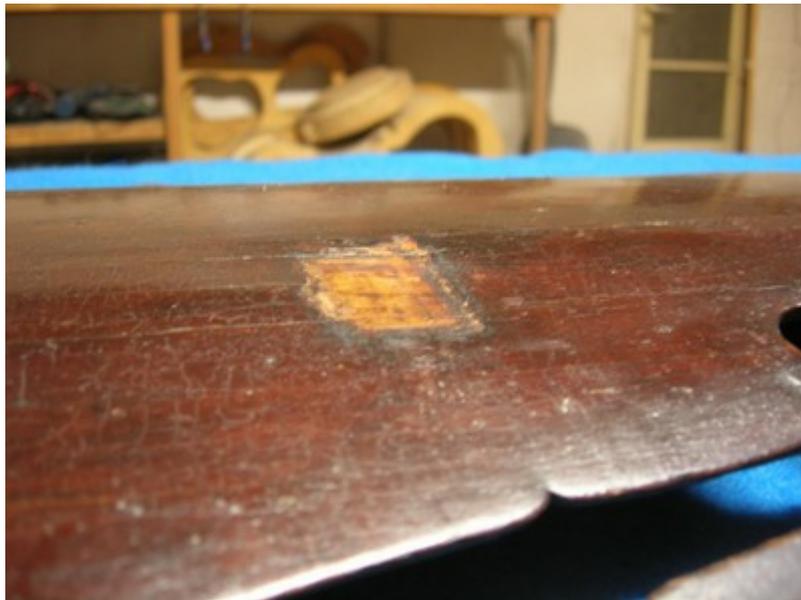
The top takes an acceptable shape in about two months. The area under the bridge's treble foot remains slightly cupped, and it will need more time to get in shape before the making of the central doubling.

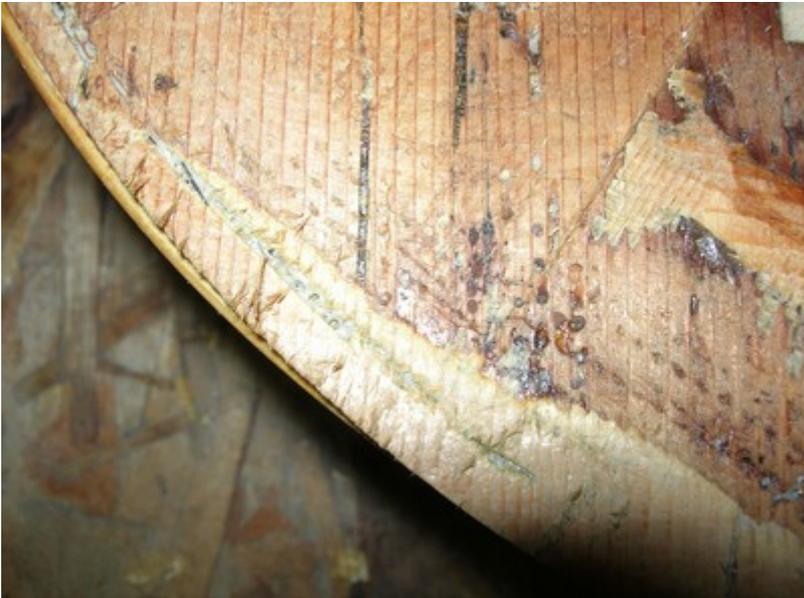
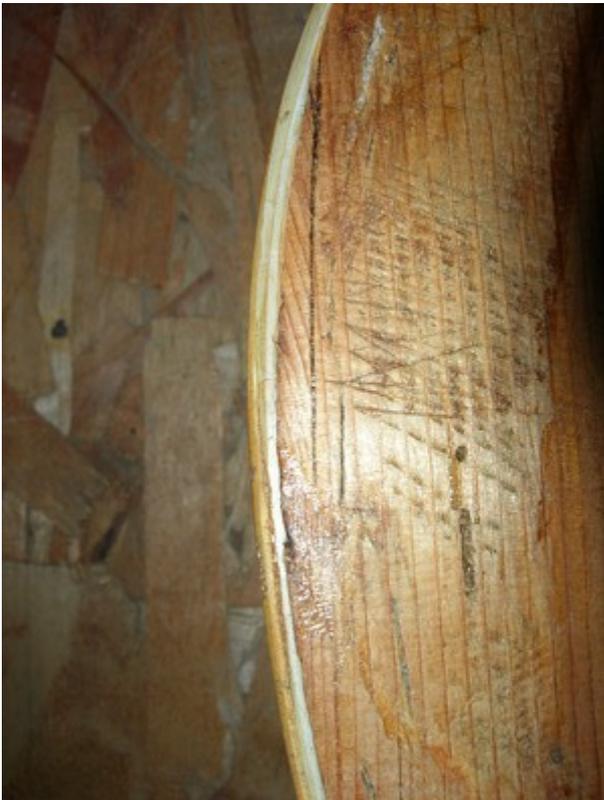
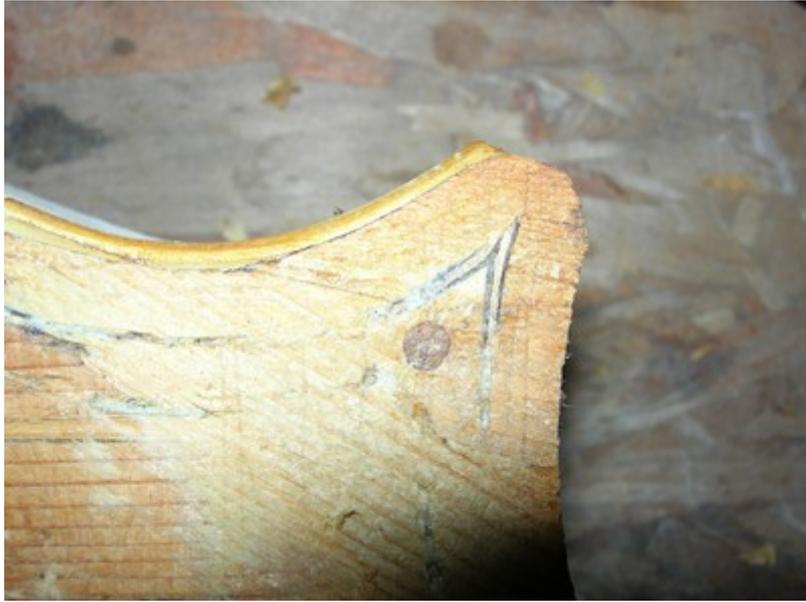
By doing so, I can see that the edge had been replaced in the lower part, at the widest part of the bout and at the corner, where I see a wooden pin.

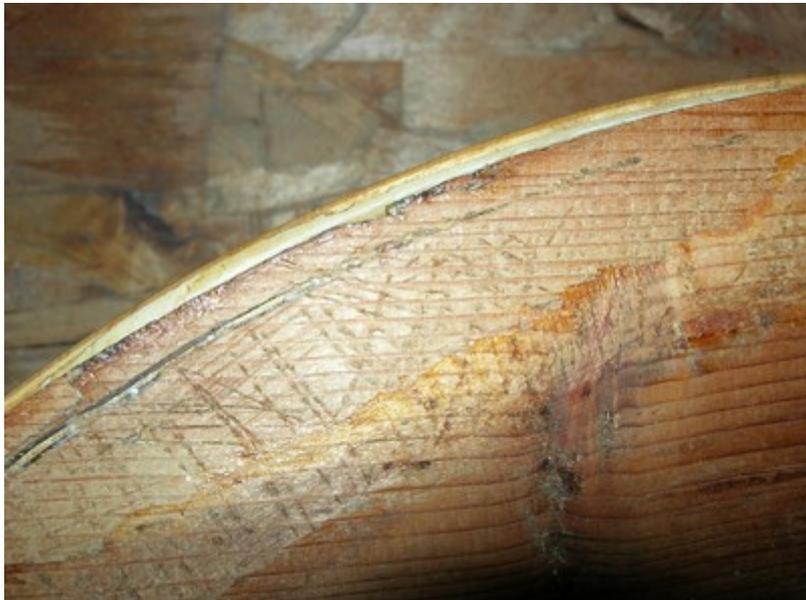
The outer purfling has been partially replaced or reglued with white glue.

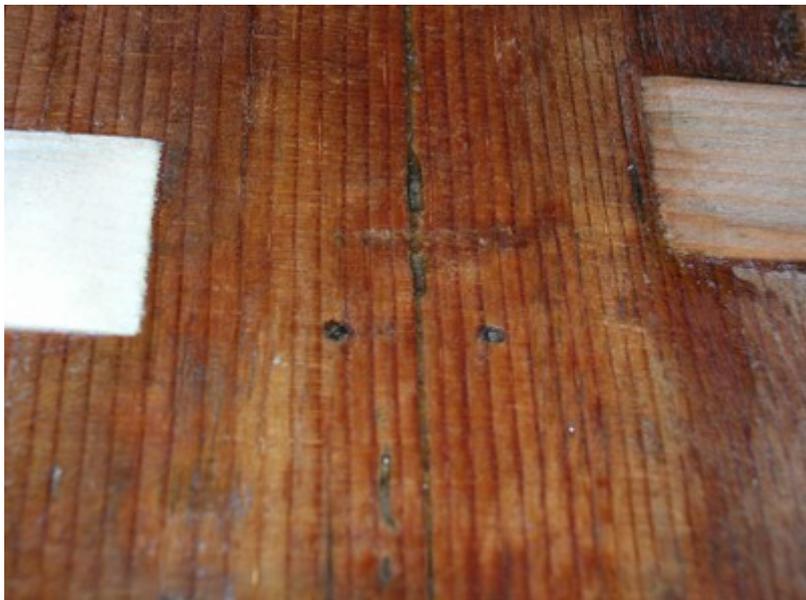
I proceed in the same manner with the following two cracks
The inner one has been repaired with stiches, of which holes still remain.
The outer one has two well made shims.

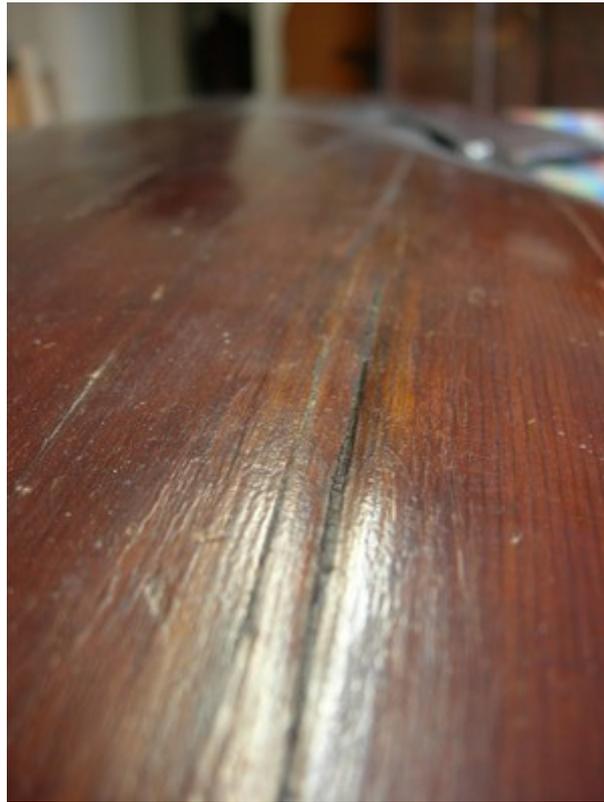
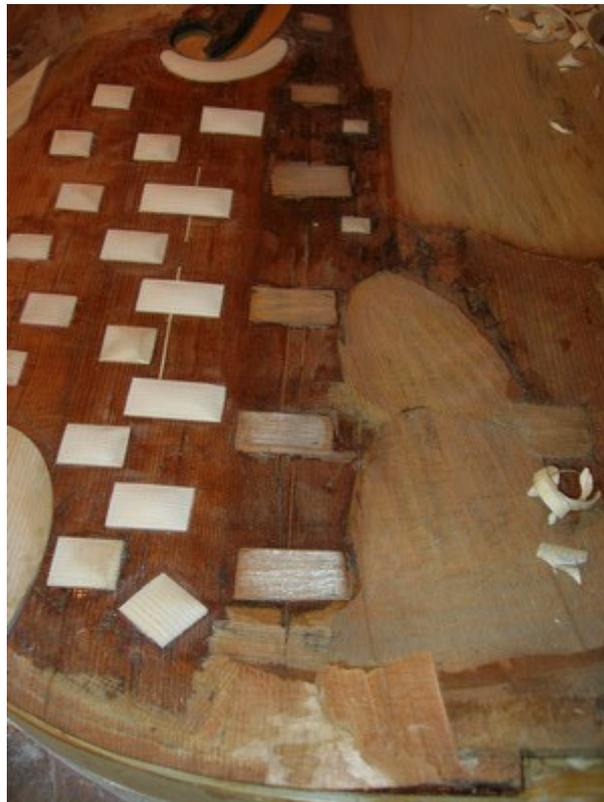
The next two cracks, close to each other, were repaired offset, with shims and filler. The front has been leveled from the outside, removing the varnish, which has been later retouched.

I unglue, remove shims and filler, repair the upper part, were there are no missing parts.

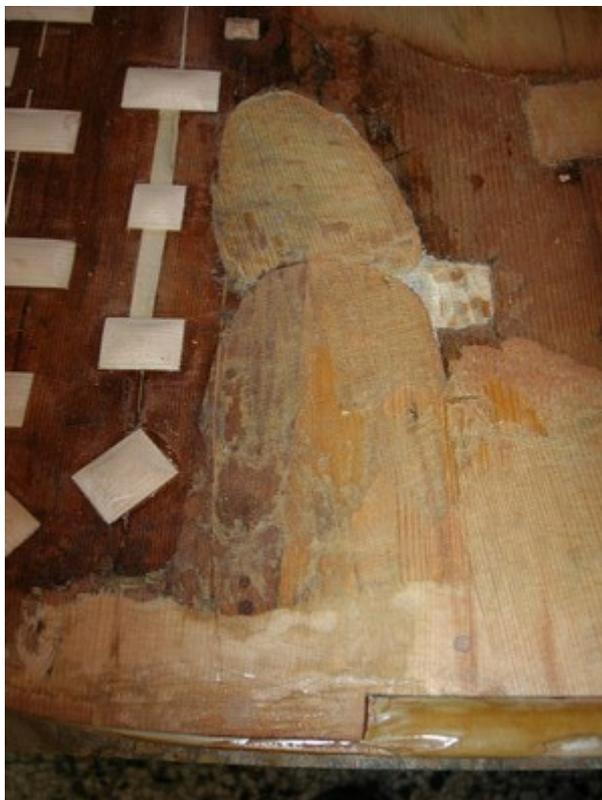
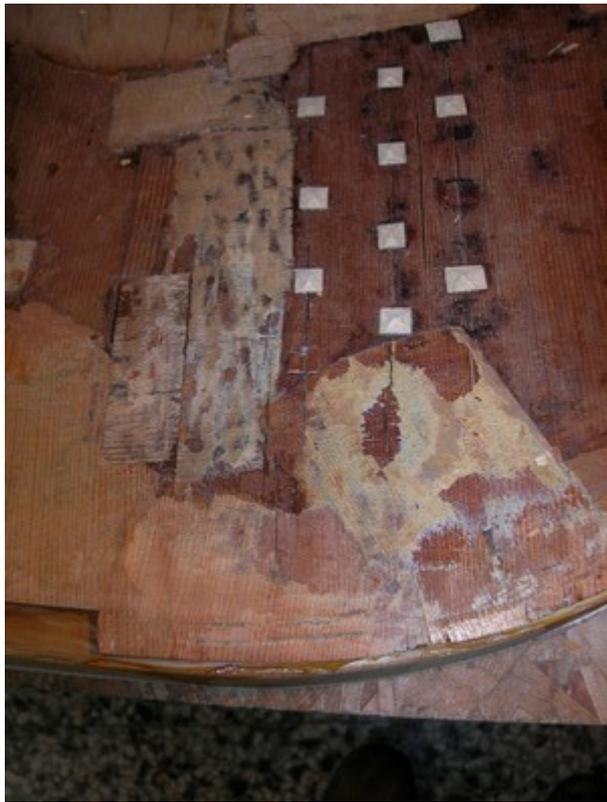
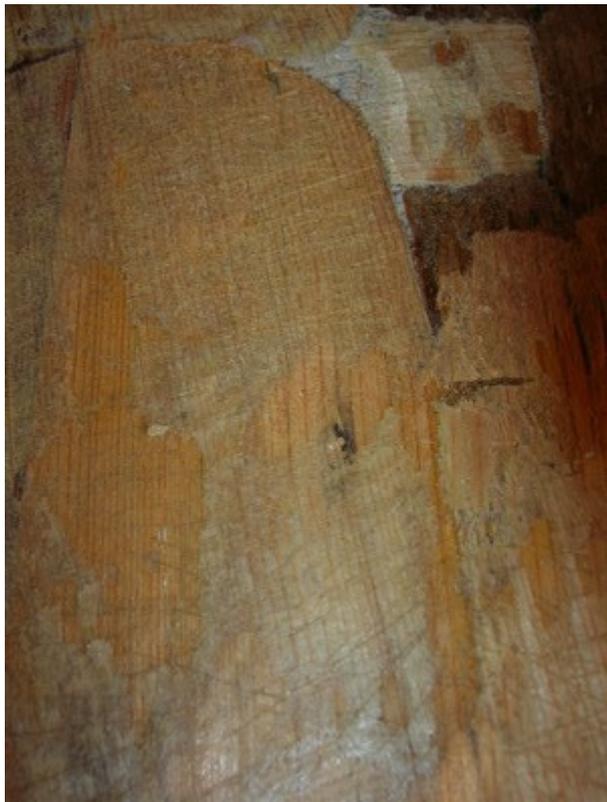
I notice that an old doubling covers the large reconstruction, made before the edge doubling and the lateral reinforcements.

Both doubling and reconstruction show a crack repaired with a walnut shim.

The thickness of the external reconstruction is of about 2 millimetres. The old doubling covering it brings this area to 4,2 millimetres.

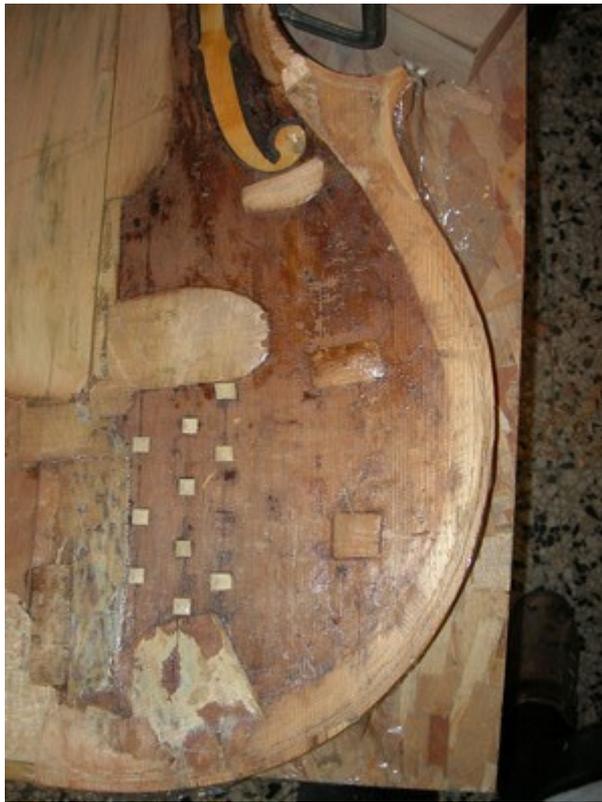
By doing so, edge reconstructions come to light along the whole bout, together with a corner reconstruction.

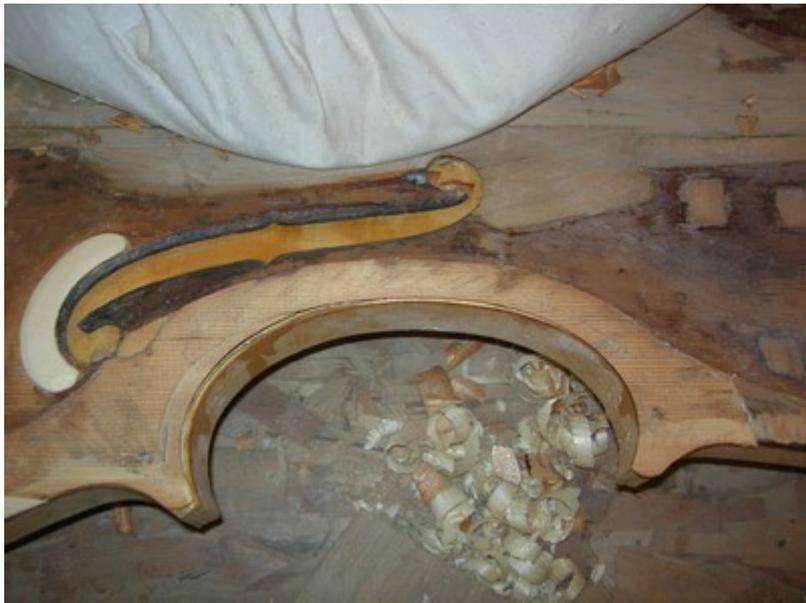
It is possible to see an edge replacement of the treble C bout, maybe made because of the bowing action. The corners have centering pins.

The bass C bout has both corners reconstructed.
Here as well are centering pins.

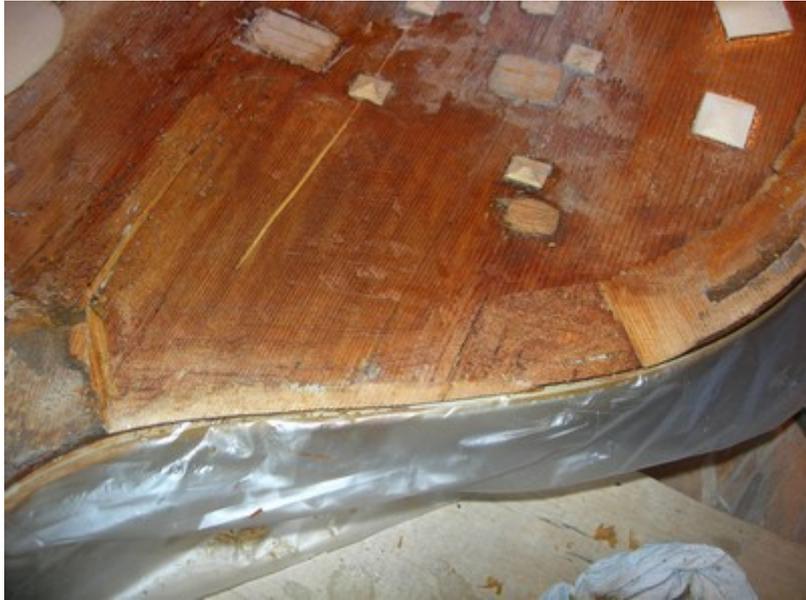
This way the replacement of the top edge made to widen it can be clearly seen.

The extension of the edge doubling towards the inner part of the top was inserted in the wood, and the top is here thinned to 2,7 millimetres.

There are two well done shims as well.

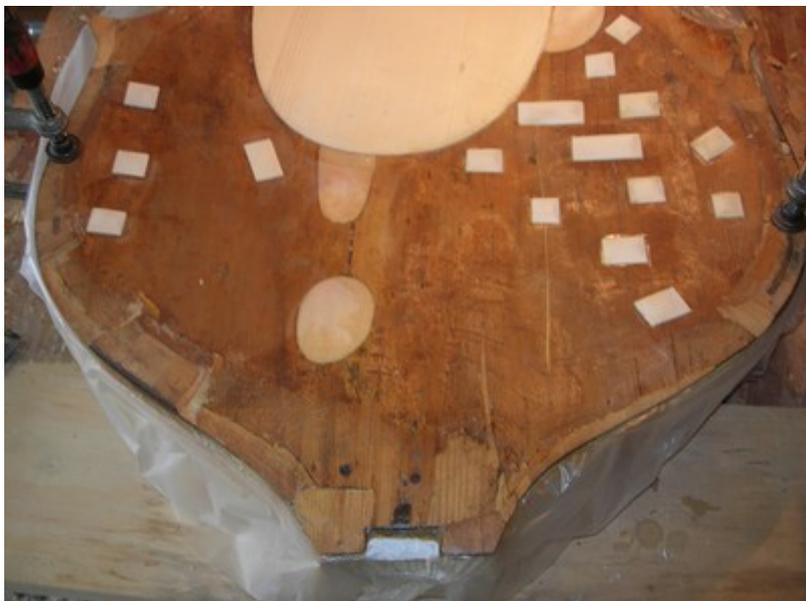
Now it is possible to see the edge reconstruction and four centering pins in the upper part of the top.

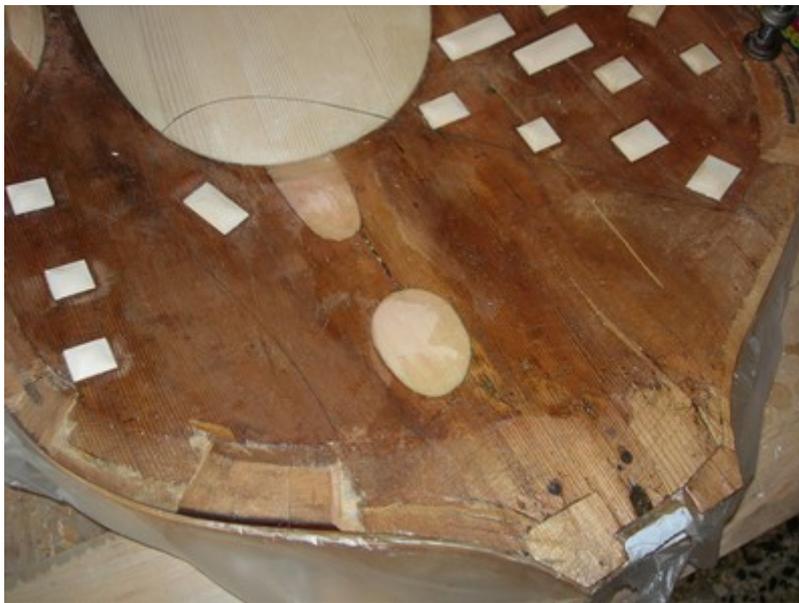
Between the tip of the bass bar and the edge doubling there is an area, 7 millimetres thick, that is maybe original. Unfortunately I will have to thin it to glue the upper new doubling. This area is cracked anyway.

The thickening of this area is interesting, maybe revealing the maker's intention to reinforce a part of the top subject to sollicitation.

Another thickening of the upper part of the top, up to 11,5 millimetres, can be found in proximity to the central "crest" carved on the outside.
