Giuseppe Cazzaniga, Liutaio.

Bernareggio, 28 Maggio 2009

## “Nicola Rossi 1844” Double Bass Restoration

The instrument is property of the “Conservatorio G. Verdi” of Milano

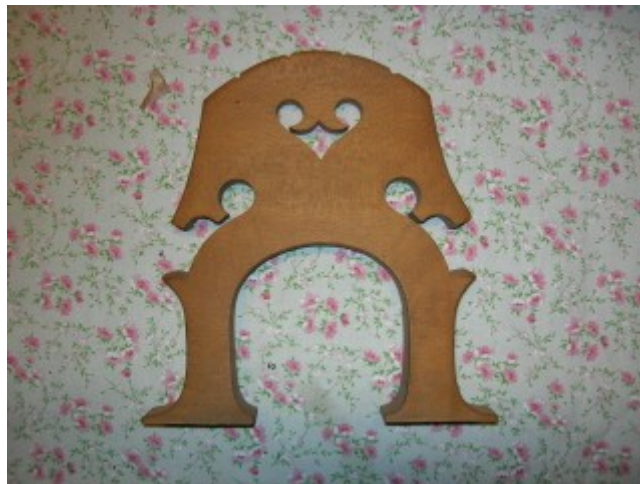
**Figura 23**

I will not use again the warped bridge.

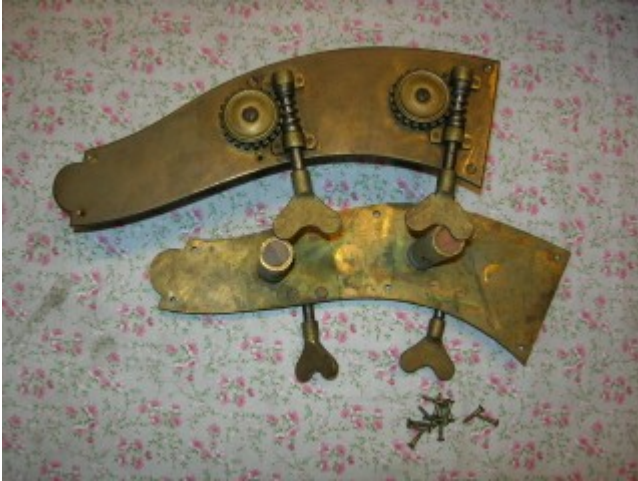
**Figura 24**

The gears are a craftmade turning work of the '50 years of the last century. They are heavy and unpleasant for our contemporary taste, but well machined and perfectly working.

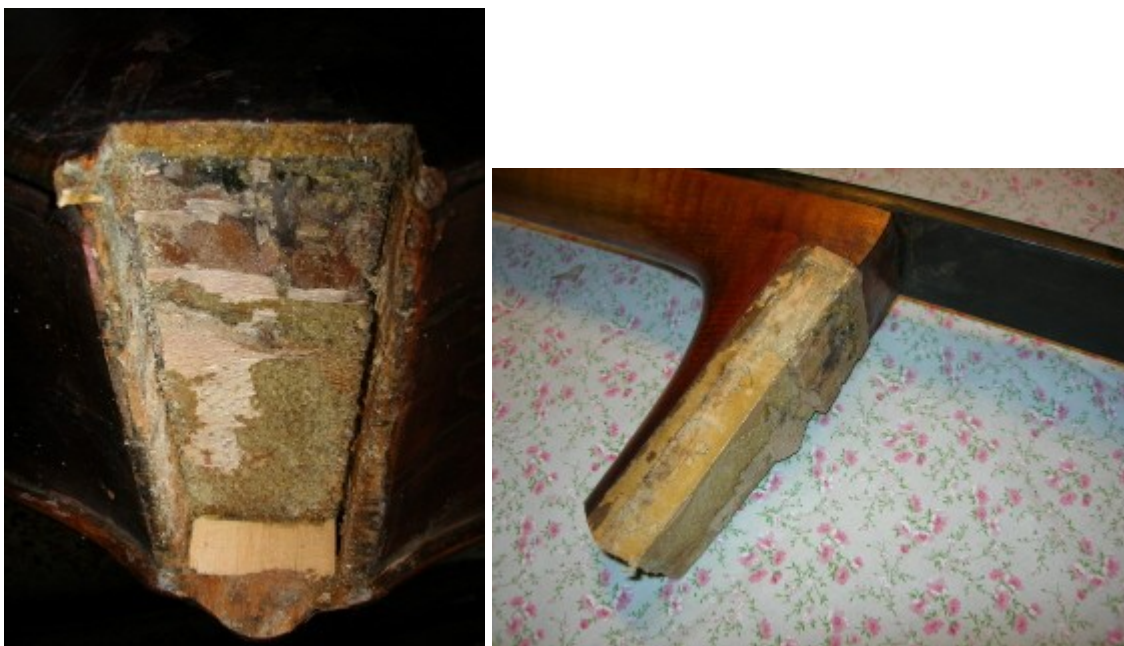
**Figura 27, Figura 28**

The mortise is almost perpendicular, and some plane tree pieces are glued in.

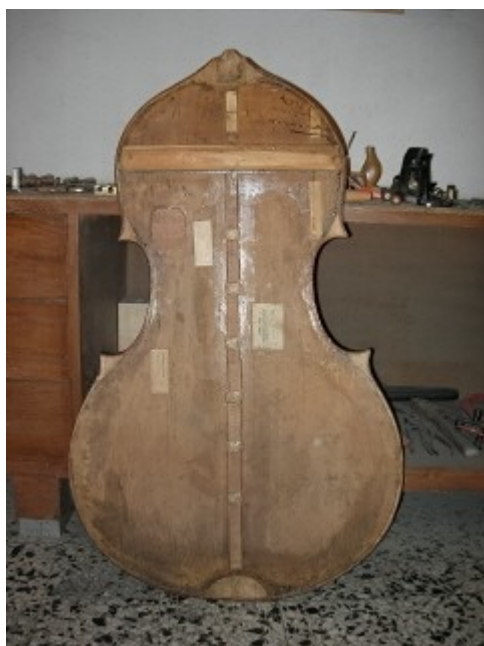
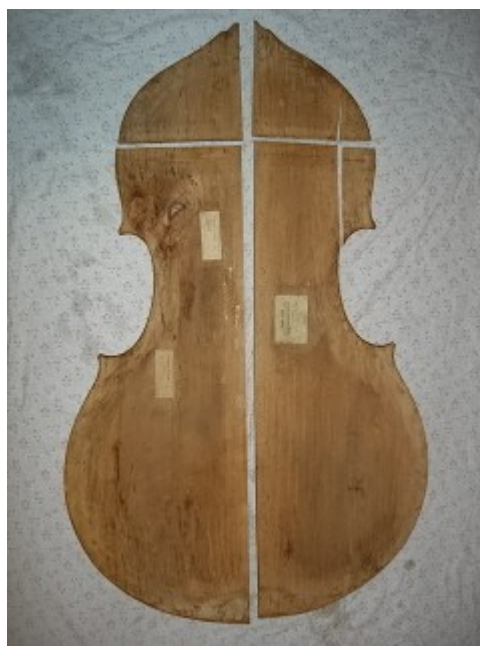
**Figura 39, Figura 40**

The back is quite thick. Along the central joint the thickness increase to mm14,6 at the lower part and mm8 above the bend.

The edges are mm6 above the bend and mm8 elsewhere.

Between the central joint and the edges the thickness is more or less mm8 at the lower part and mm6 above the bend.

I remove the bend bar from the back, which is broken and seems to be not original.

I also remove the central joint and the repaired cracks reinforcements. I clean the inside surface from the dirt and the glue drops.

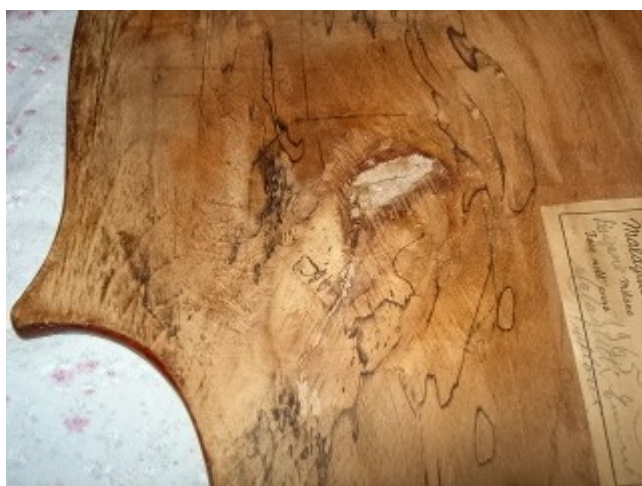
**Figura 47**

and, on the E side, the cracks at the lower corner, at the lower bout “slab” of the beechn, the knot near the upper corner

Firstly I repair separately the two parts of the back above and under the broken bend.

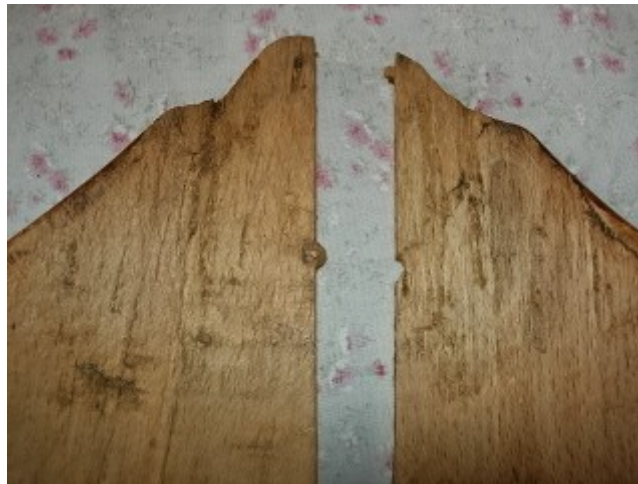
**Figura 49**

the one on the E side near the central joint and the joint itself.

A peg is inserted in an hole at the joint, where probably a centring pin was removed in a previous restoration.

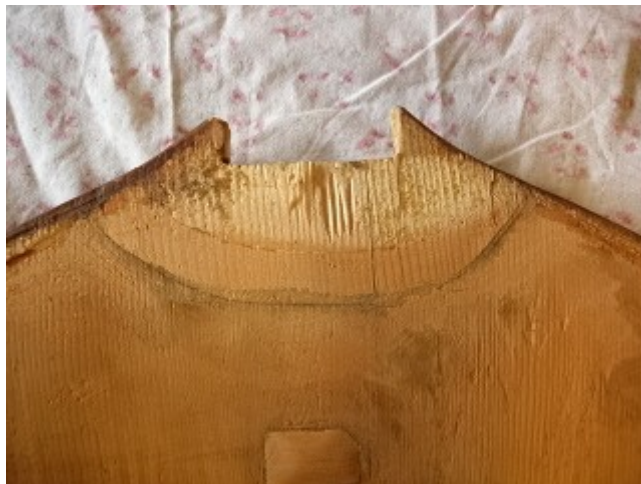
**Figura 85**

The gluing plane is partially duobled: with spruce at the neck block joint;

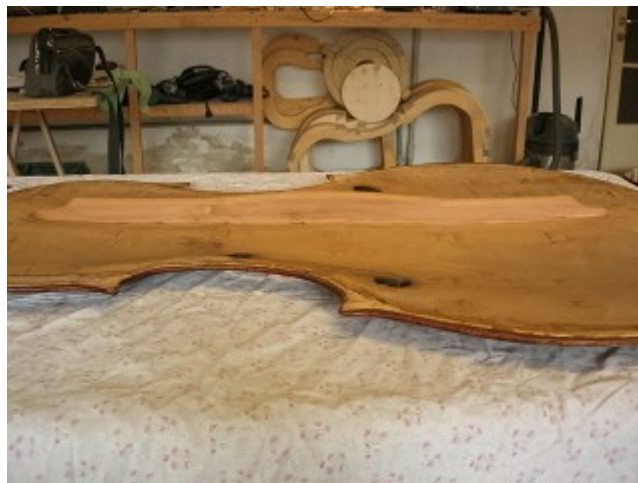
**Figura 97**

The shape is very stiff, but I don't change it for the arching weakness and to save a typical half '900 work.

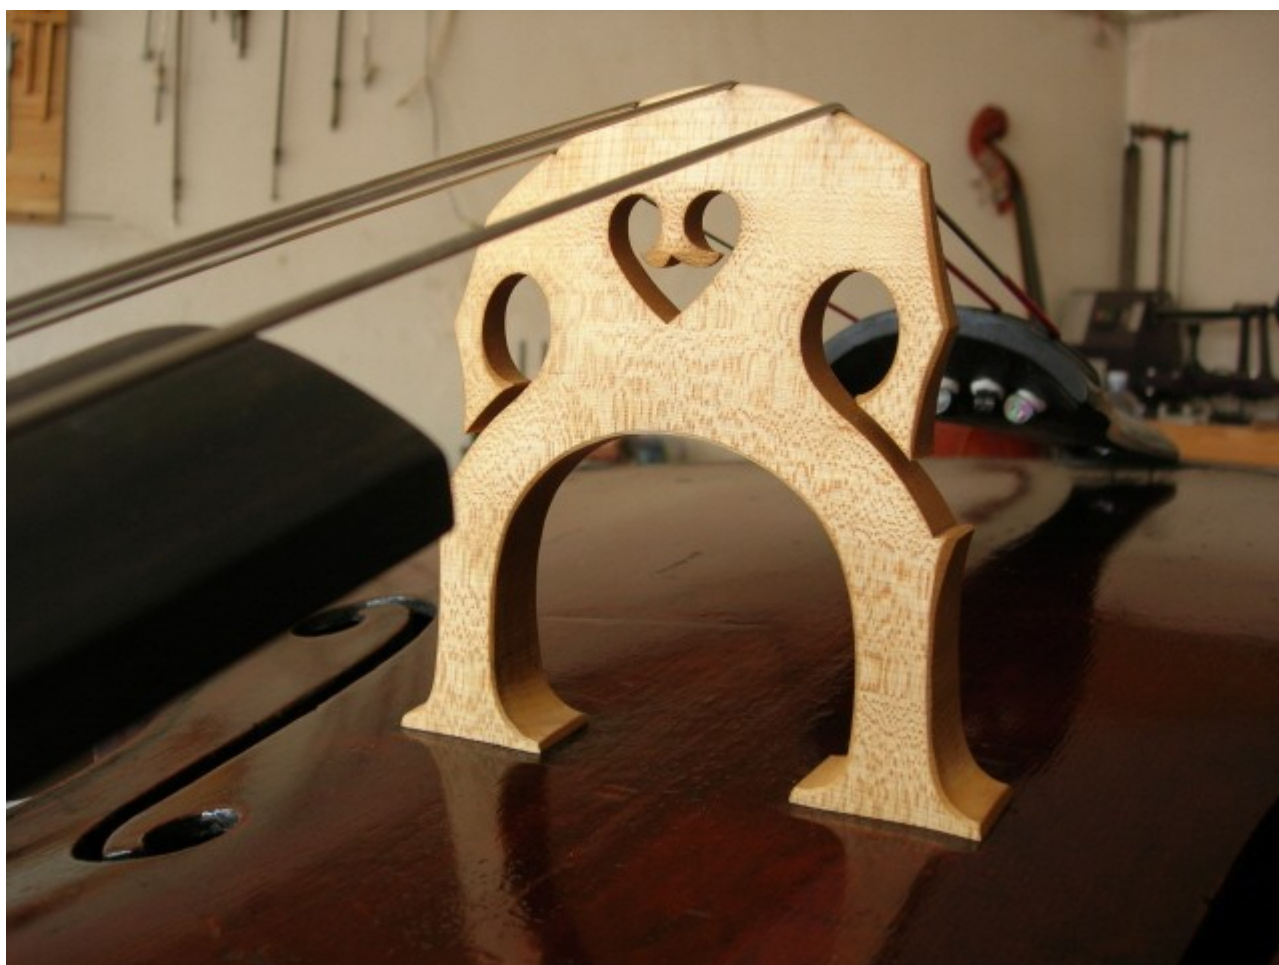
**Figura 119**

The cuts are not positioned at the f holes centre. The Maker put them a little high.

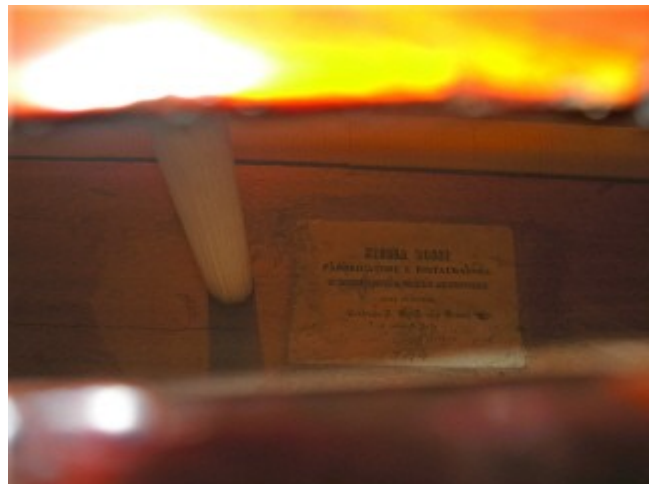
**Figura 120**

The label is glued on the back under the G side f hole. So the soundpost cannot be placed too near the bridge.
