Giuseppe Cazzaniga, Liutaio

Restoration of a Brescian style double bass

The instrument is property of Maestro Ezio Pederzani

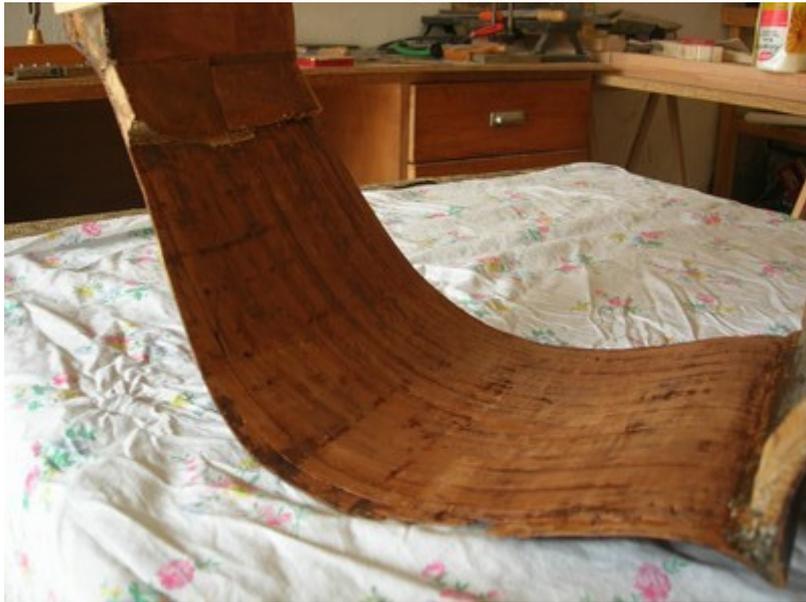
The lining on the belly side, in linden wood, is cut and bent. This overlaps a second one, maybe in poplar.

The rib is between 1,8 and 2,3 millimetres thick.

I remove all repairs and linings from the rib.

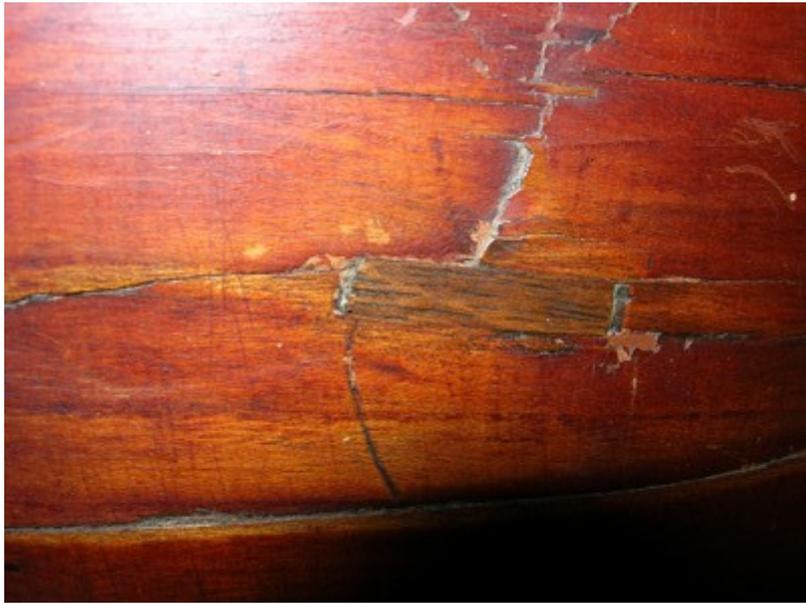
There is a small replacement in the center of the rib as well.

I clean the rib from all repairs and linings.

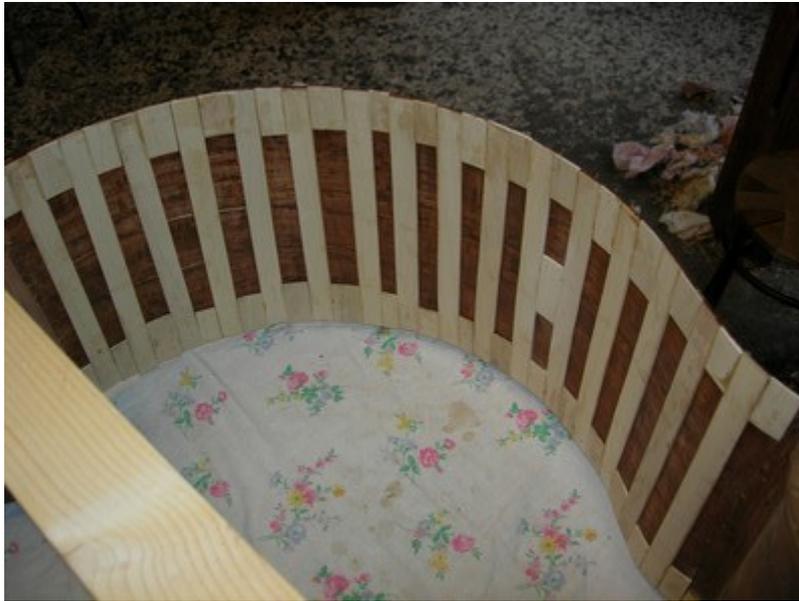
The glueing surface between ribs and back has been lowered, probably during the replacement of the lower edge of the back.

In order to rebuild the missing section, I glue a set of poplar splints longer than the current height of the rib.

I then glue the doublings between the splints.

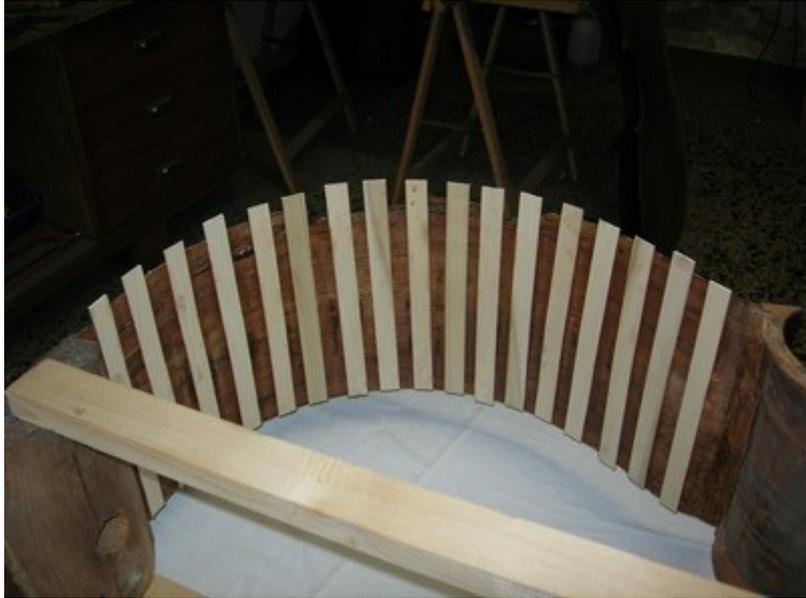
The glueing surface of the back to the ribs next to the lower block has been lowered.
Once the rib is cleaned, I make the poplar splints higher than the rib, to rebuild the missing part.

I then glue the poplar doublings between the splints.

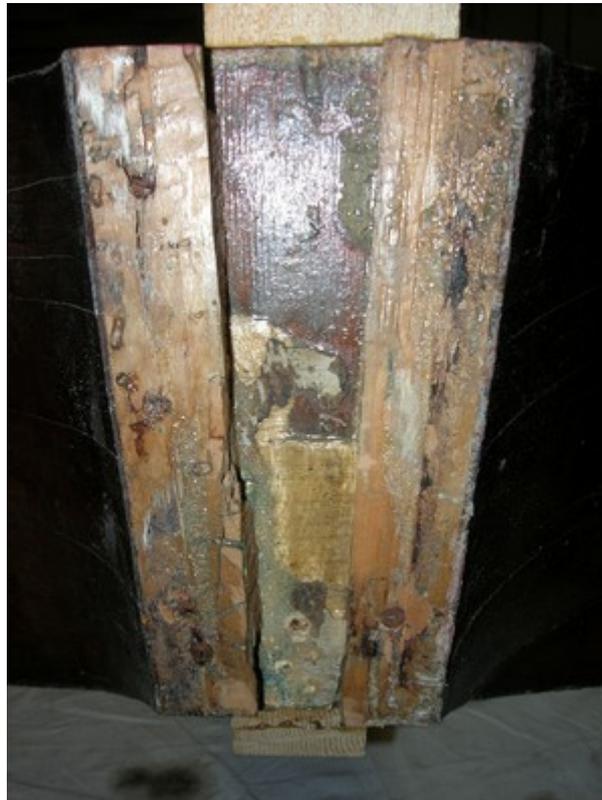
The external layer is screwed to the inner ones, and is not original. It is made of walnut, and forms the cheeks of the dovetail neck fitting.

In the middle, two layers of spruce are glued together, with transversal fiber.

The last layer is in slab cut spruce, and the fiber is perpendicular to the ribs.

On the sides of this are two grafts, both in two pieces, that were probably made to widen the shoulders on the belly side, while tightening the back, as can be seen from the back's purfling and the front additions.

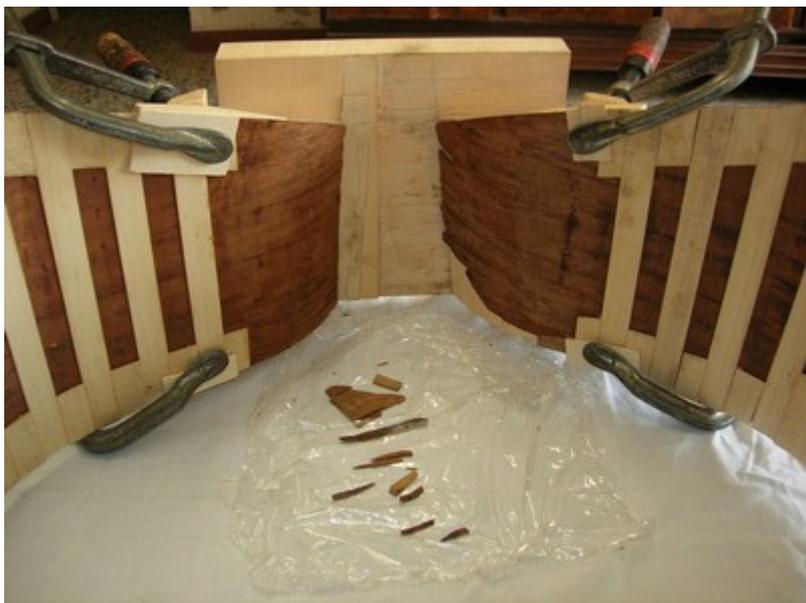
During the cleaning of the ribs, two replacements on the bass side get unglued, and some splinters break off.

The two middle layers of the block, with the fiber running perpendicularly to how it is commonly used, are glued to the ribs by the endgrain, and have three holes.

I remove the crosses and the upper block.

I use the counterform the way it is to sustain the ribs while I remove the block. I will eliminate the irregularities, while maintaining the same profiles on both top and back side for the making and glueing of the new block.

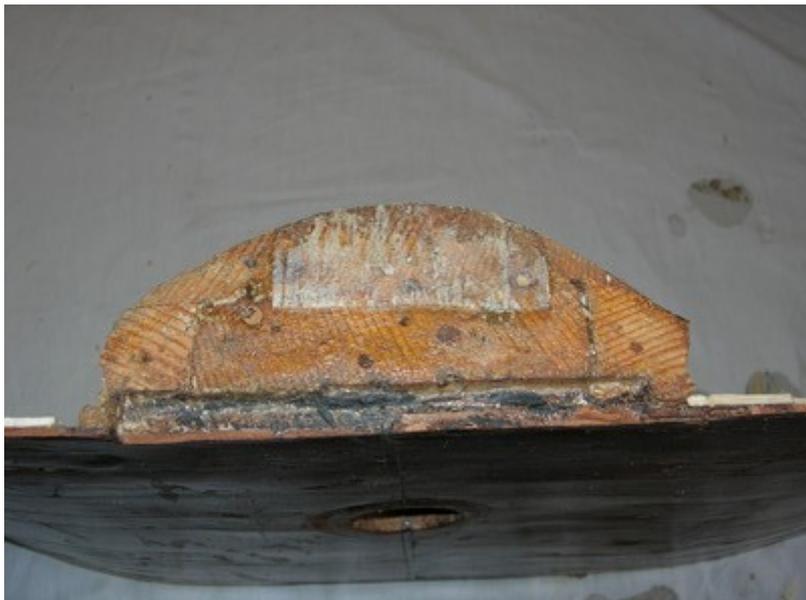
It is made of four pieces of spruce, with the grain running in different directions, but all perpendicularly to the ribs

The endpin hole is off center in respect to the height of the ribs

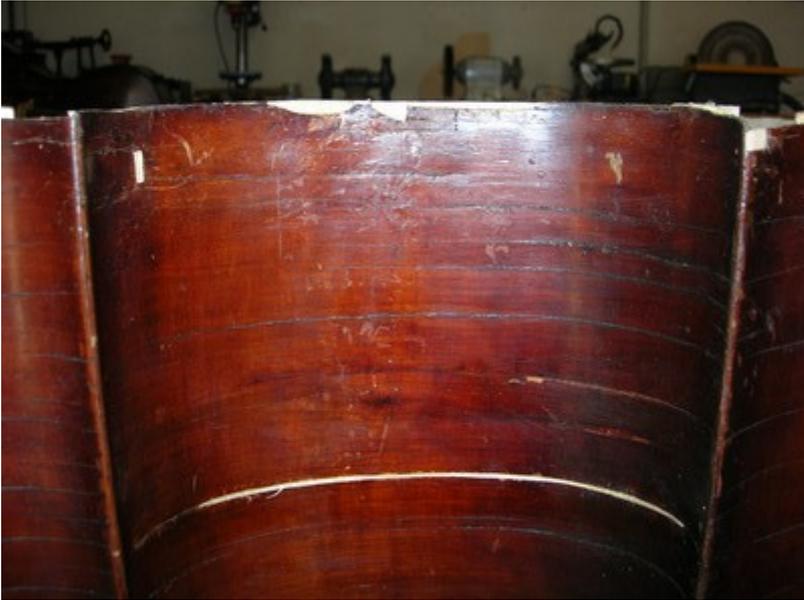
On the back side, the corner blocks are lower than the ribs.

I rebuild the missing parts and two replacements on the lower corner.

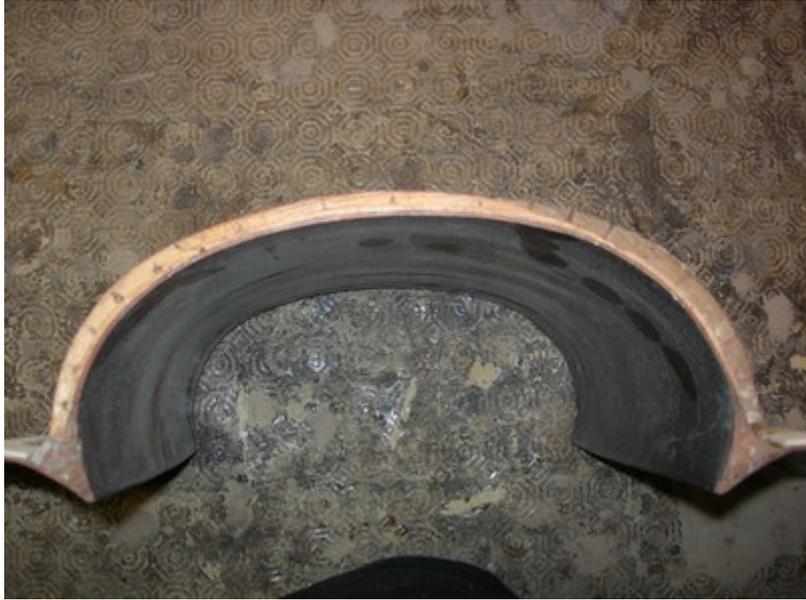
On the top side a straight fiber lining is covered by a second one, cut and bent.

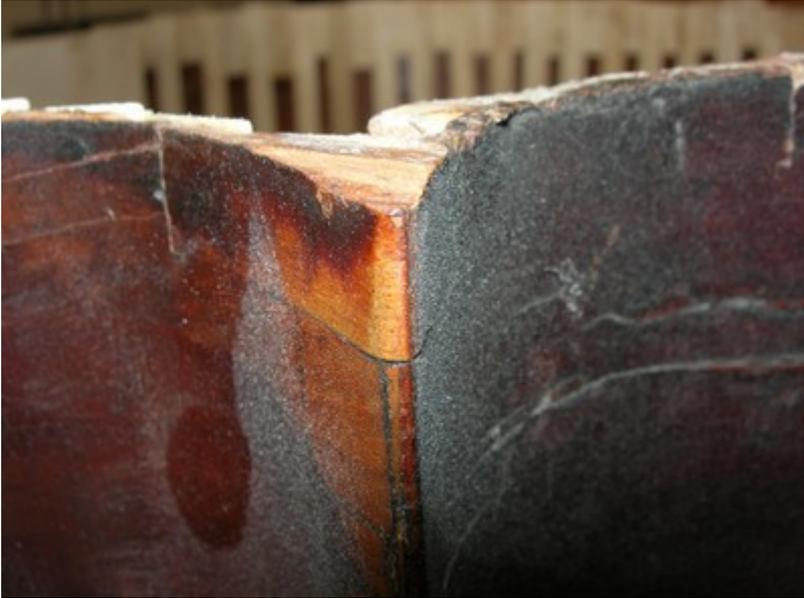
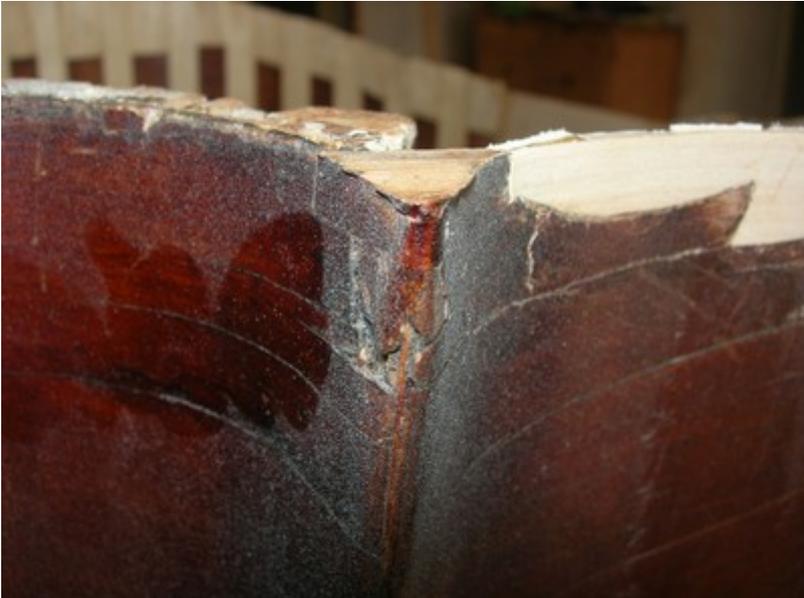
In proximity to the glueing surface on the back side, there is a rectangular replacement, and part of the edge is missing and filled.

At about 35 millimetres from the edge there is a reconstruction meant to fill a crack.

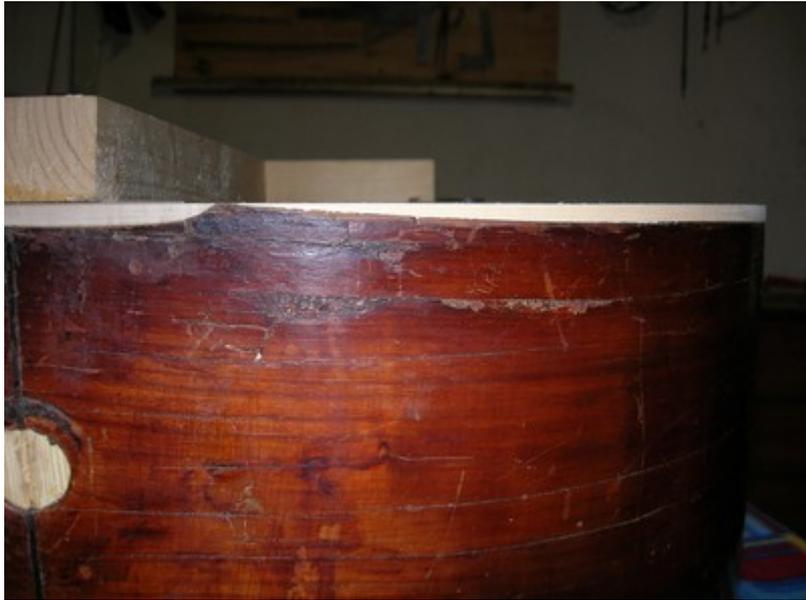
The top also shows an edge replacement on the lower bout on the G side, and here as well the rib has been lowered and the glueing surface altered.

I let part of the lining on the G side lower bout jutting, where the ribs have been lowered, next to an edge replacement and where I make and glue the missing part of the rib.

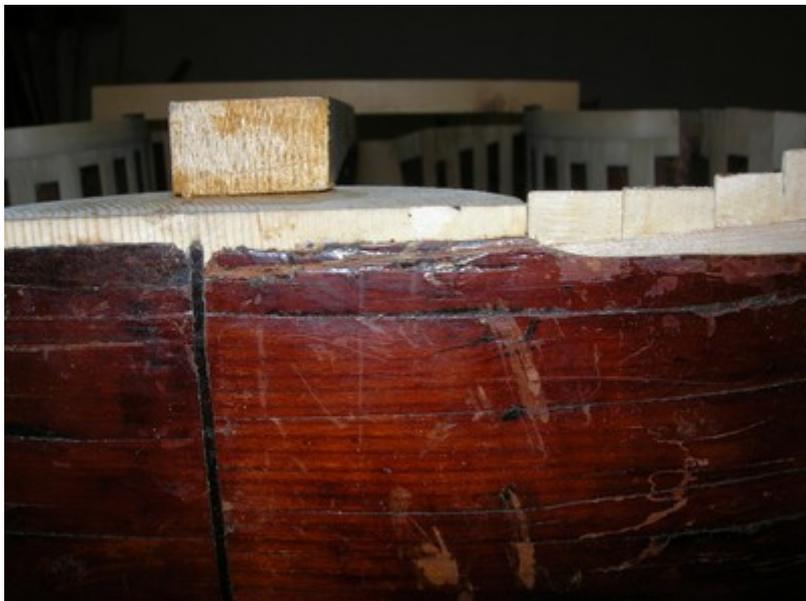
The ribs have been lowered next to the lower block on the back side as well. In this area I kept the lower block, splints and doublings higher.
