Giuseppe Cazzaniga, Liutaio

Bernareggio, July 2009 - June 2012

Restoration of a Brescian style double bass

The instrument is property of Maestro Ezio Pederzani

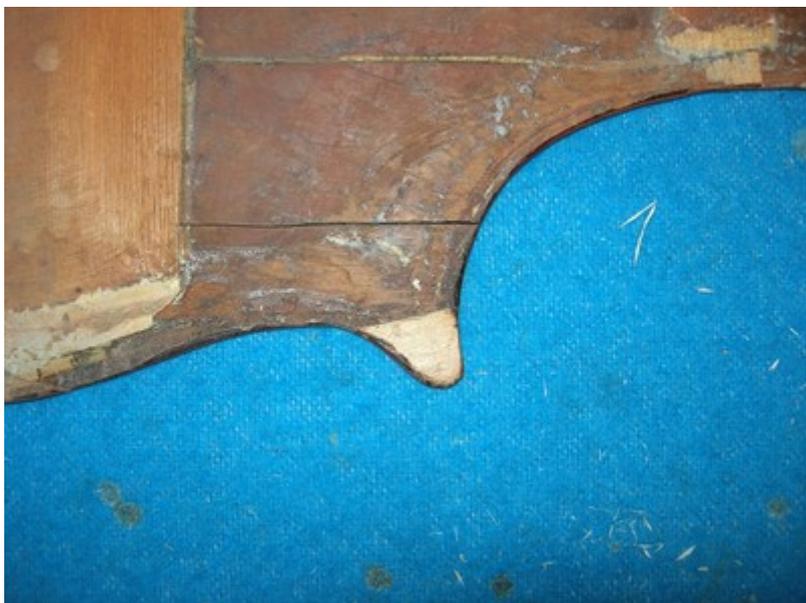
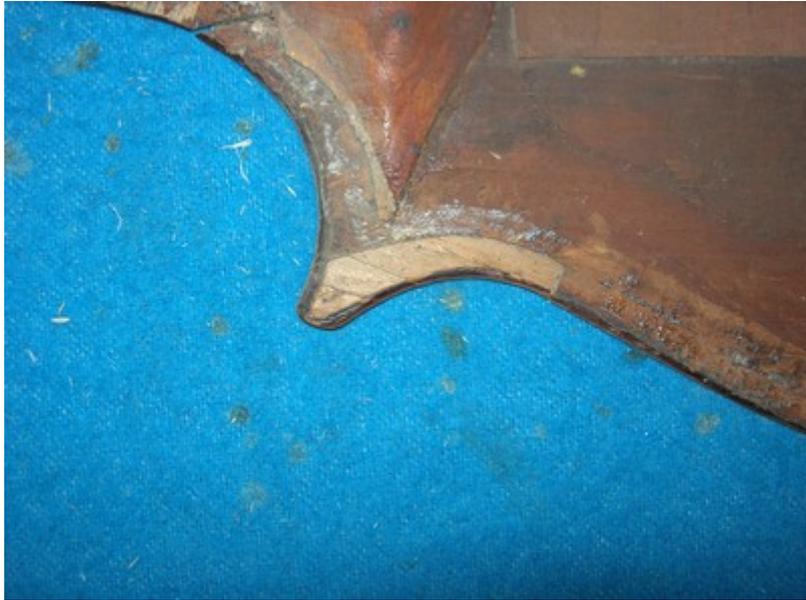
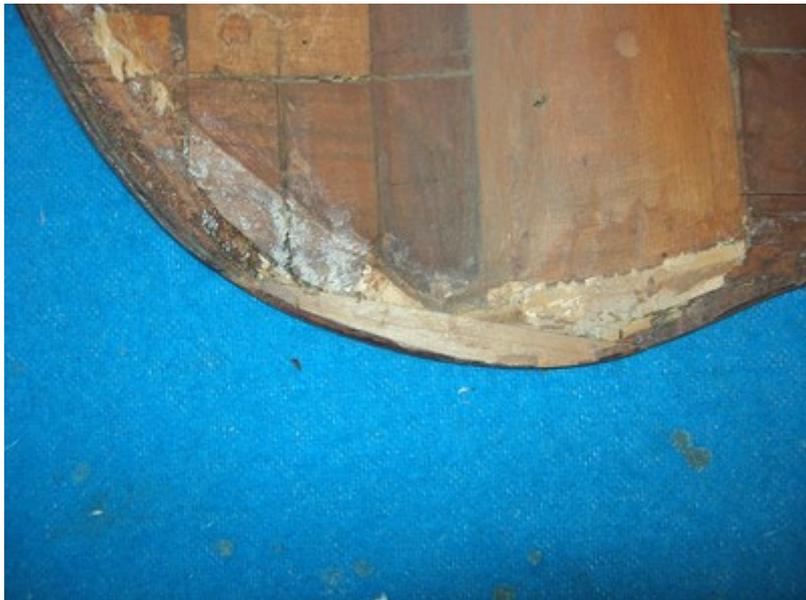
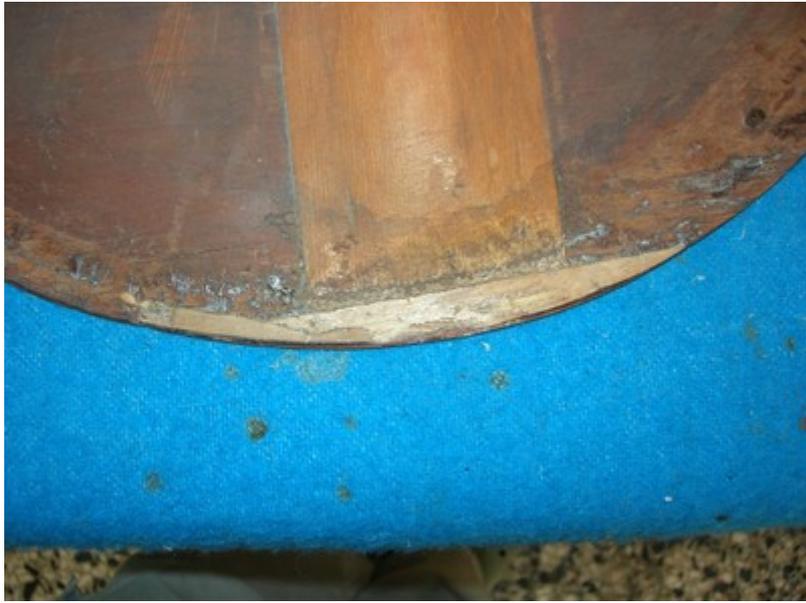
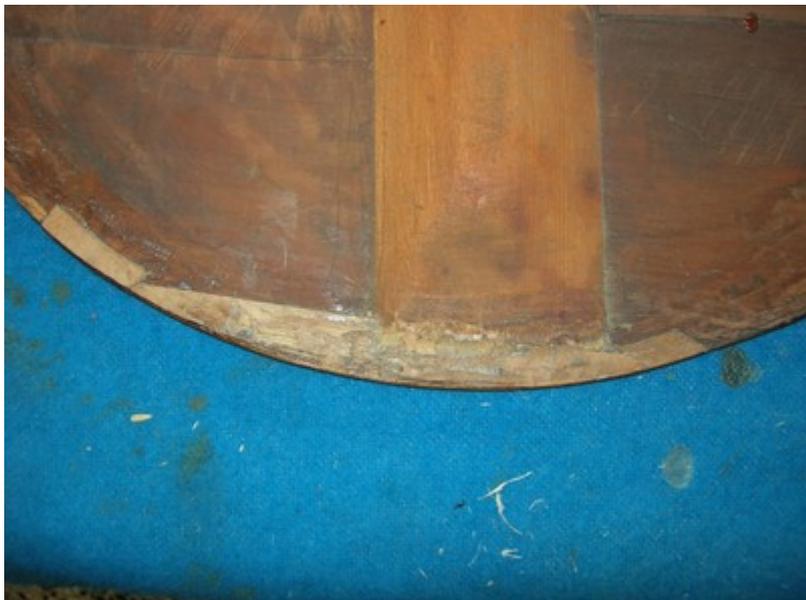
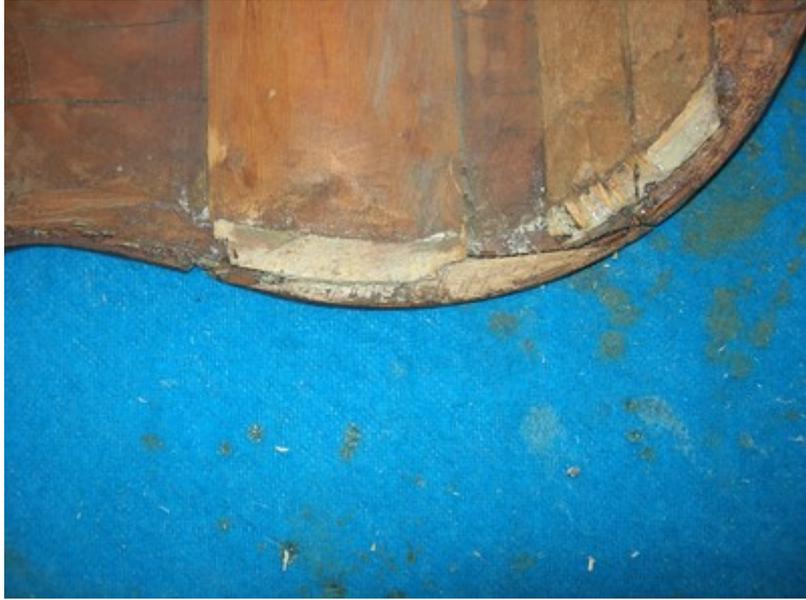
The corners on the bass side were remade, and there are large sections at the maximum upper and lower width which have been replaced.

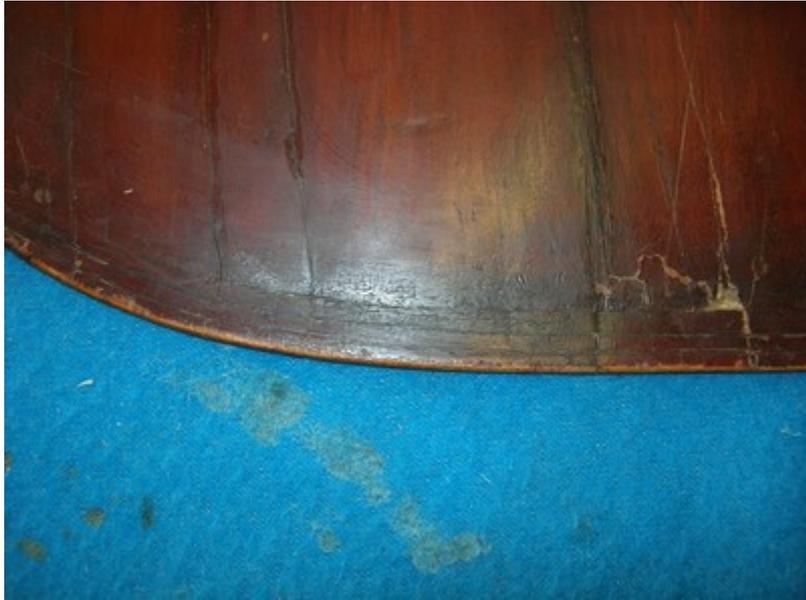
The lower edge, adjacent to and under the block has been remade, maybe to repair the damage caused by playing the instrument without an endpin.

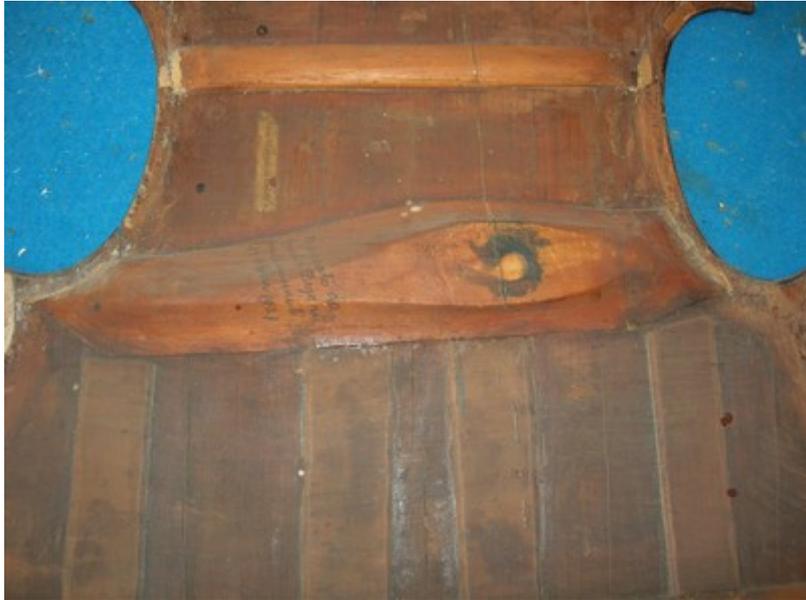
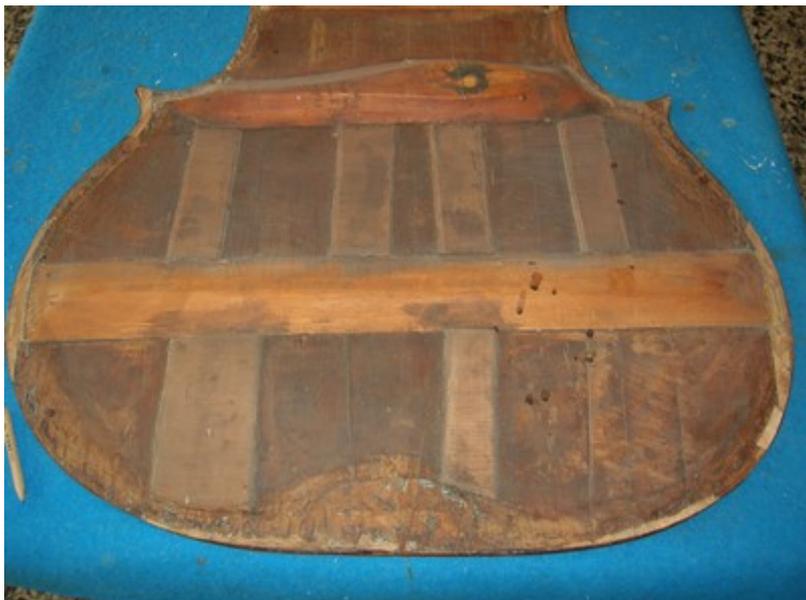
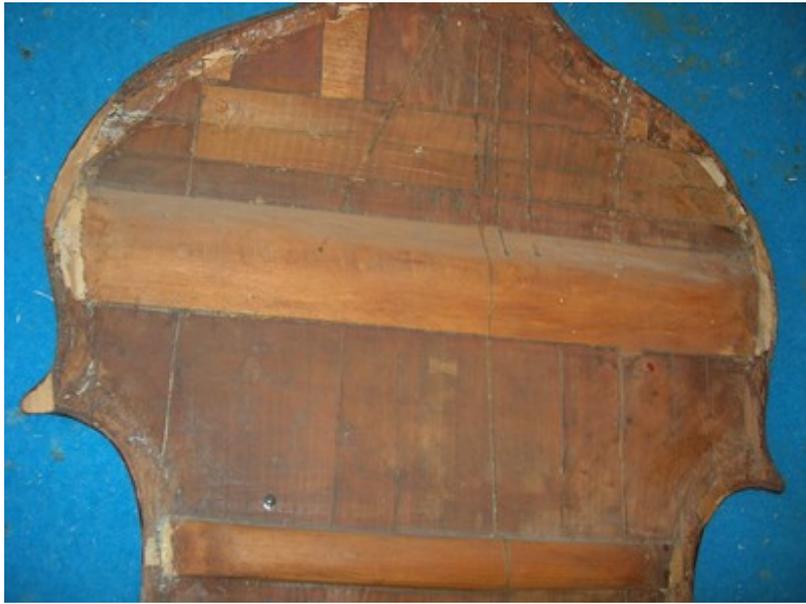
The soundpost crossbar, of strange form, as well as the upper and lower bars, are made of the same wood and seem to have been replaced by the same person, whose work resembles the shaping of the linings and of the reinforcements at the upper and lower blocks, which I found while repairing the ribs.

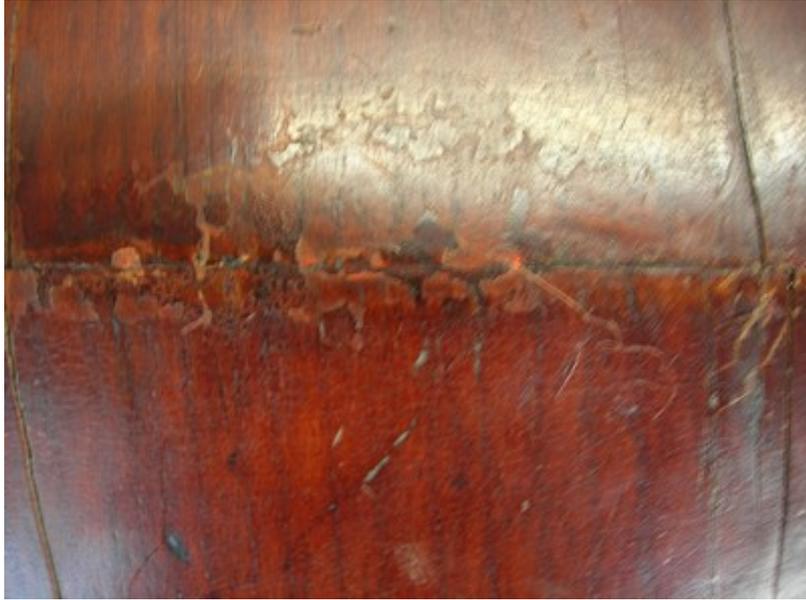
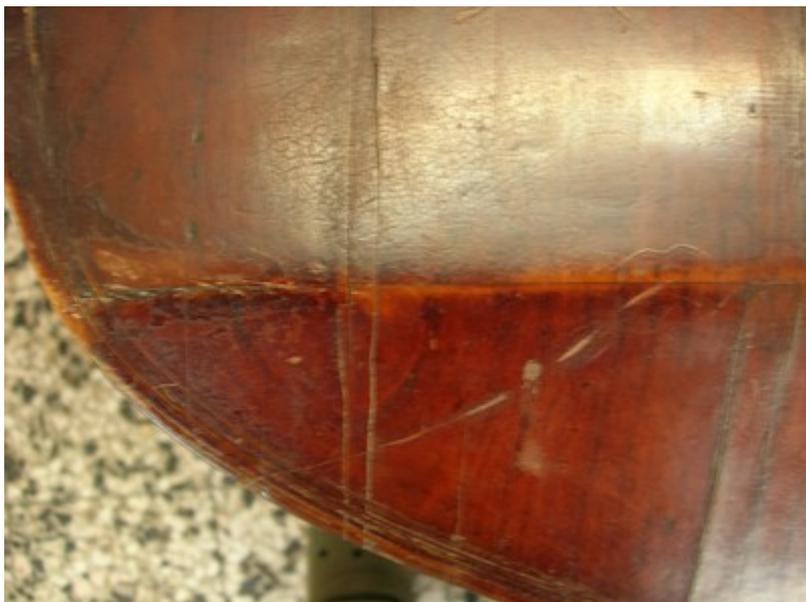
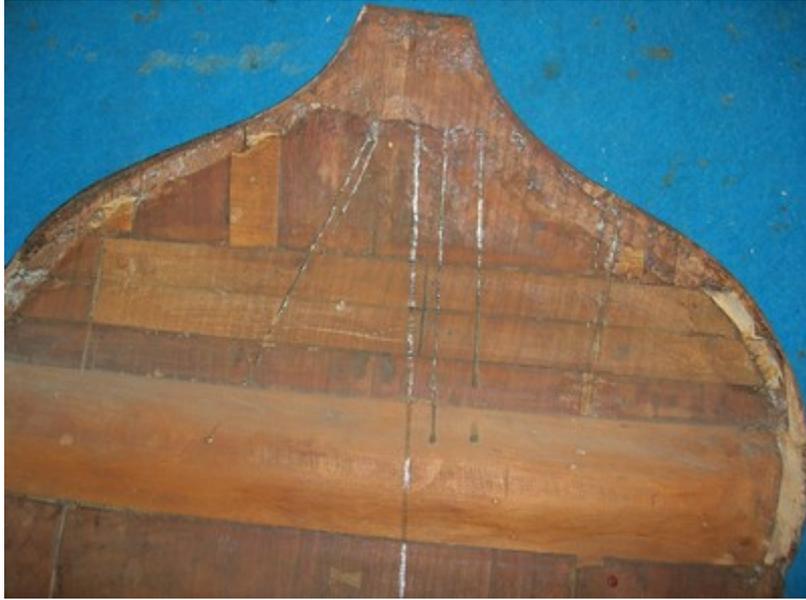
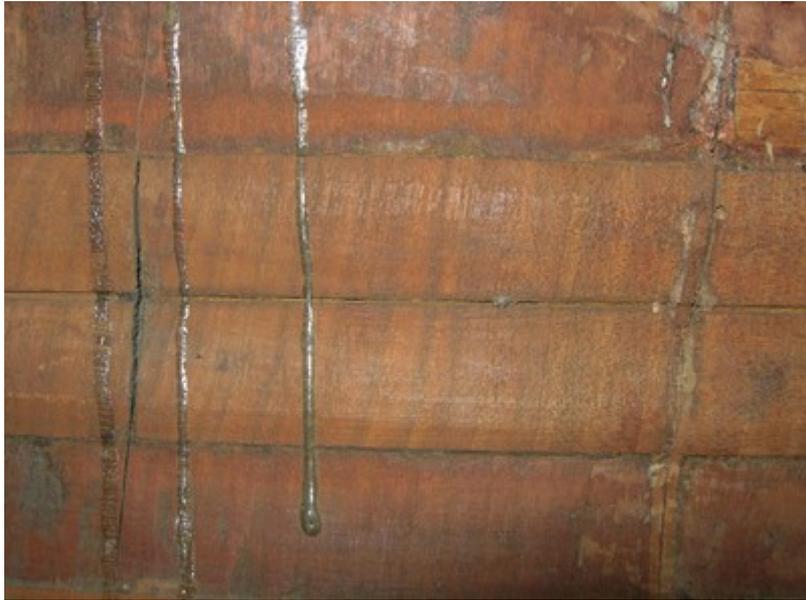
The bend, placed fairly high, has been broken, and there is some filler from the outside. Inside it has been reinforced with a strip of walnut, with grain parallel to that of the back.

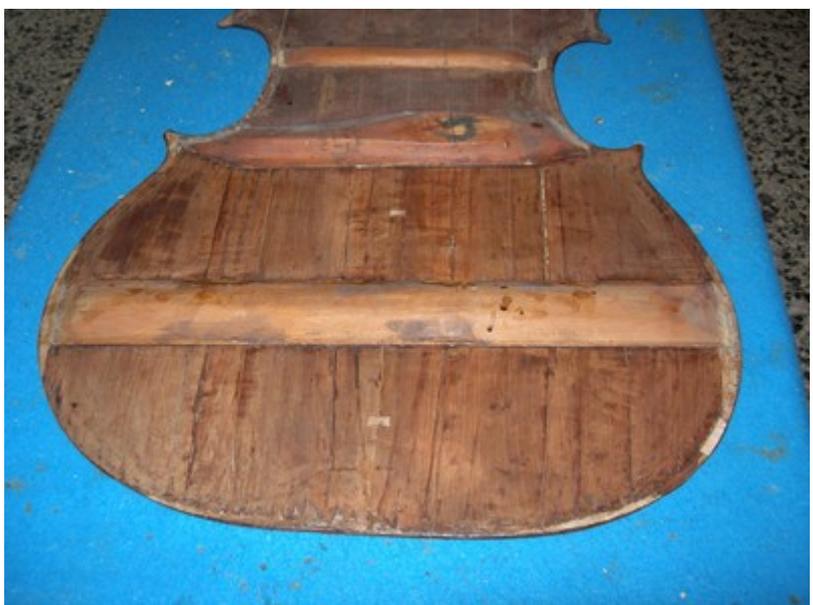
The reinforcement along the bend has also cracked.

I remove the reinforcements along the cracks in the lower section, and clean the area.

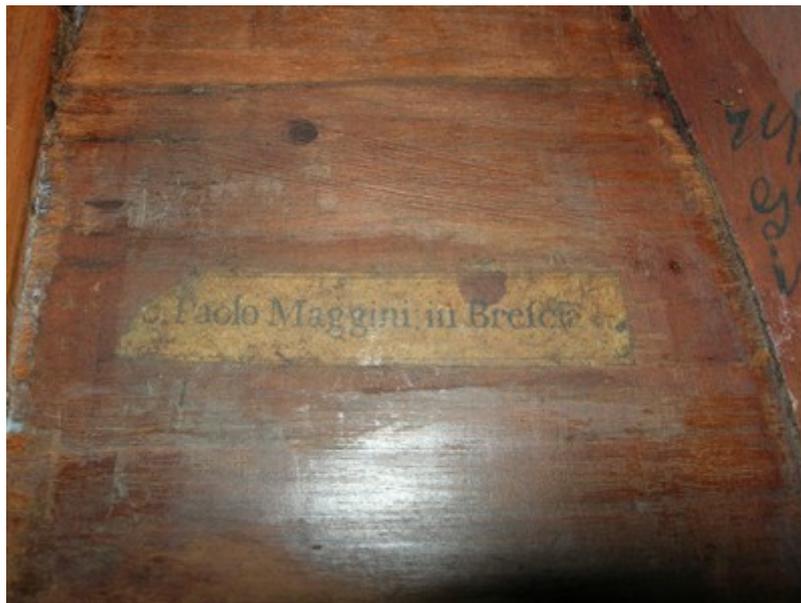
The area around the label has been varnished, maybe to protect the label.

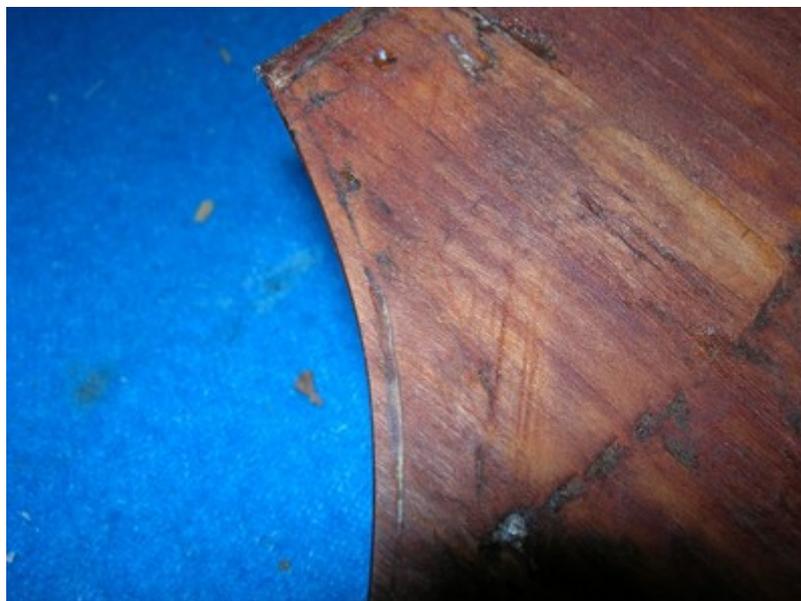
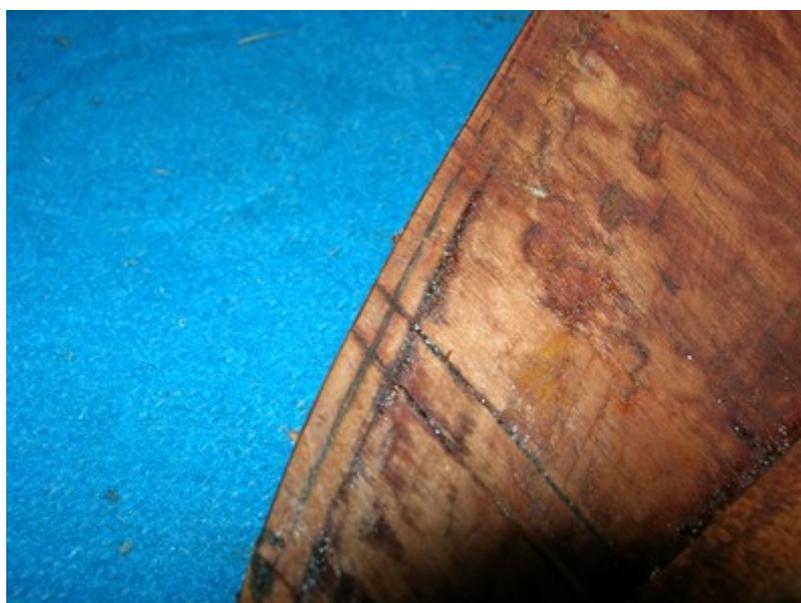
Given that the upper part of the back has been modified, it is probable that the profile of the ribs was rescribed during a previous repair.

I clean the upper part.

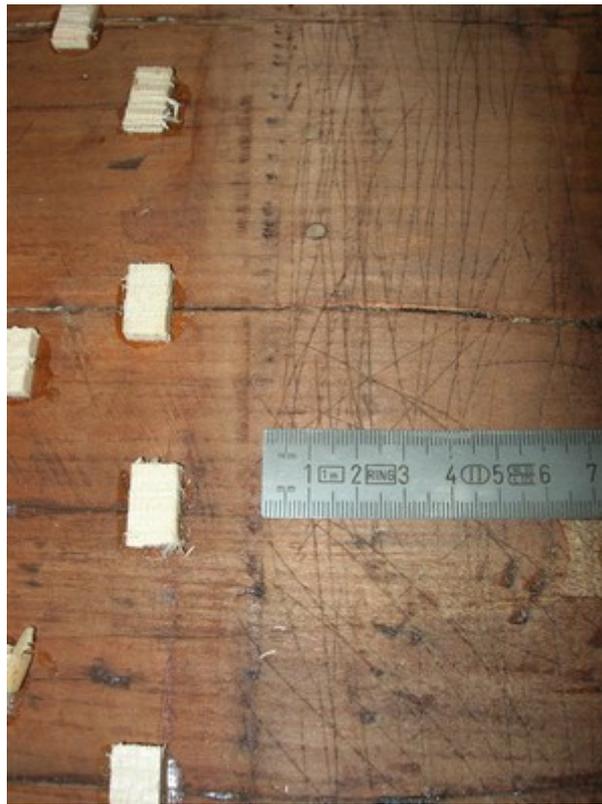
The previous bar would have had a width of 20 - 22 millimetres, and was placed along the upper edge of the bar I removed, corresponding with the widest point of the back.

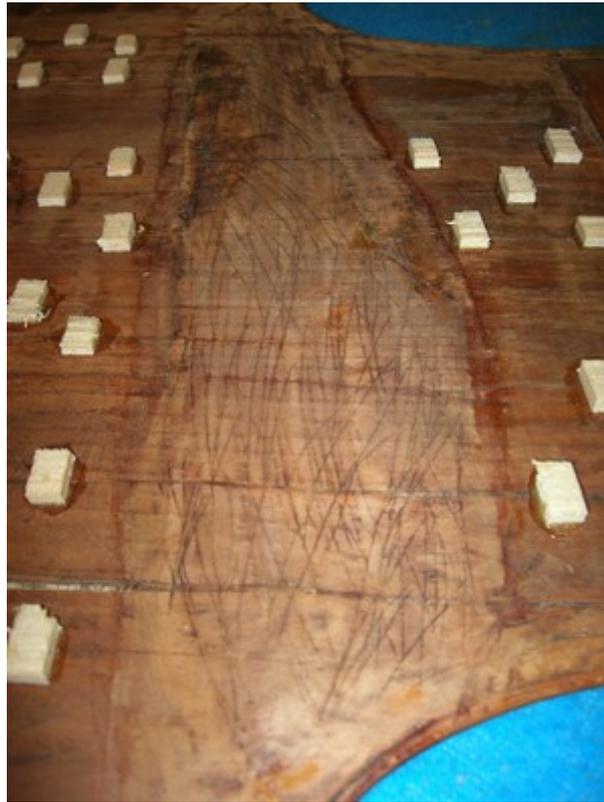
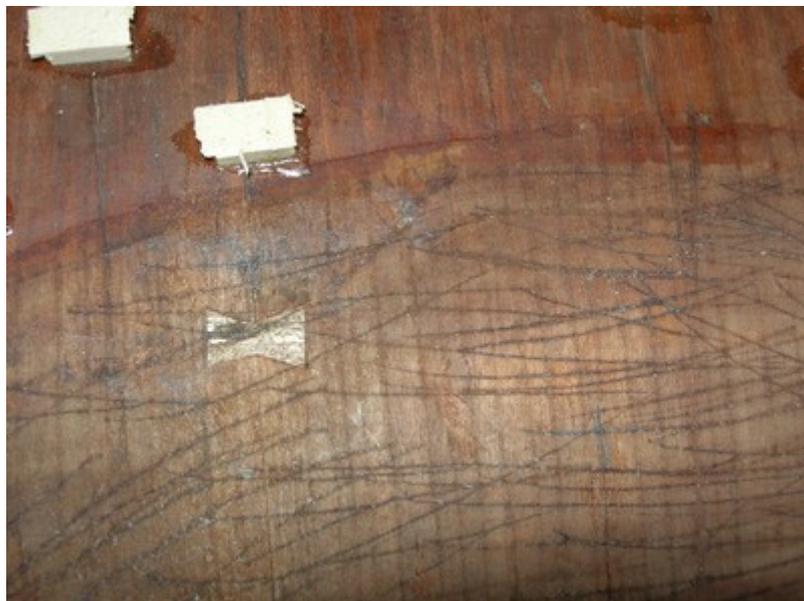
The scratch marks on the glueing surface are present here as well, and under the bar there is another butterfly insert.

The butterfly and the surrounding area are rich with tool marks. Maybe a previous bar was narrower, but similar to the one I removed.

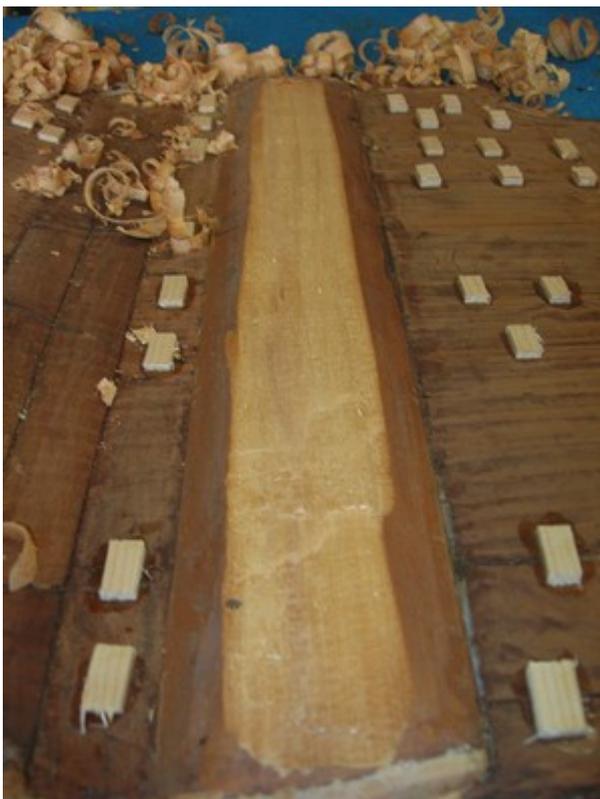
The glueing surface has been scribed here as well, and there are several pins similar to those under the lower bar.

The position of a previous bar is visible, at the widest point of the upper bouts, and 20 -22 millimetres wide.

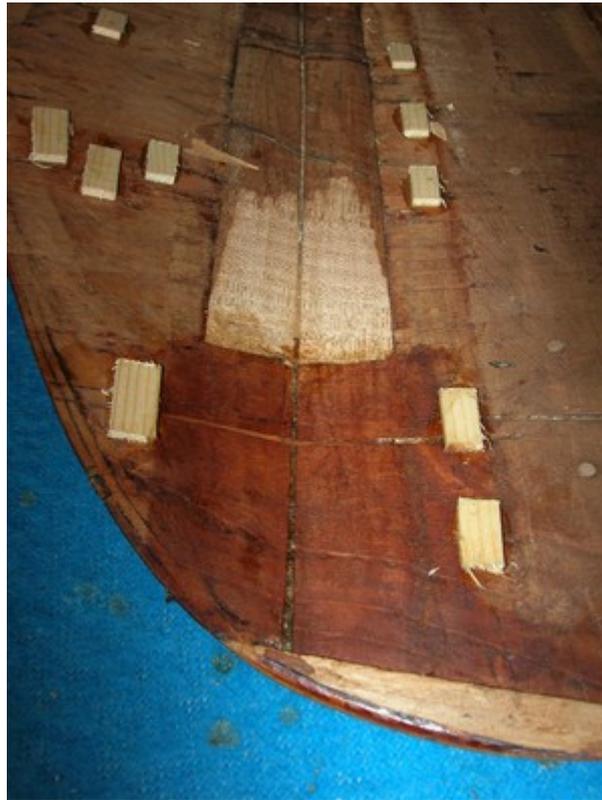
The edge between the widest point of the upper bouts and the bend has been remade with maple which is thicker than the rest of the back.

I remove part of the reinforcement along the bend, on the bass side.

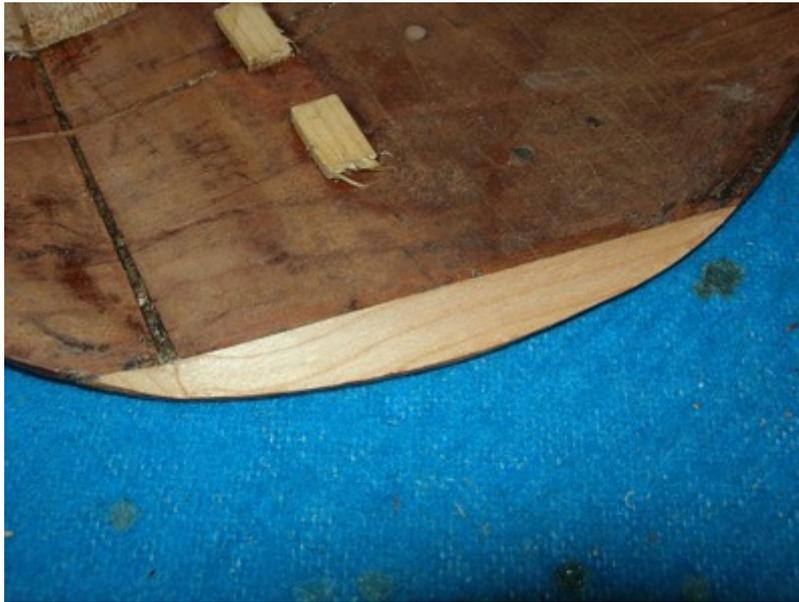
There are double lines of non original purfling inlaid into the remade edge, which are present along the entire profile of the back, placed over or near another wider purfling with very thin black sides, maybe the original.

The older purfling would outline a wider profile in this area of the instrument.

I bring it to the same thickness

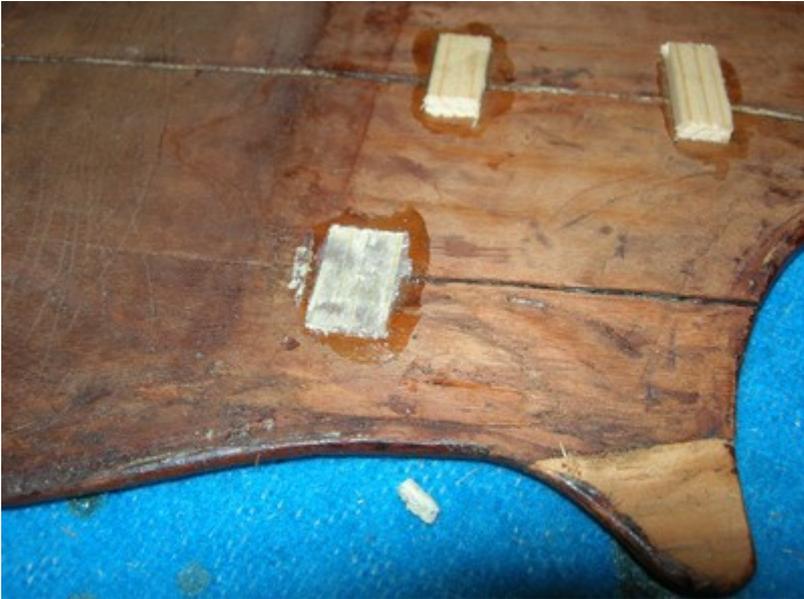
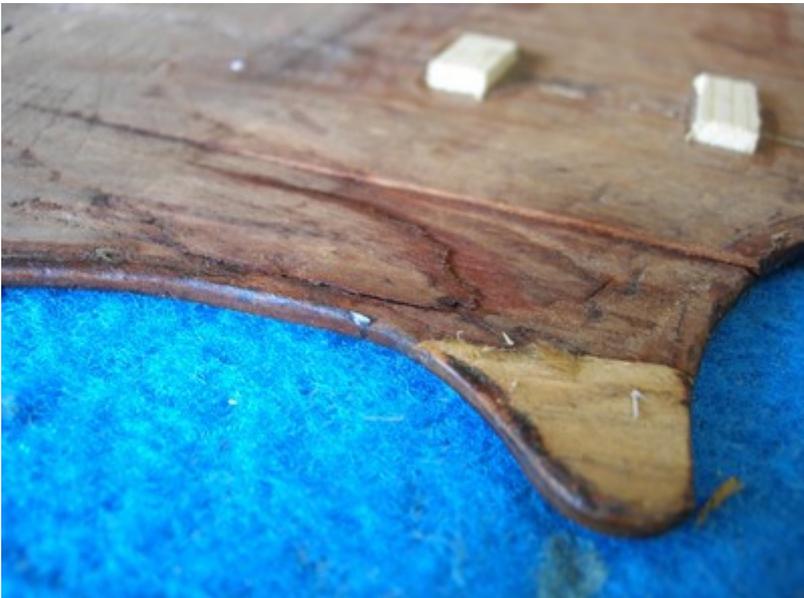
I remove a temporary cleat near the upper corner on the bass side where there is a crack as well as splintered wood, and clean the surface.

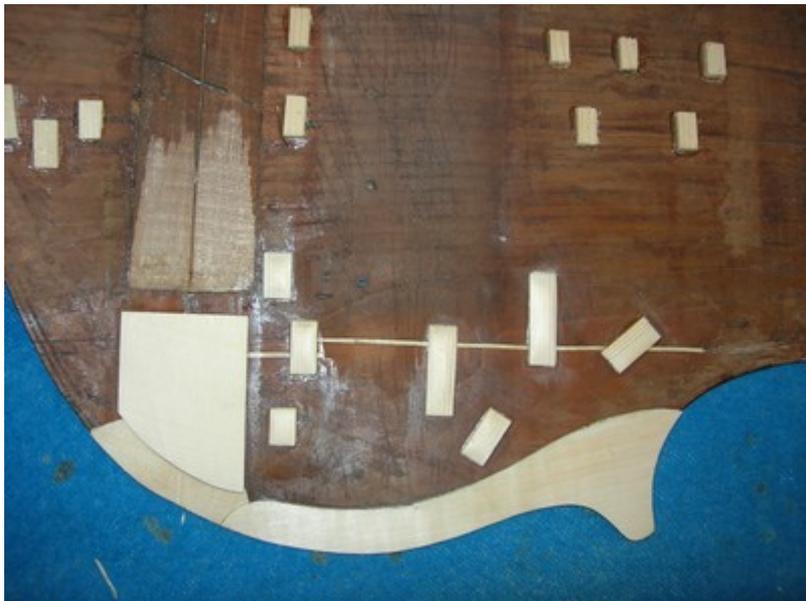
The next crack, near the bend, was caused by one of the walnut pins under the upper bar.

I remove the pin and repair the crack.

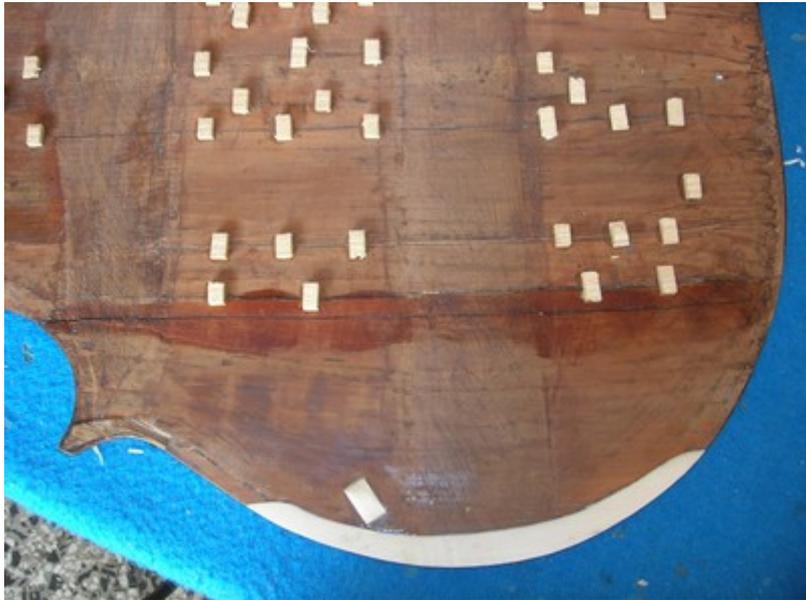
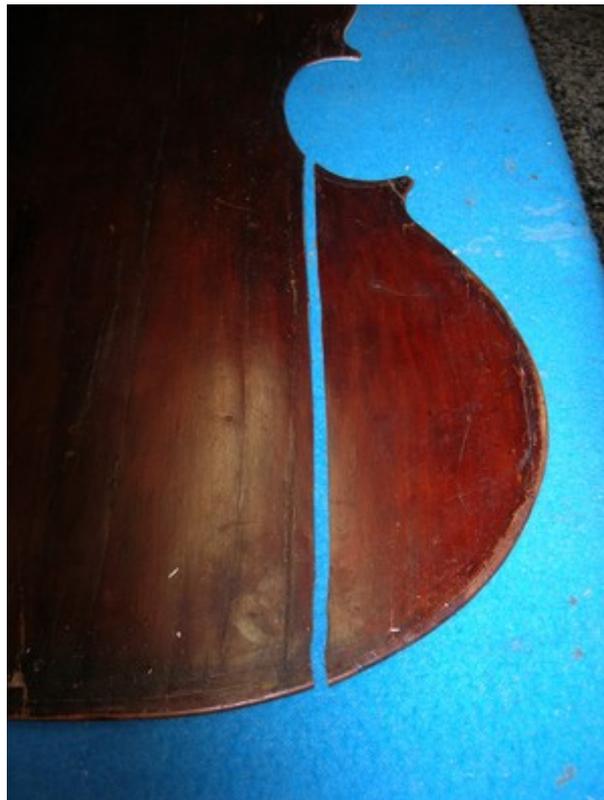
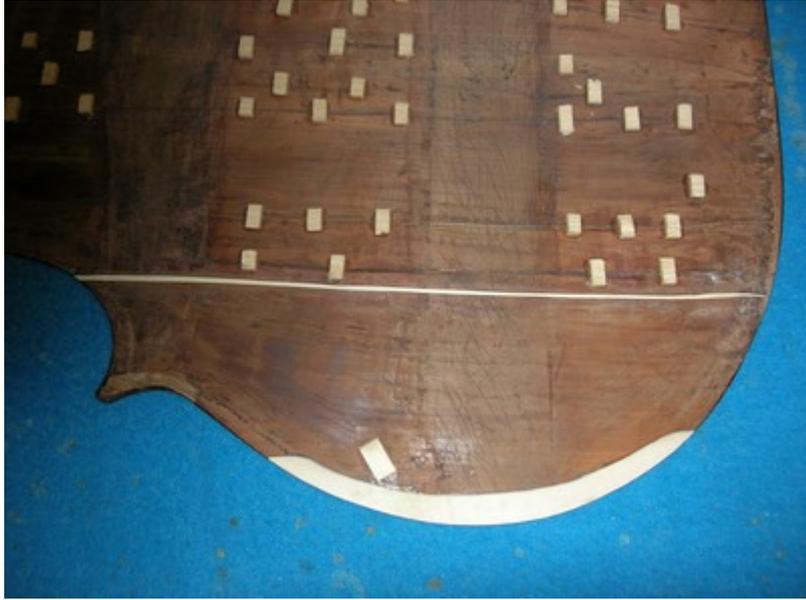
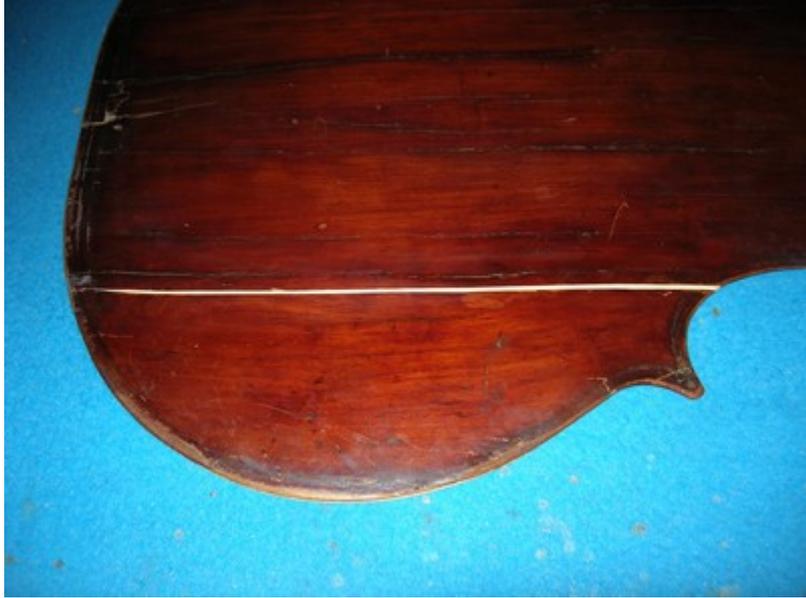
The next crack, in the lower section on the bass side, was repaired with several slivers of walnut and with putty. It reopened.

I remove the temporary cleats, open the crack, remove the slivers and repair the crack, rebuilding the missing part in white maple.
