Giuseppe Cazzaniga, Liutaio

Bernareggio, July 2009 - June 2012

Restoration of a Brescian style double bass

The instrument is property of Maestro Ezio Pederzani.

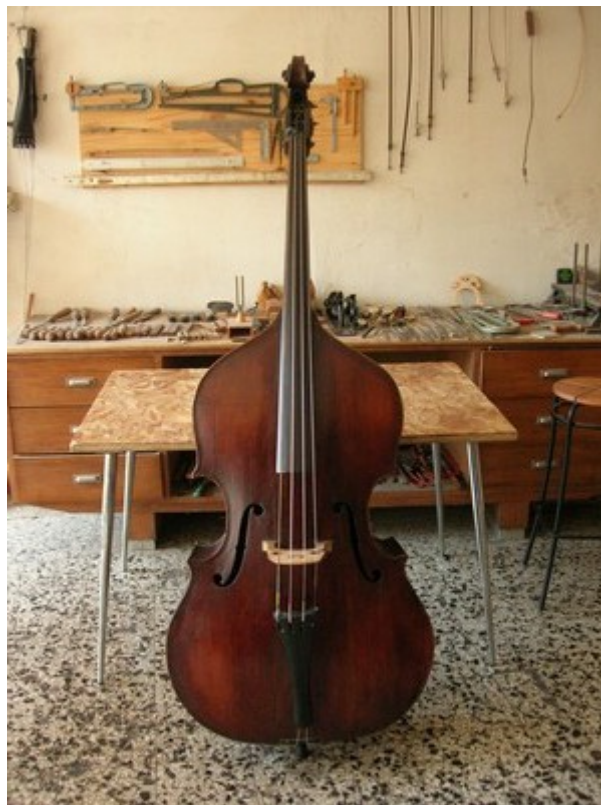
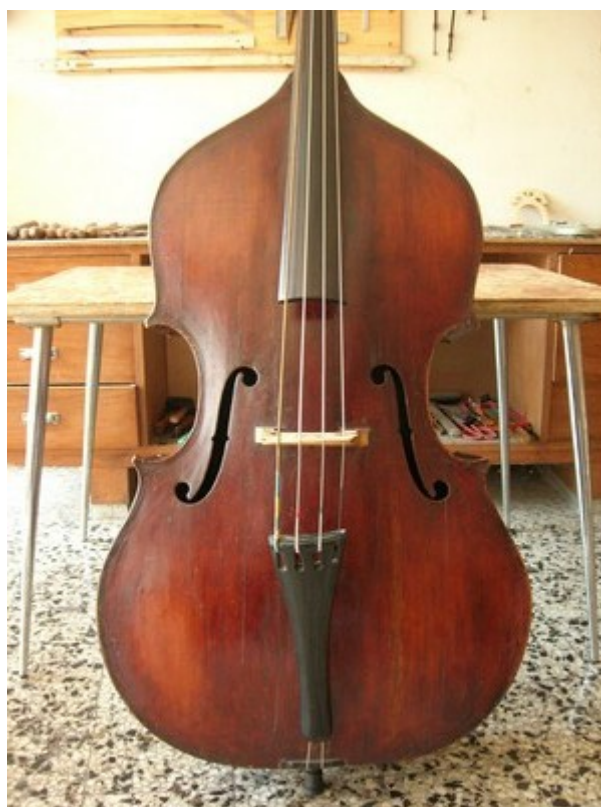
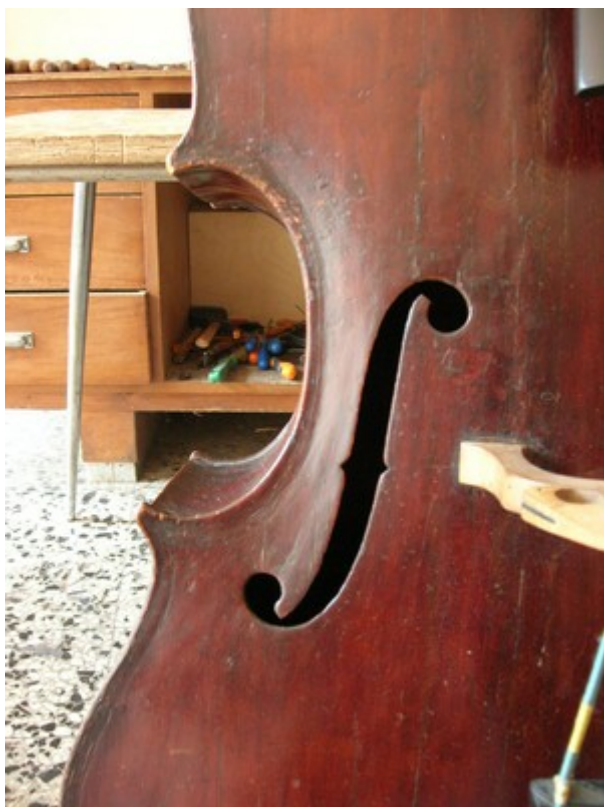
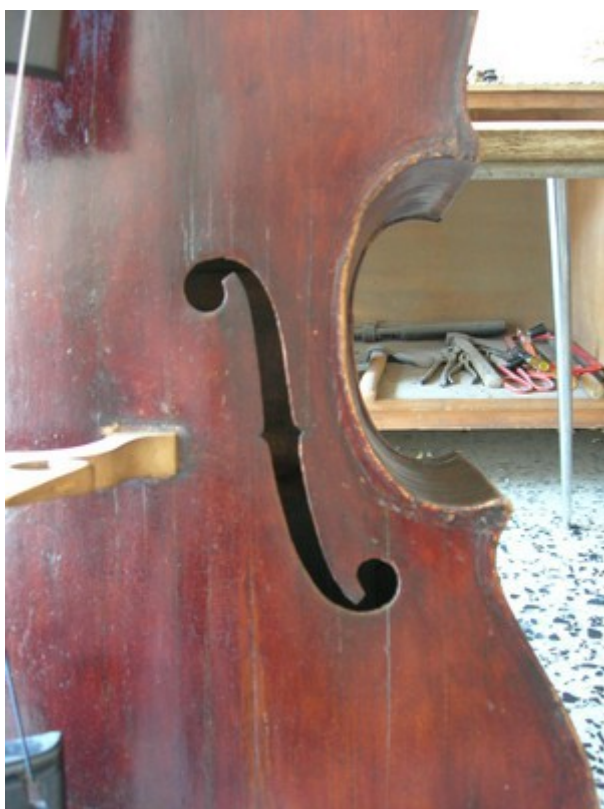
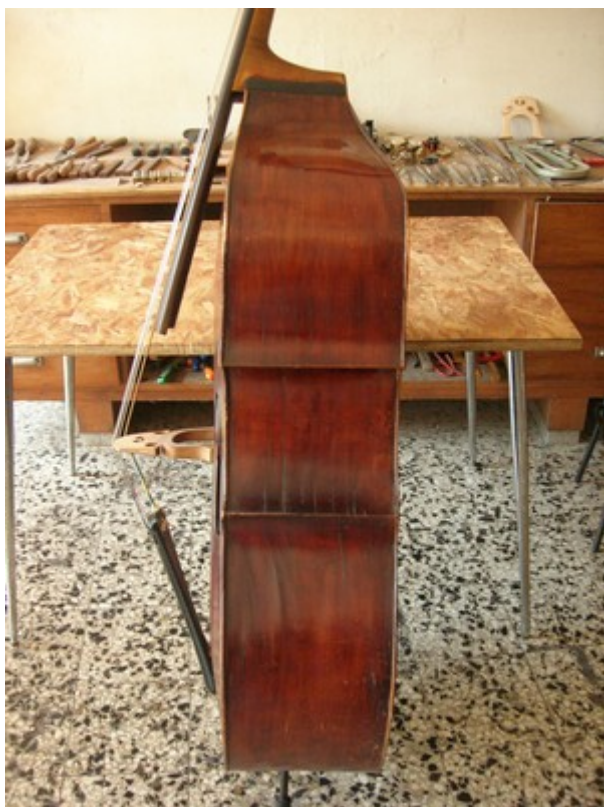
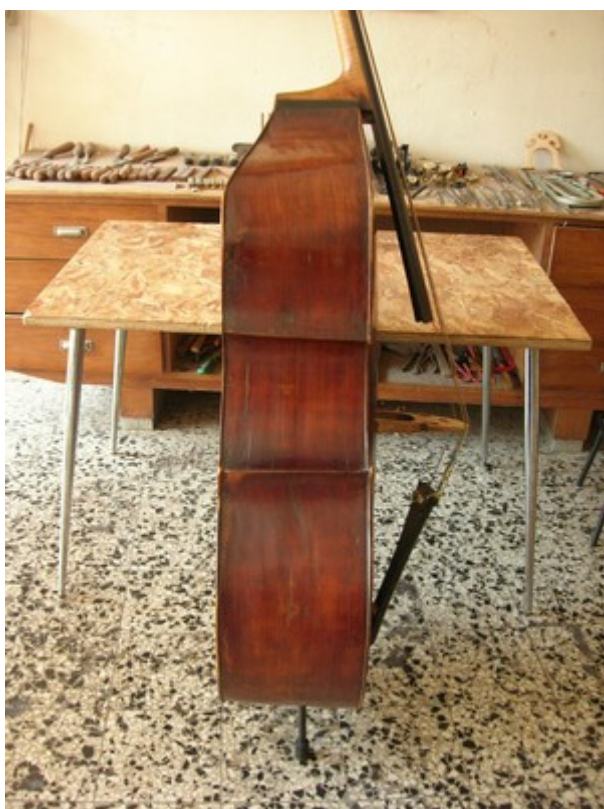
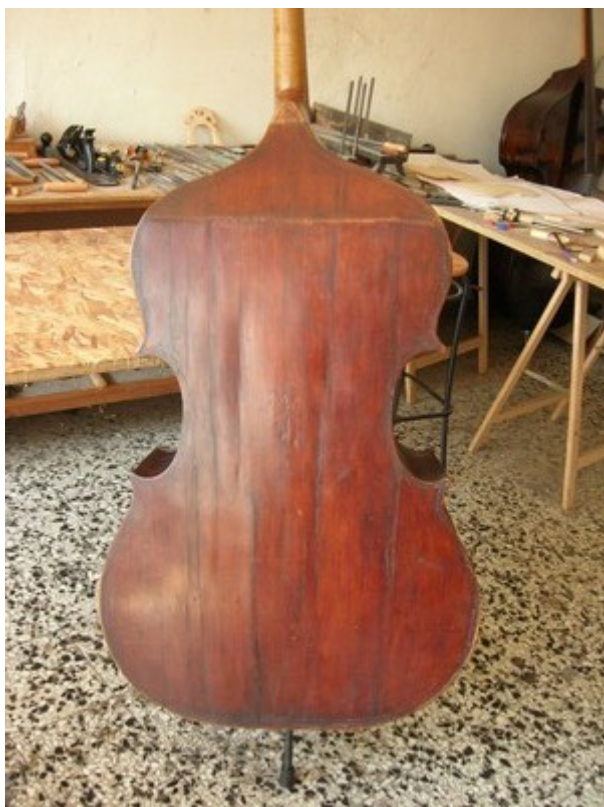
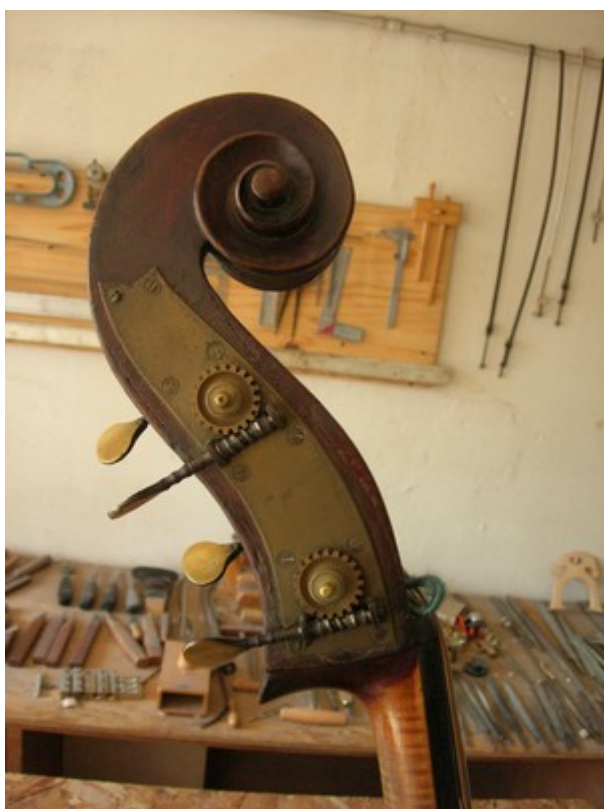
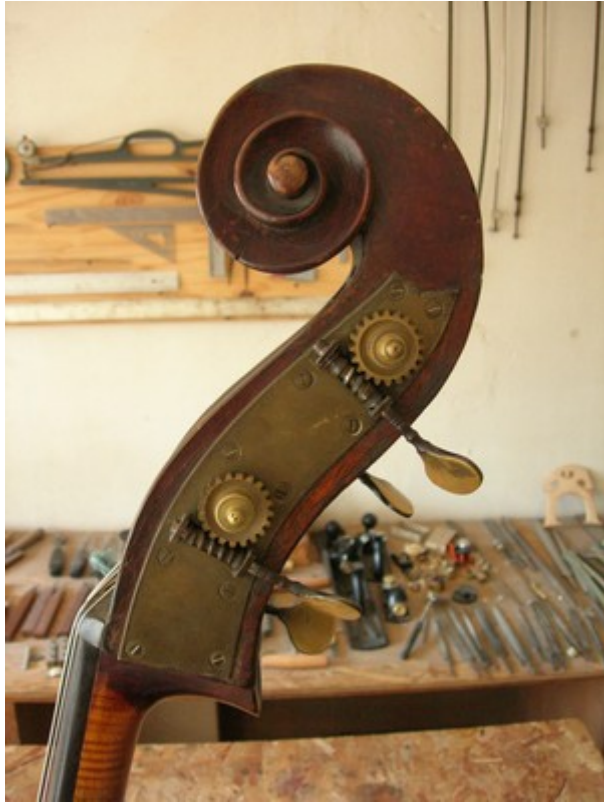
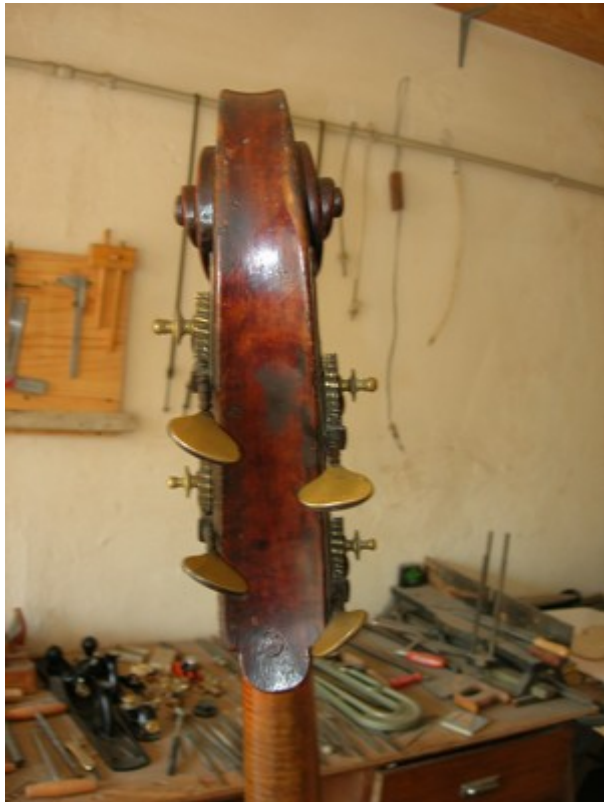
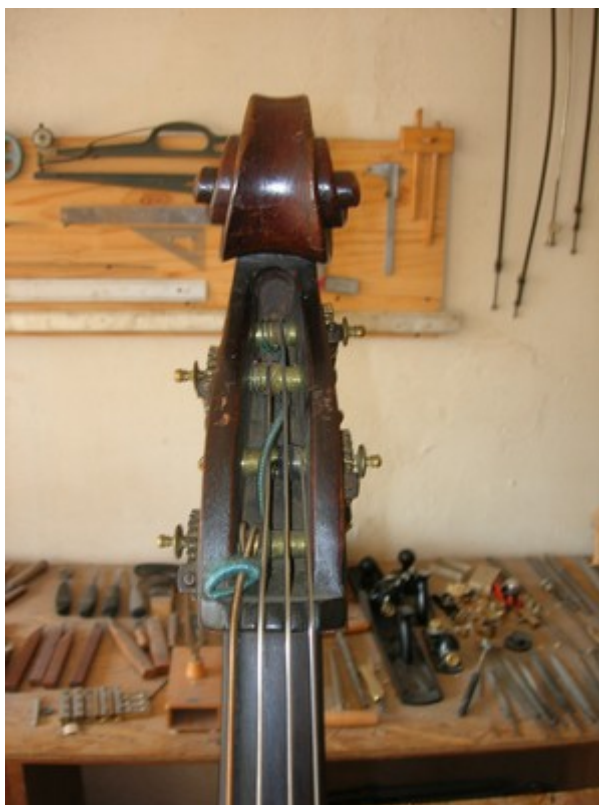
Large areas are touched with a darker material.

There are many cracks on every surface, most of them already repaired, often with filler

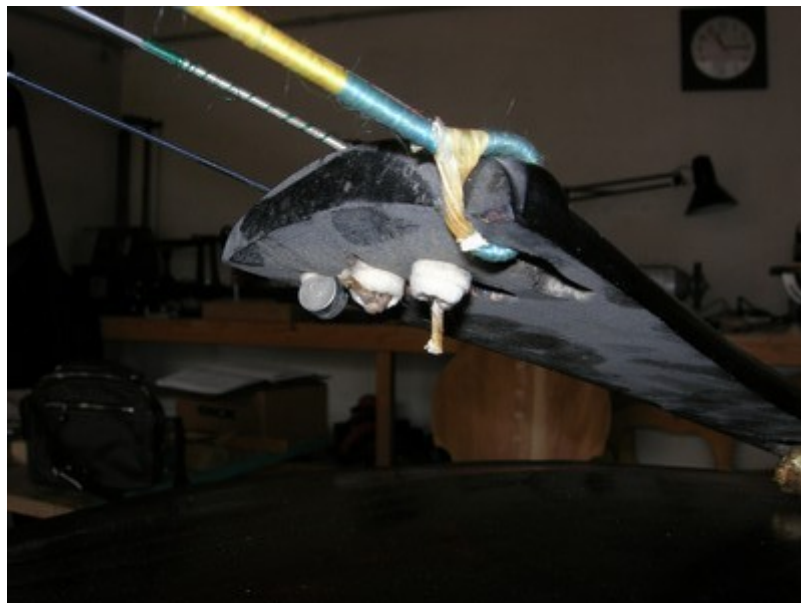
Of the strings mounted, the E string is gut core with a copper round winding, the middle two are gut core flat wound, the G string is metal.

This stringing suggests that the instrument was last played in the 60's.

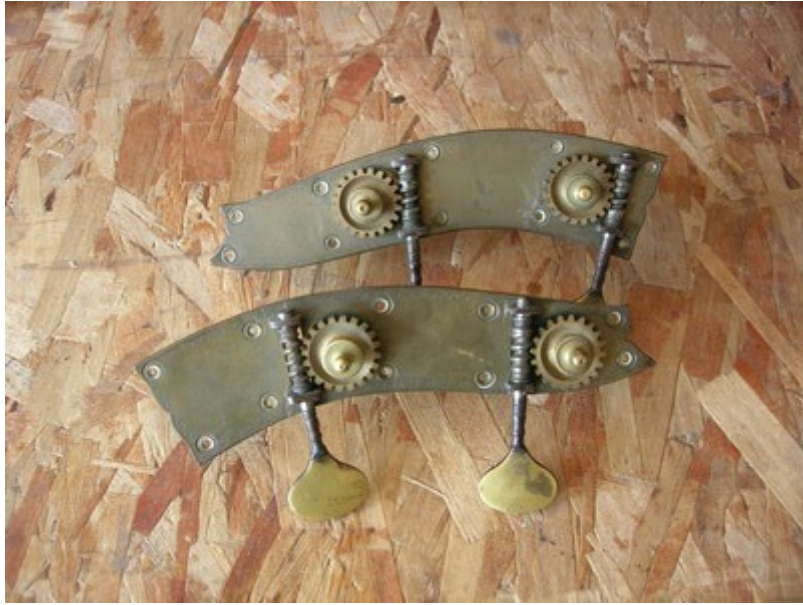
The tuning machines are German made.

I take down the strings, the bridge and tuning machines.

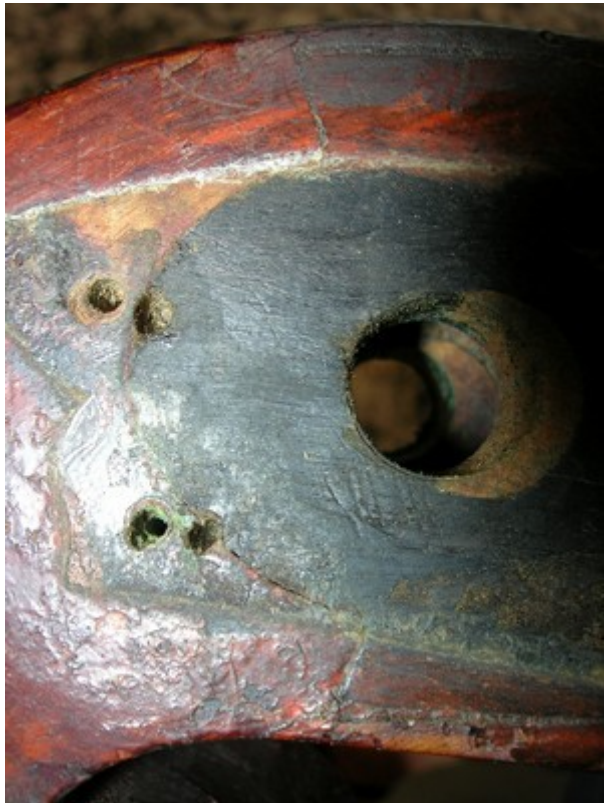
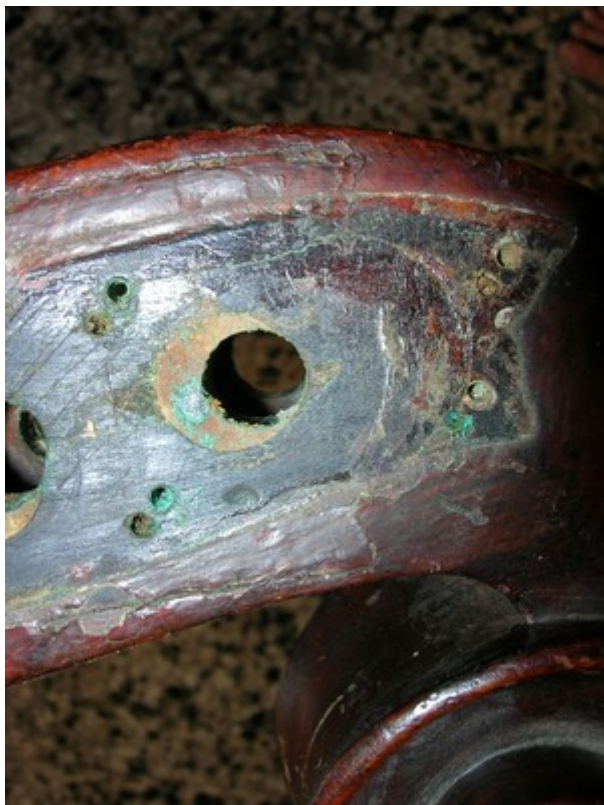
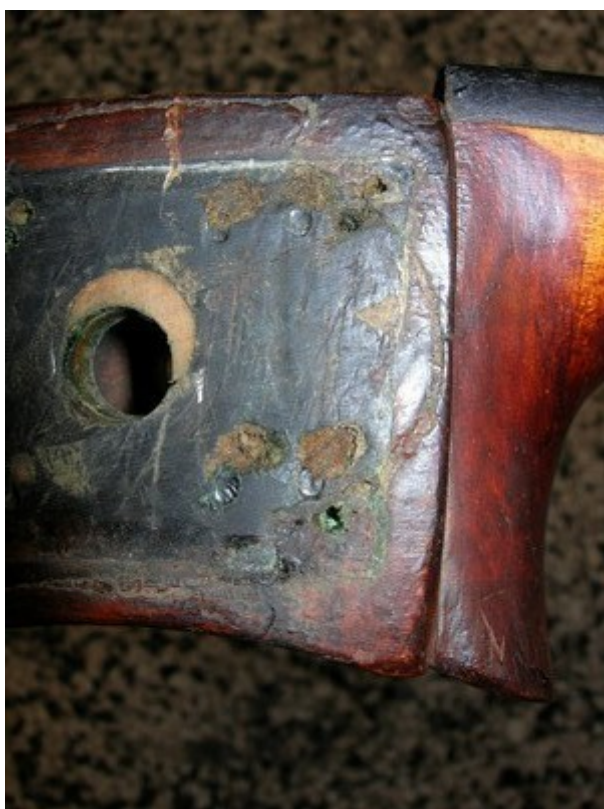
Under the plates there are two ebony and filler replacements, where a previous set of tuning machines for four strings were inlaid in the pegbox.

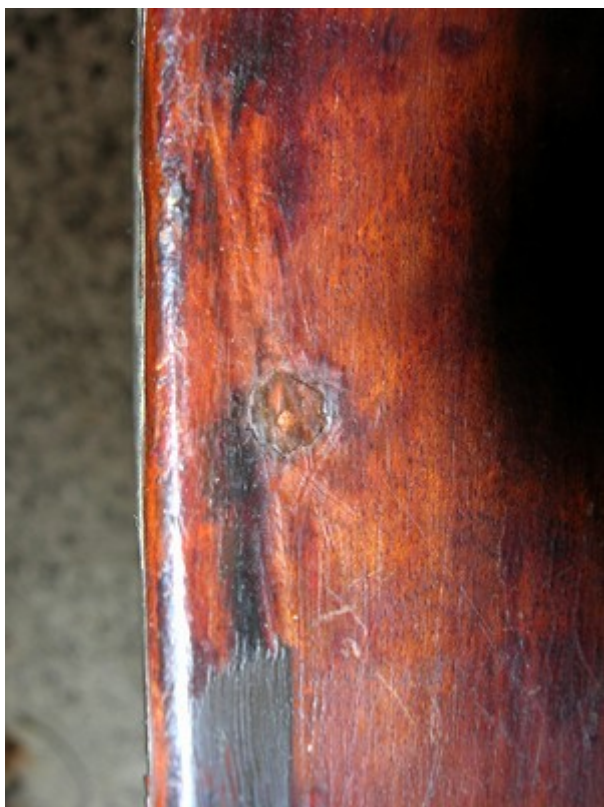
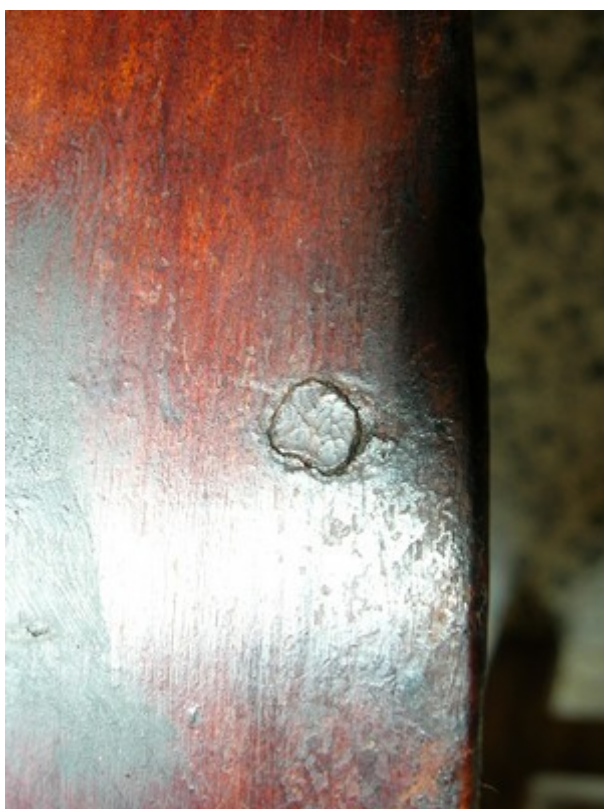
On the back of the pegbox it is possible to see three filled holes, that might be left from a previous set of three machines with retaining pins.

I will be able to get better informations on the previous stringing when I will repair the pegbox by removing the ebony and filler from the walls in order to make new additions.

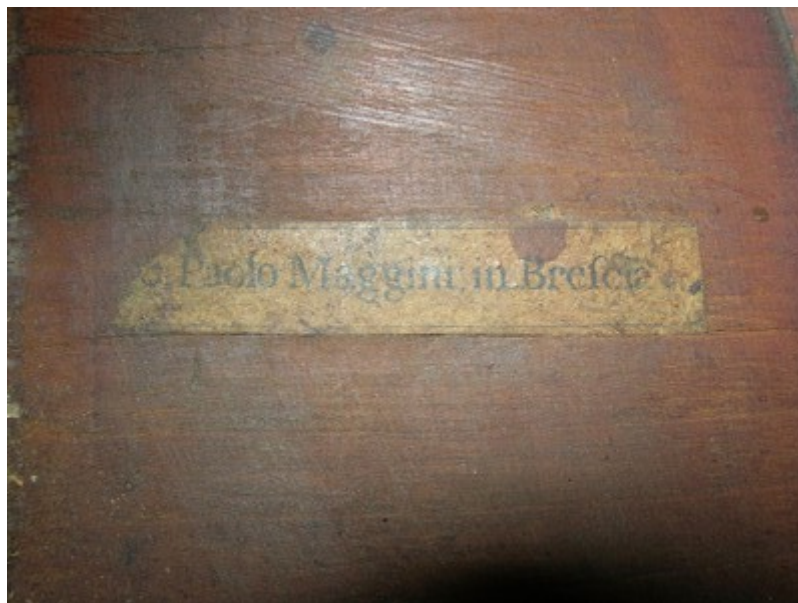
By having access to the inside of the instrument, I can see a label:

"o. Paolo Maggini in Brescia"
