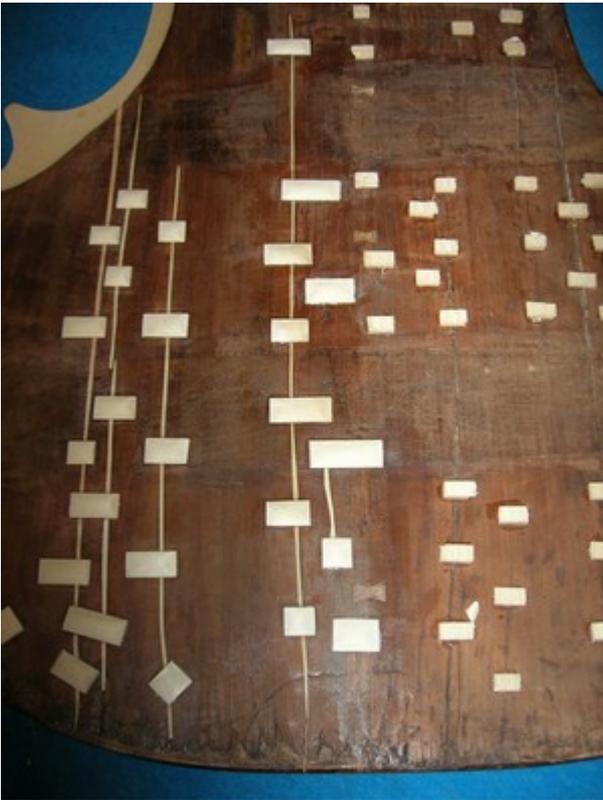
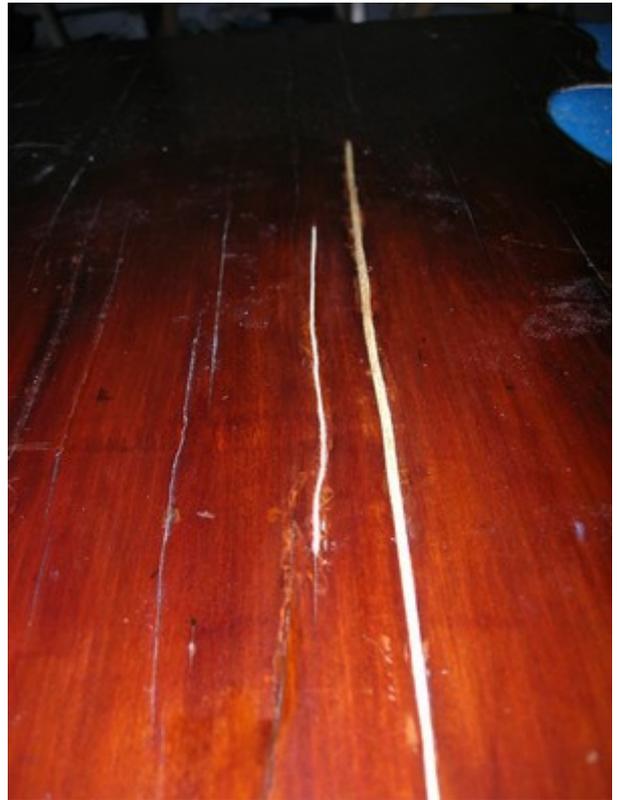
The first is well glued and level, but has a gap filled with glue on the inside; the second and third are partially open and offset, with brownish retouches to the varnish.

The central joint in this area is solid, maybe due to the butterfly inserts, and I can reinforce it with cleats without reopening.

I remove the temporary cleats and repair the cracks, inserting maple into the gaps.

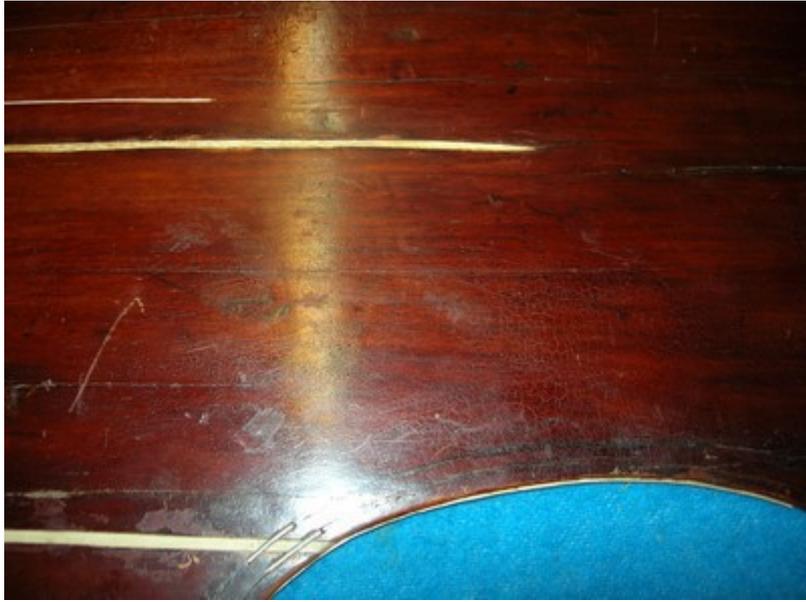
In the center there is a crack next to the label, which I repair inserting glue from the outside and placing cleats on the sides. This way I do not risk damaging the label, while a large part of the crack will be reinforced by the soundpost bar.

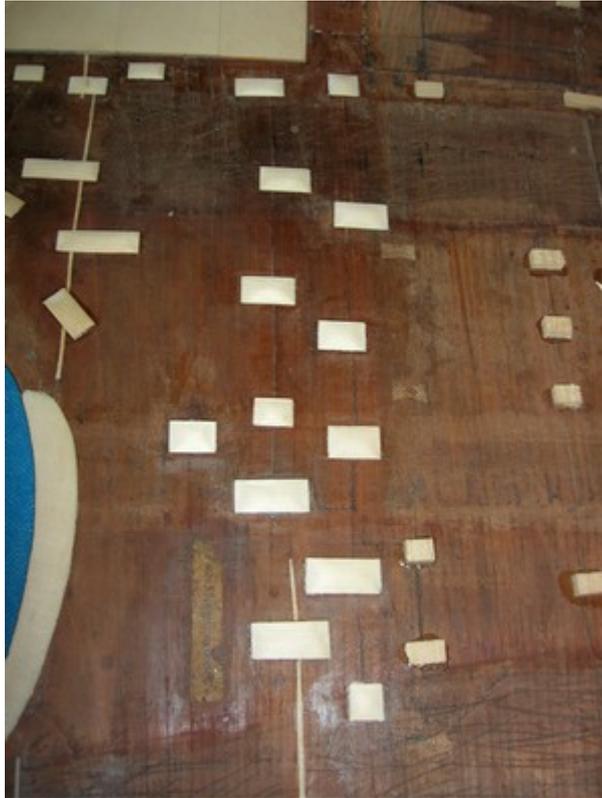
In the upper section, between the bend and the soundpost bar, along the side of the central joint on the bass side, there is a long crack, repaired without filler, partially open and dirty.

I remove the temporary cleats, reopen, clean and glue the crack, reinforcing with cleats.

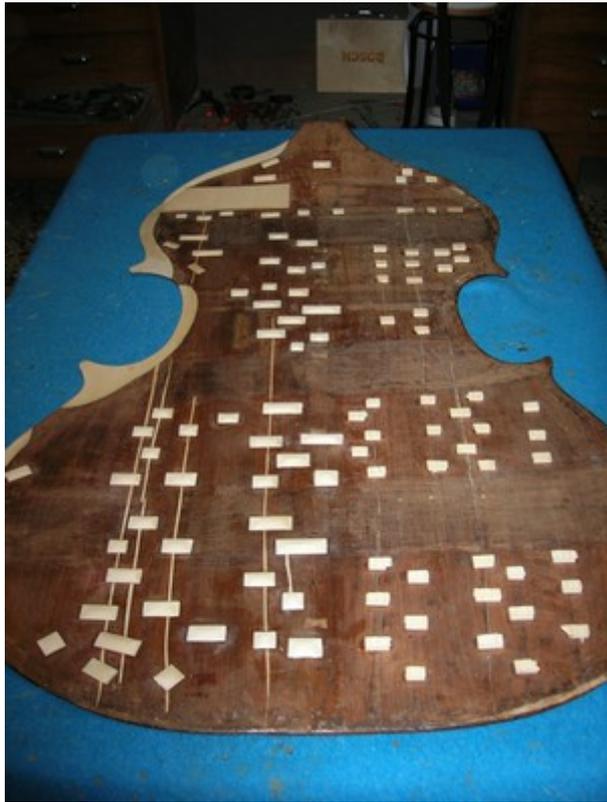
The exception is a short area on top of the soundpost bar, which has been repaired with a walnut shim.

Also, under the soundpost bar, next to one of the butterfly inserts and by this probably caused, there is a crack, repaired with a walnut shim as well.

I reopen and repair the two openings, and reinforce the central joint with cleats

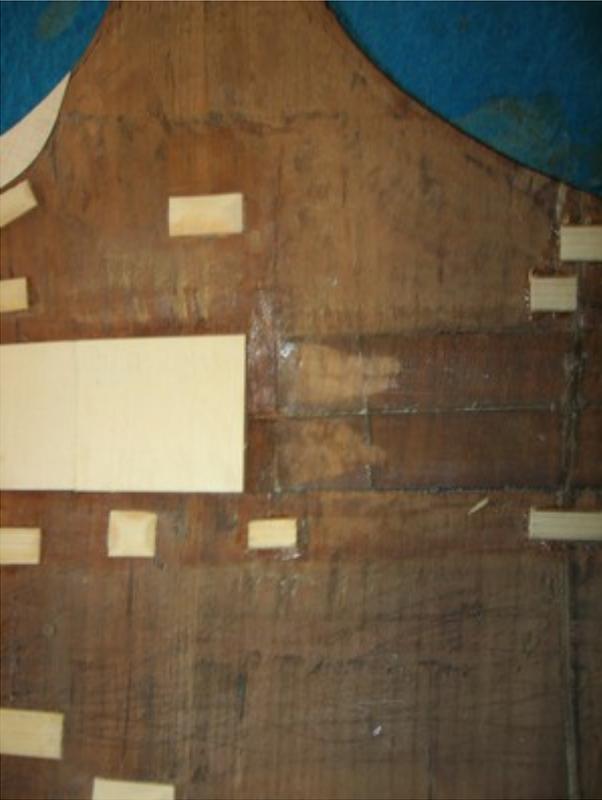
In this way it can be noticed that the section of the back on the upper side of the bend was shifted of about 2 millimetres towards the treble side, probably during a previous bend repair.

I replace part of the reinforcement at the bend.

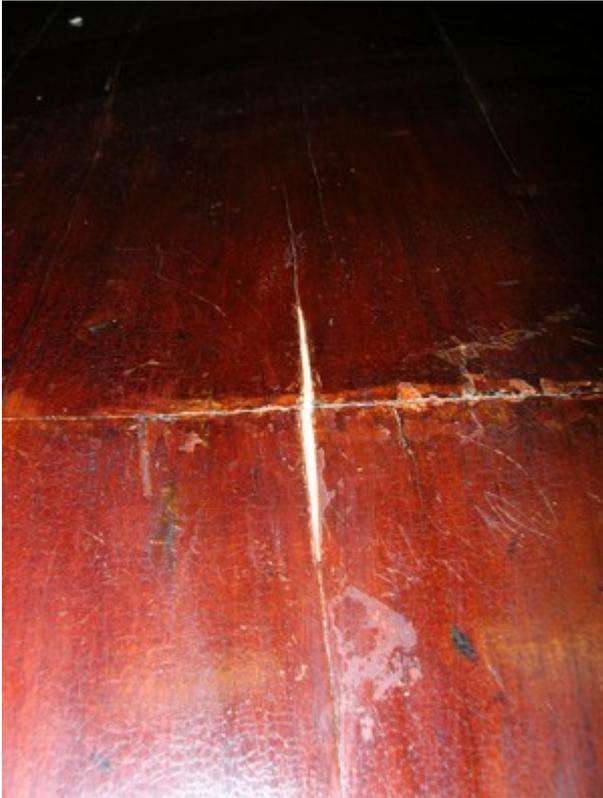
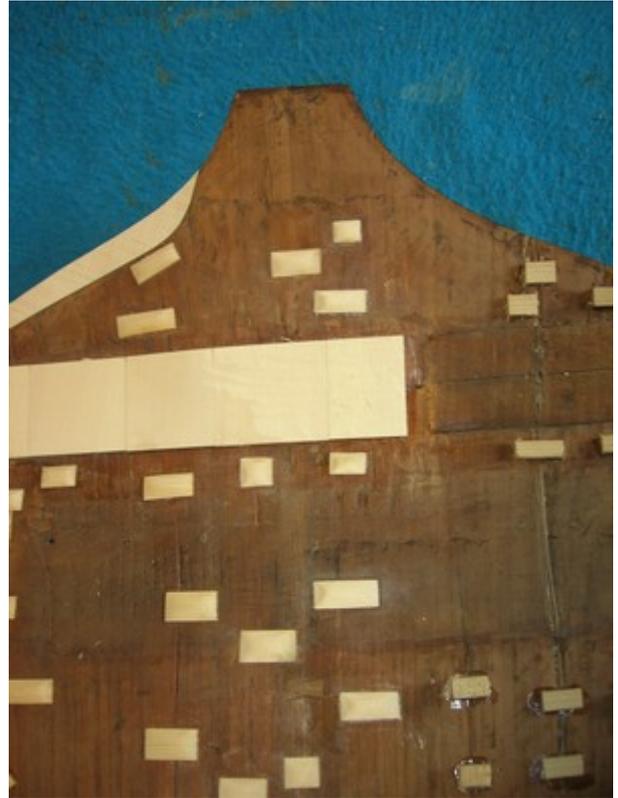
I remove the next section, uncovering a crack that starts at the upper block's glueing surface and continues down to the upper bar, through the bend, where it is open.

I repair the crack and replace another part of the reinforcement.

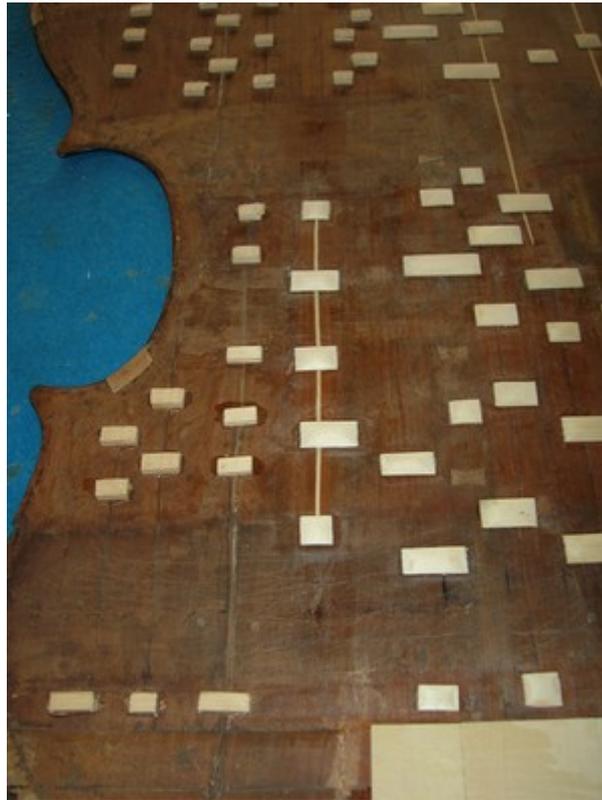
In the area between the upper bar and the soundpost bar, there is a crack repaired with a walnut shim, well glued from the inside, but open and putty filled on the outside.

I remove the temporary cleats, clean and repair.

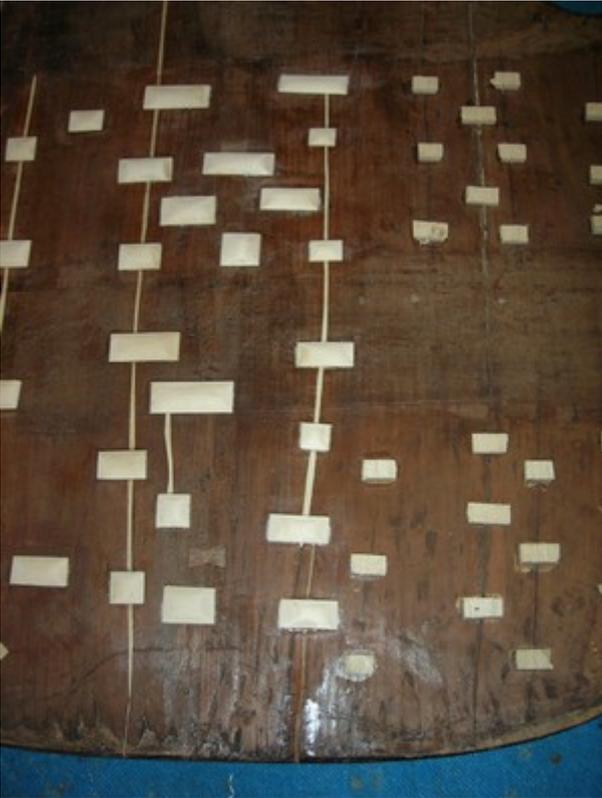
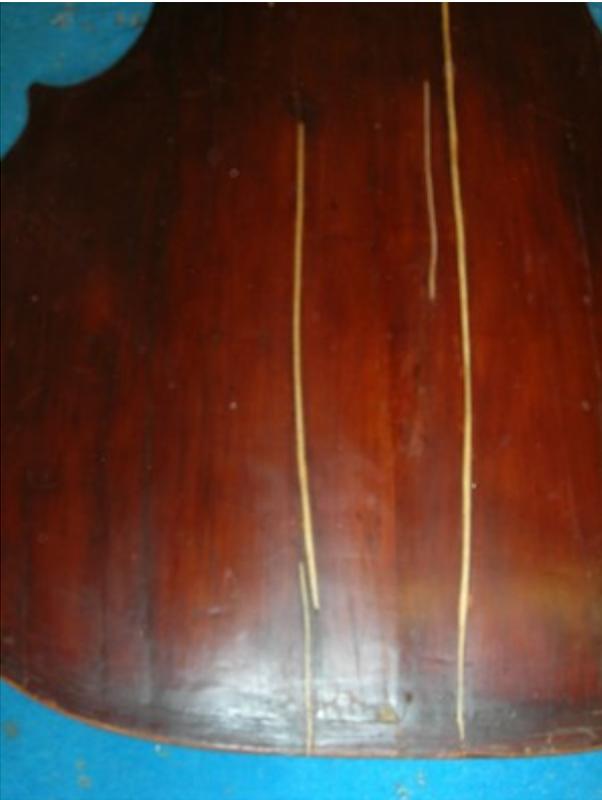
There is another open crack between the soundpost area and the lower edge, repaired with a walnut shim and putty, and two shorter cracks alongside, one right under the soundpost bar, the other at the lower edge.

I remove the temporary cleats, clean and repair.

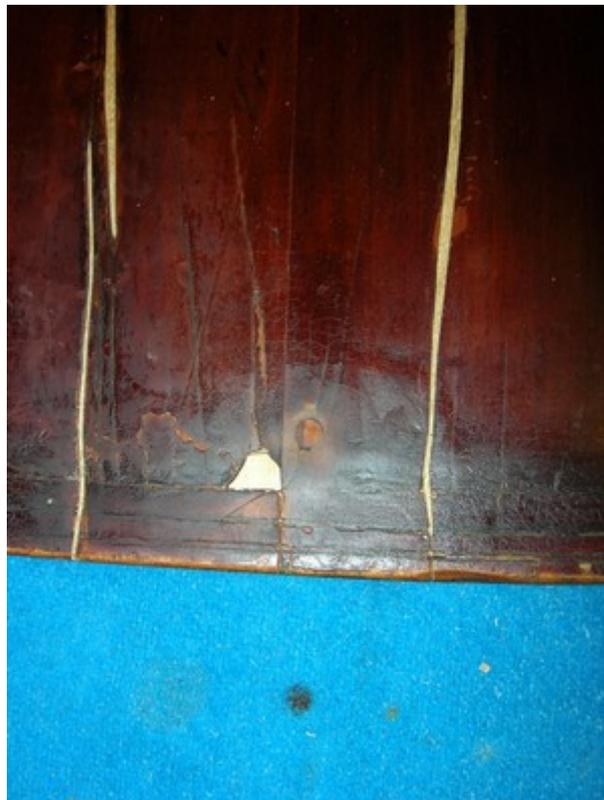
At the glueing surface of the lower block, a broken part has been reglued and a missing part filled.
There is an hole flared on the outside as well.

I remake the missing parts.

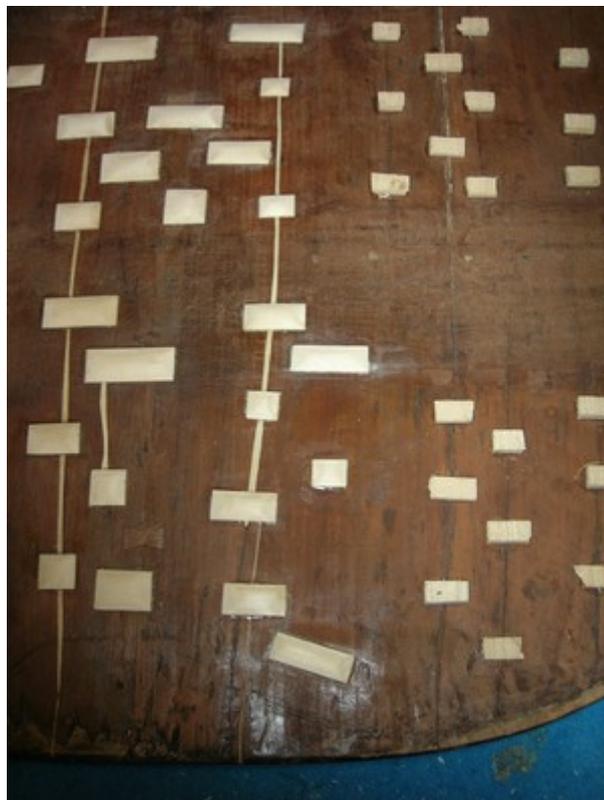
On the side of the block area there is an open crack about 16 centimetres long.

I reopen, clean and repair.

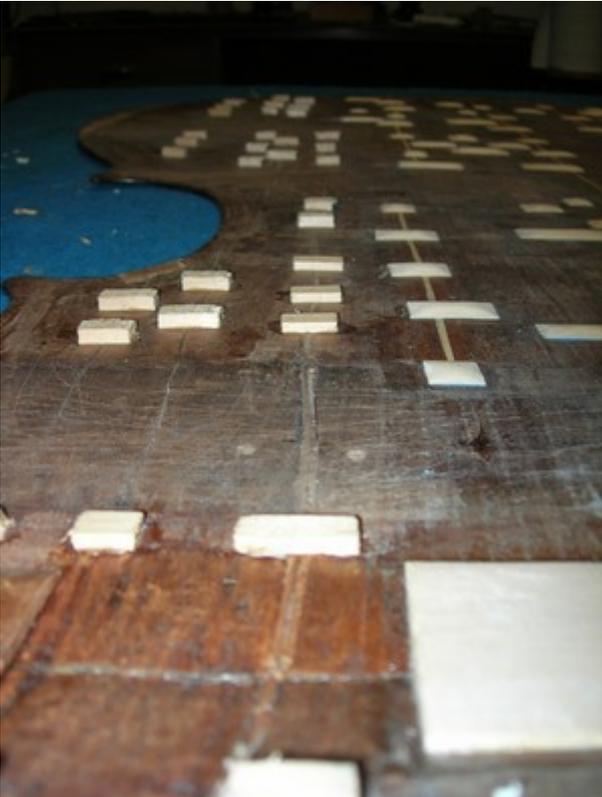
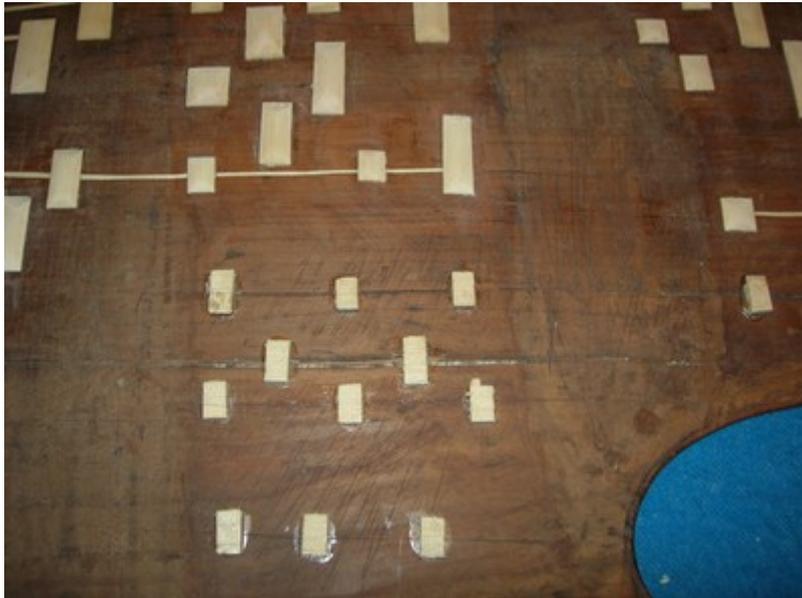
This runs from the upper edge to the lower bar.

The section between the lower bar and the soundpost bar is open but has no filling shims.

From the soundpost bar to the upper edge there are many shims, some side by side, and putty.

Also, the sides of the crack are offset on the inside, while they were smoothed and retouched from the outside, making the joint sunken.

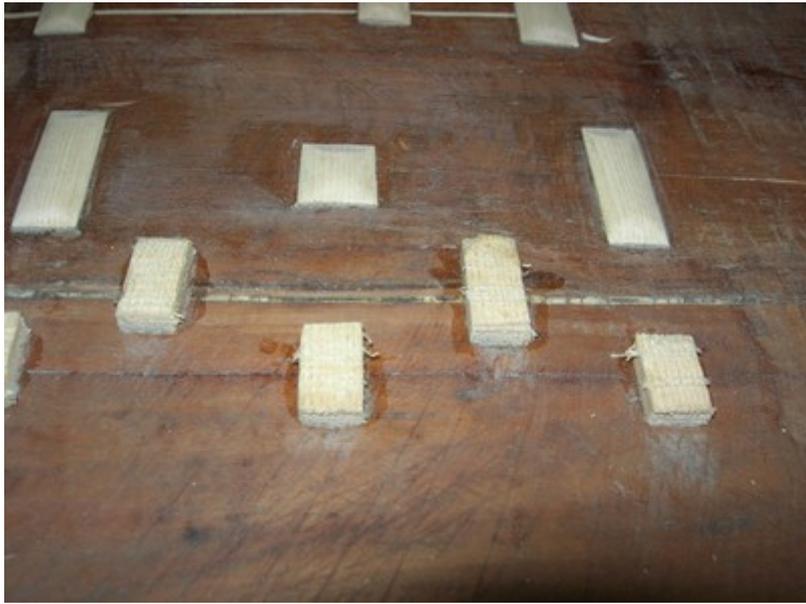
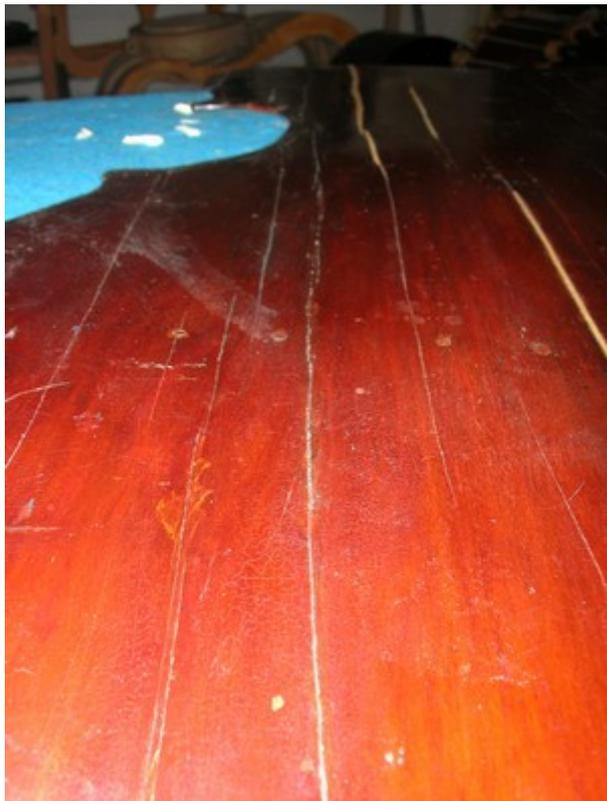
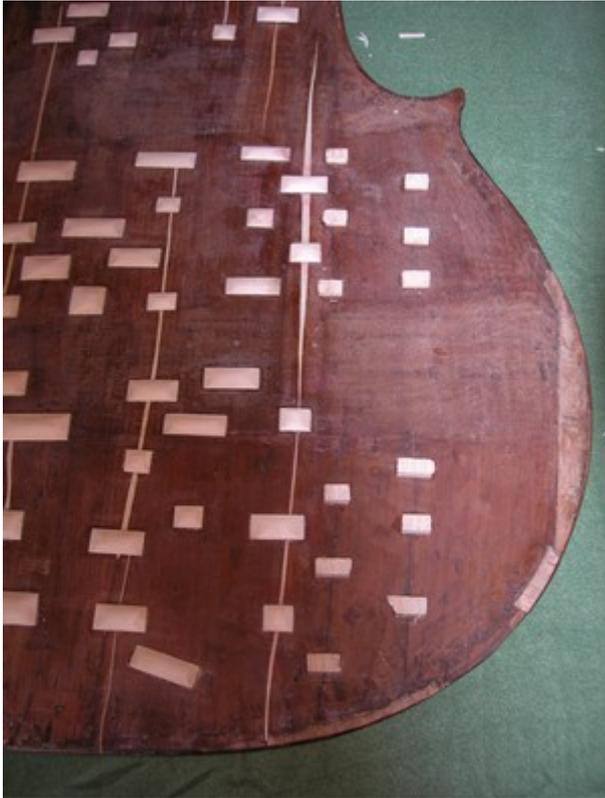
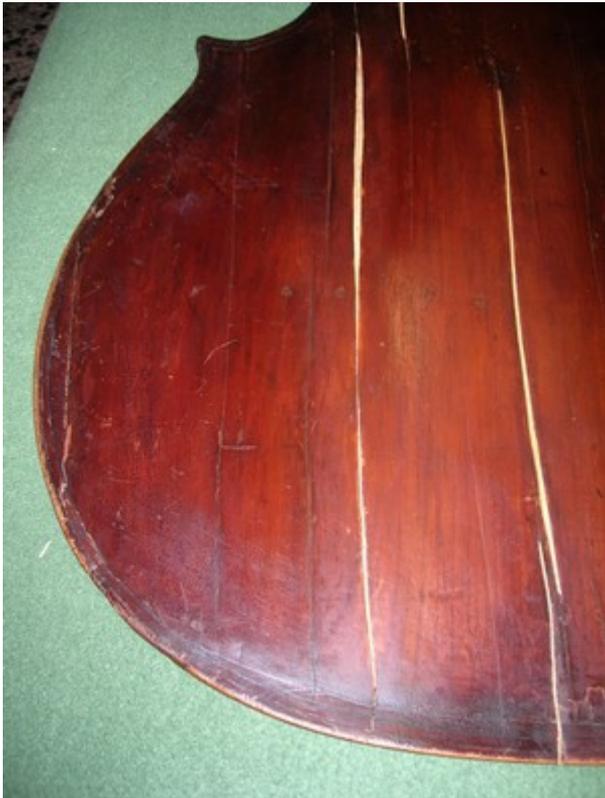
There is a crack in the lower part between the lower edge and the treble C bout, repaired with shims and filler.

I remove the temporary cleats, open, clean, replace the shim and put new cleats.

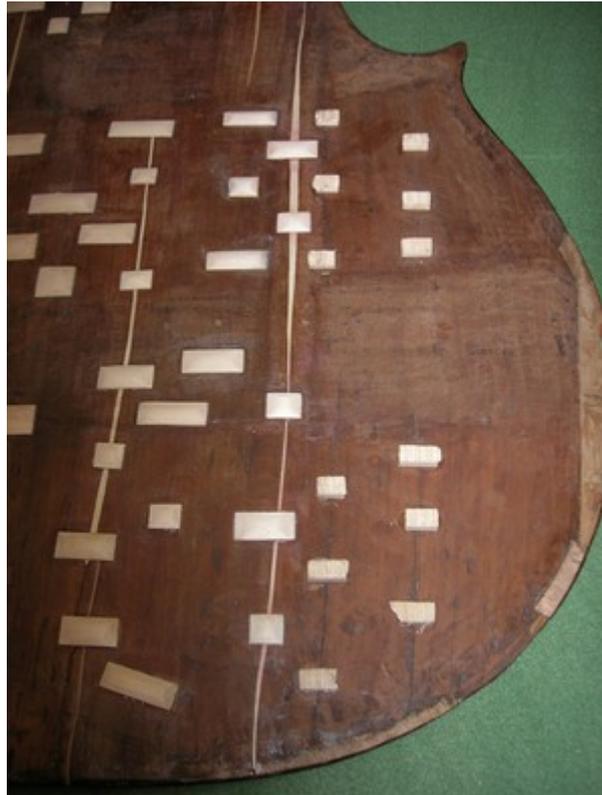
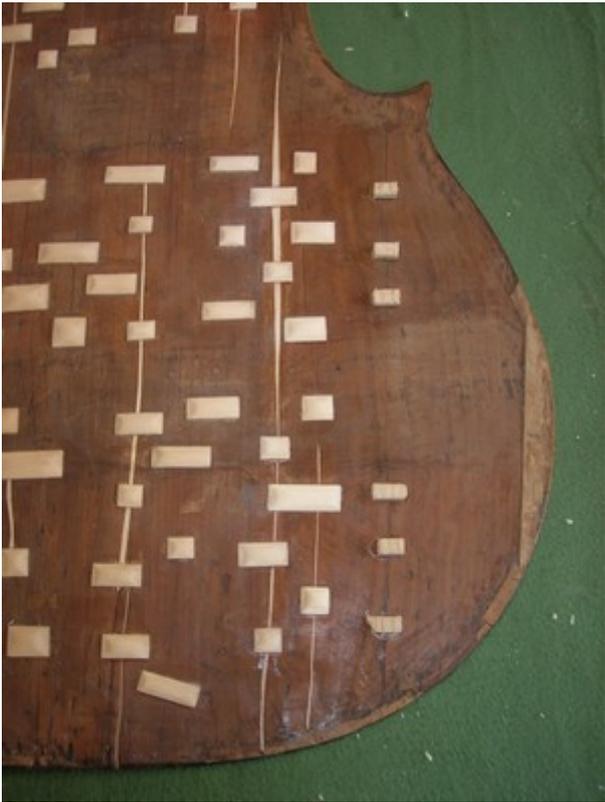
Two more cracks run parallel to the last, one between the lower edge and the glueing surface of the lower bar, the second one between the bar and the treble C bout.

In the lower crack a walnut shim was inserted from the outside, properly glued but missing a part on the inside

I open, clean and repair, with a shim to fill the crack inside.

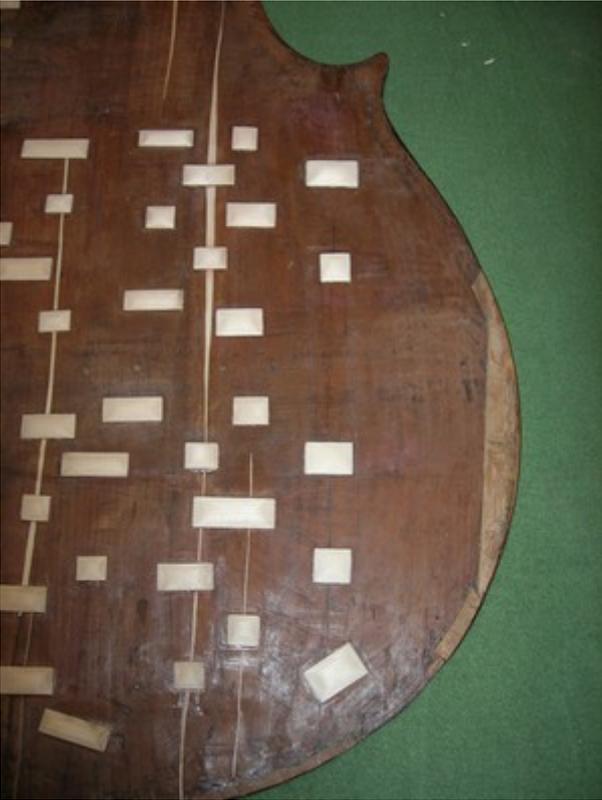
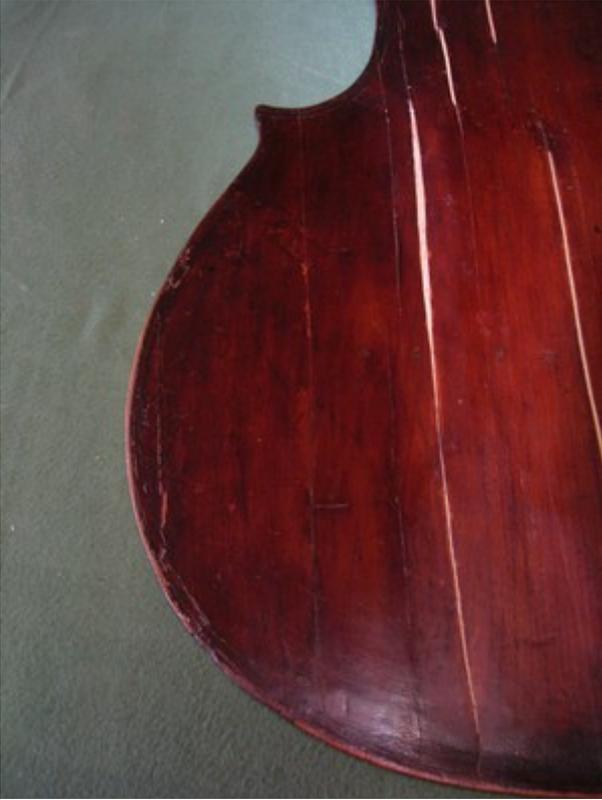
In the lower treble part there is a last crack, between the lower edge and lower corner, properly repaired with a shim, well glued.

I remove the temporary cleats, clean and reinforce with new cleats.

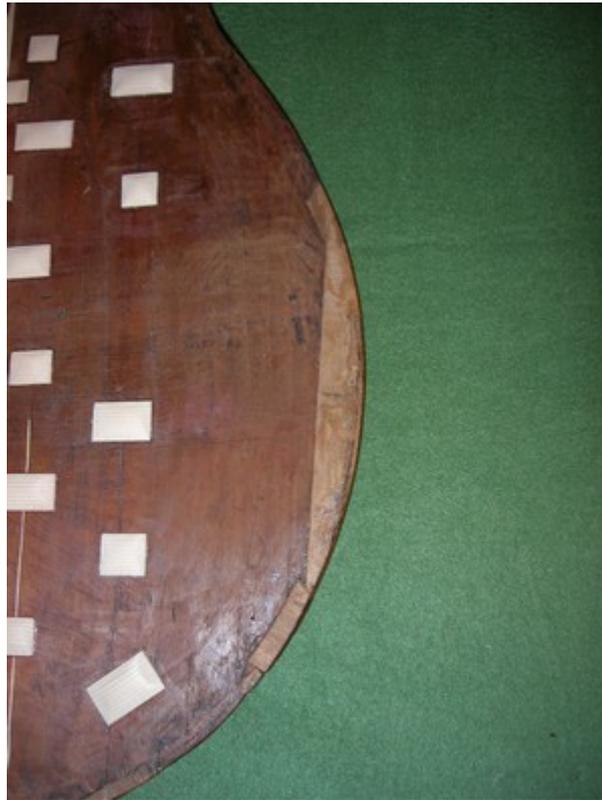
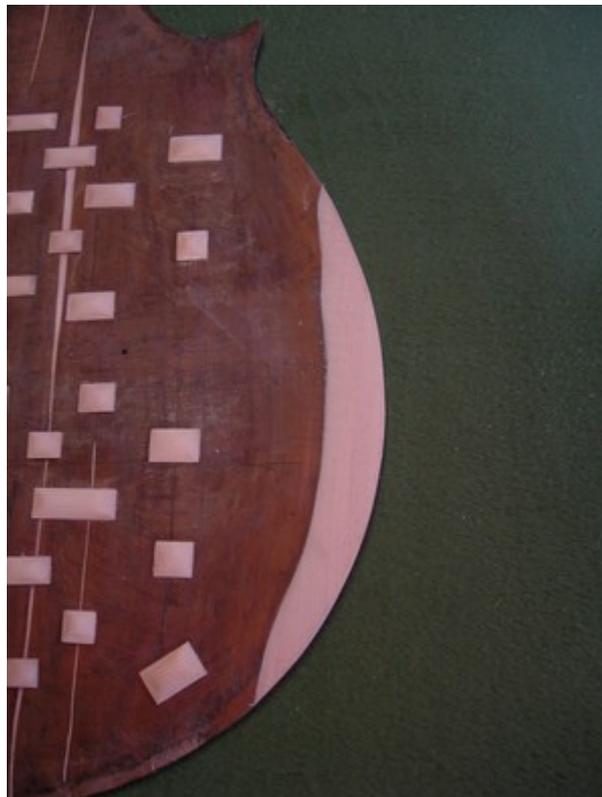
The widest part of the treble lower bout was reconstructed in various parts.

I make a reinforcing edge doubling on the inside.

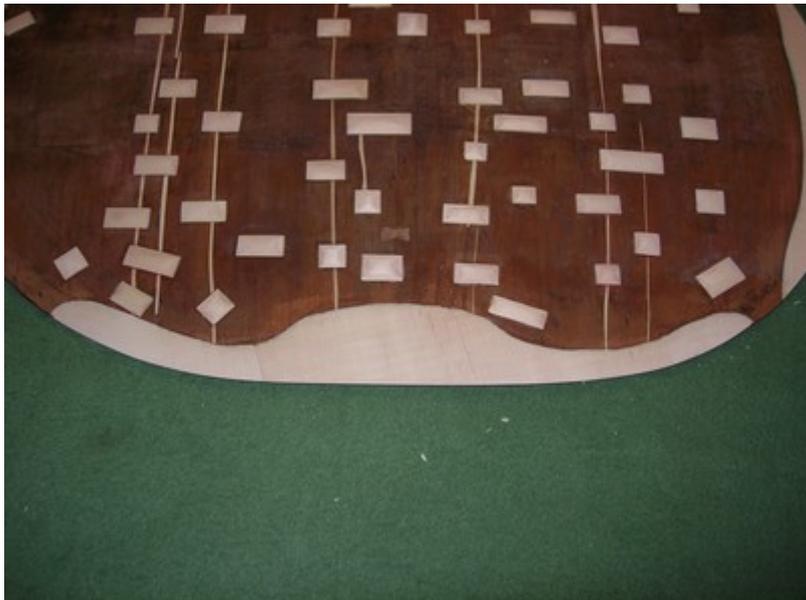
In the upper part, a crack is open from the bend to a reconstruction at the treble C bout. The reconstruction has the grain parallel to the C bout's edge.

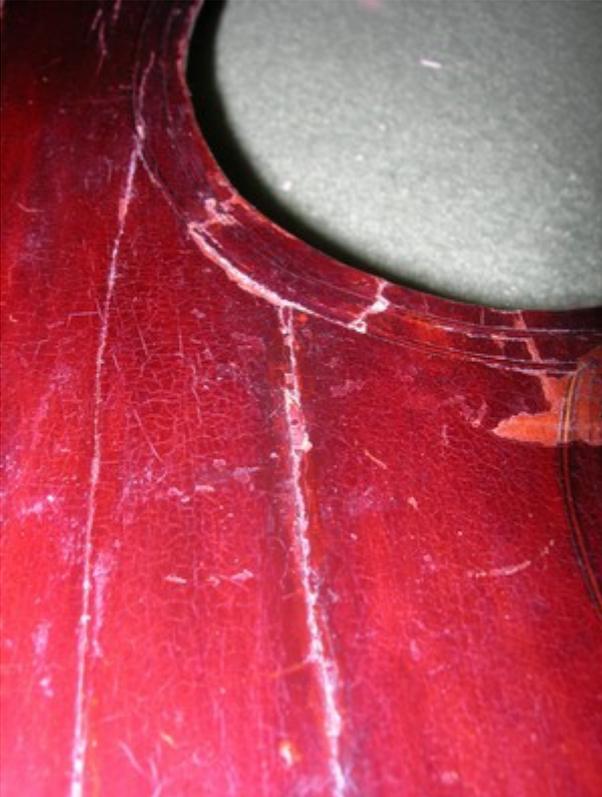
It has been repaired from the outside with a walnut shim and filler.

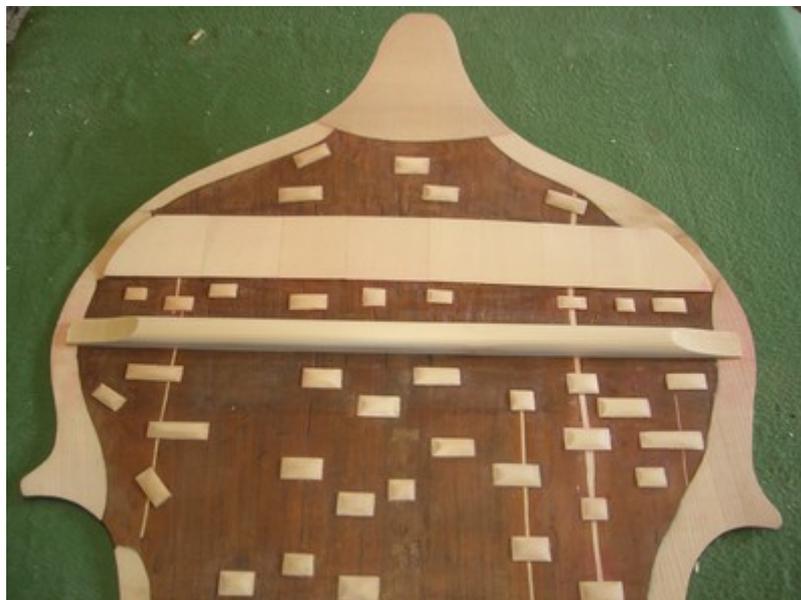
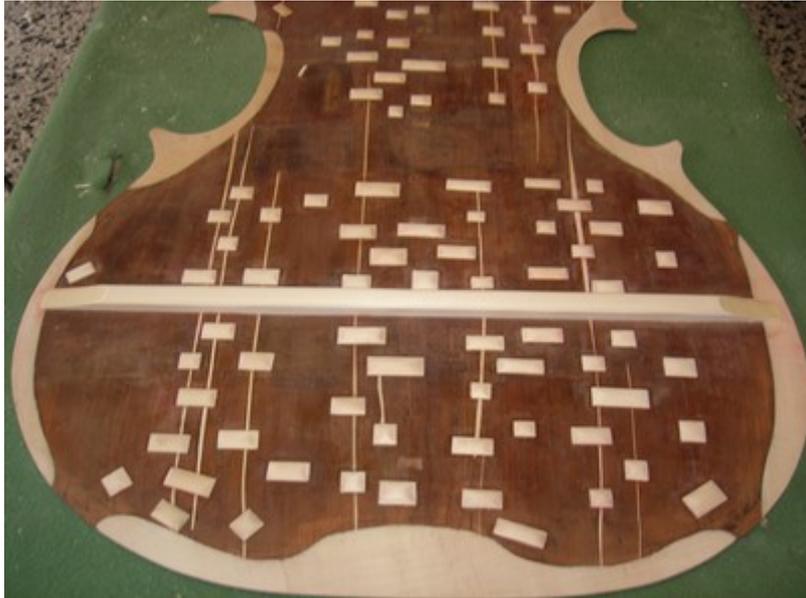
The bar structure that I found initially had four bars, none of which original.

Of all the glueing surfaces of the back to the bars, the one for the smaller bar is less damaged than the others, which probably have been replaced more than once.

Considering the damages at the back's surface, the upper and lower bars might have been around 20 millimetres wide, with an inclination converging towards the treble side, having the upper bar parallel to the bend and the lower one inclined.

I make the upper and lower bar flat, and adjust them to fit the irregularities of the back surface.

The width is 20 millimetres and the placement is as indicated by the damages.

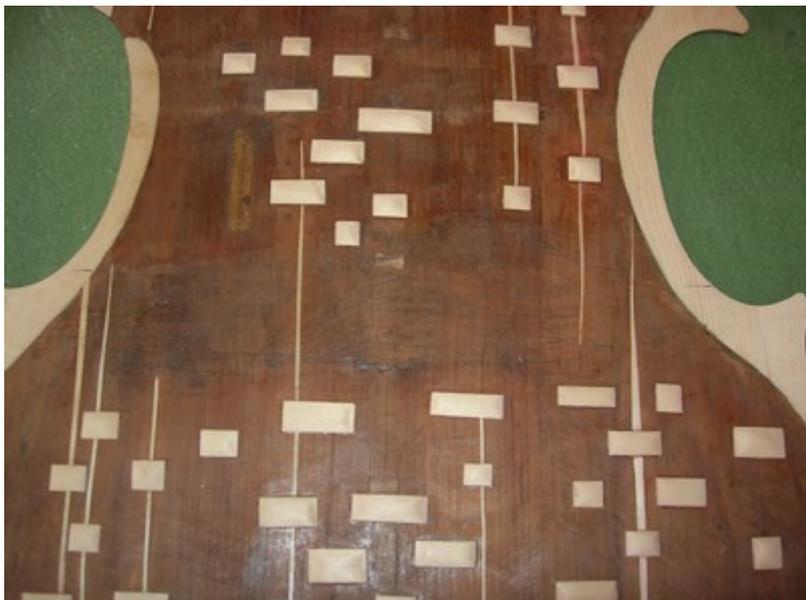
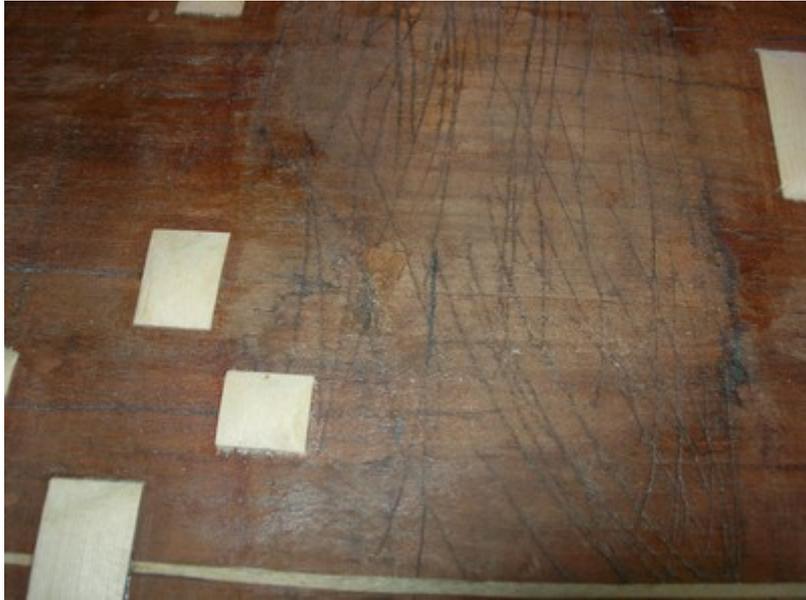
The glueing surface of the soundpost bar shows signs of at least two previous bars.

The more recent one, possibly made by Degani, was wider on the treble side, narrowing down towards the bass side.

A previous one, narrower, had similar shape but sharper curves.

Both covered a butterfly insert at the center joint.

I decide to make a bar parallel to the upper one and to the bend, of constant width, narrow enough to not cover the butterfly insert.
