Giuseppe Cazzaniga, Liutaio

Bernareggio, July 2009 - June 2012

Restoration of a Brescian style double bass

The instrument is property of Maestro Ezio Pederzani

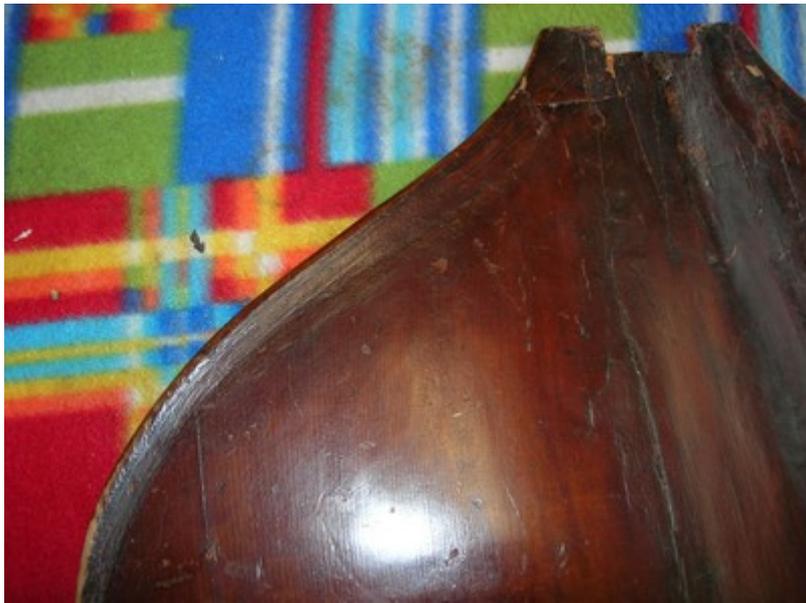
I have doubts on the lower part of the C bouts as well. I will have a clearer view after I clean the varnish and remove the edge doubling from the inside.

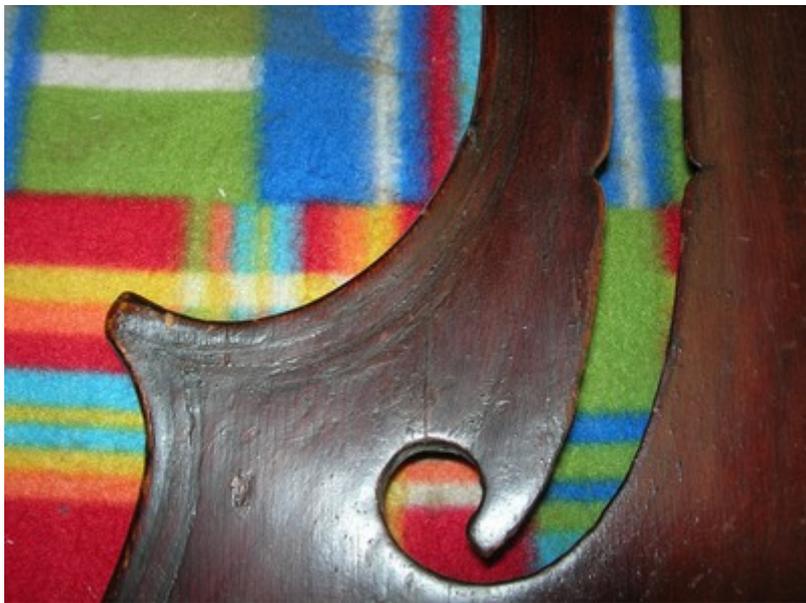
The varnish is dirty, with red brown retouchings and fillings, specially near the bass bar, where there are evident woodworm damages.

There are no open worm holes though.

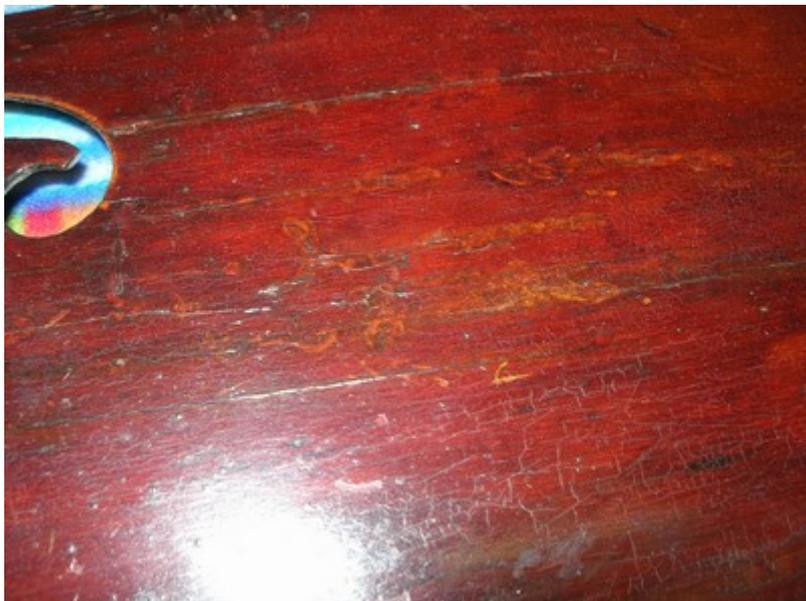
From an inside view, there are repairs by at least three different hands

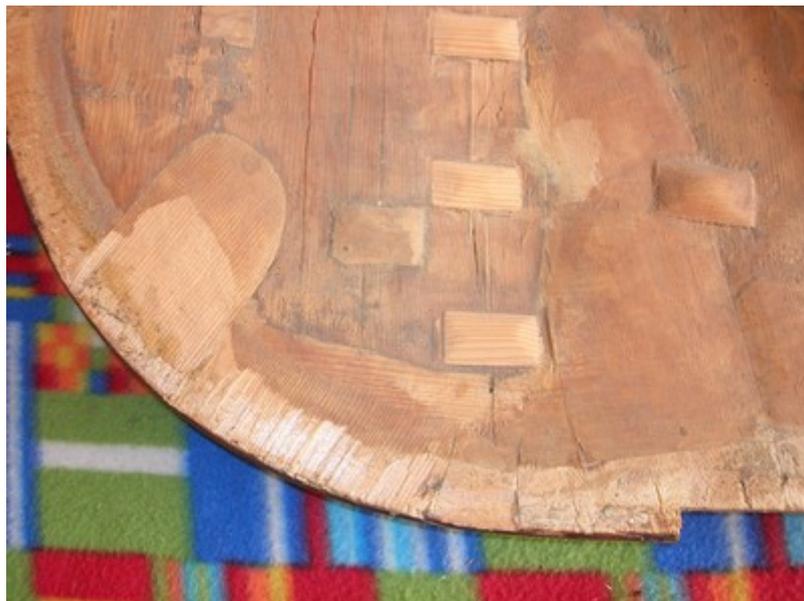
The entire edge has a spruce doubling, which has been glued with the fiber running perpendicularly to it.

At the lower edge, this doubling is glued over another (previous?) one.

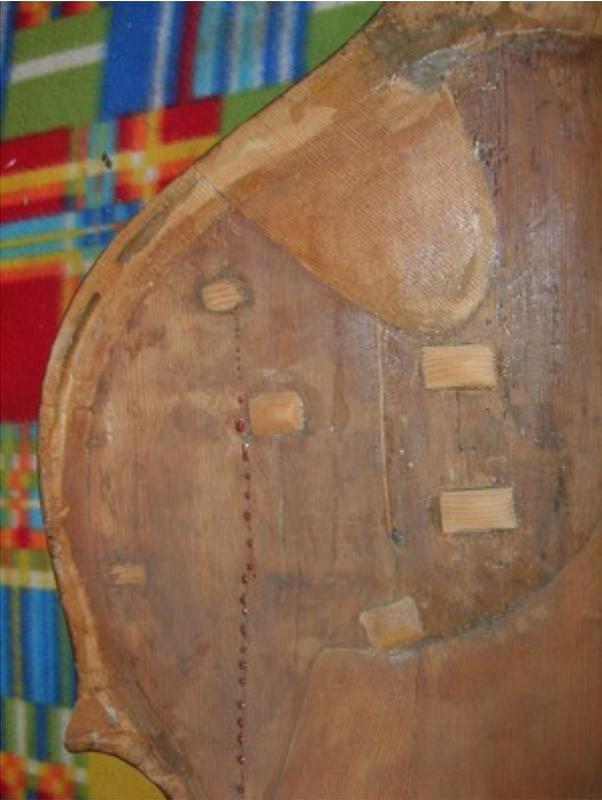
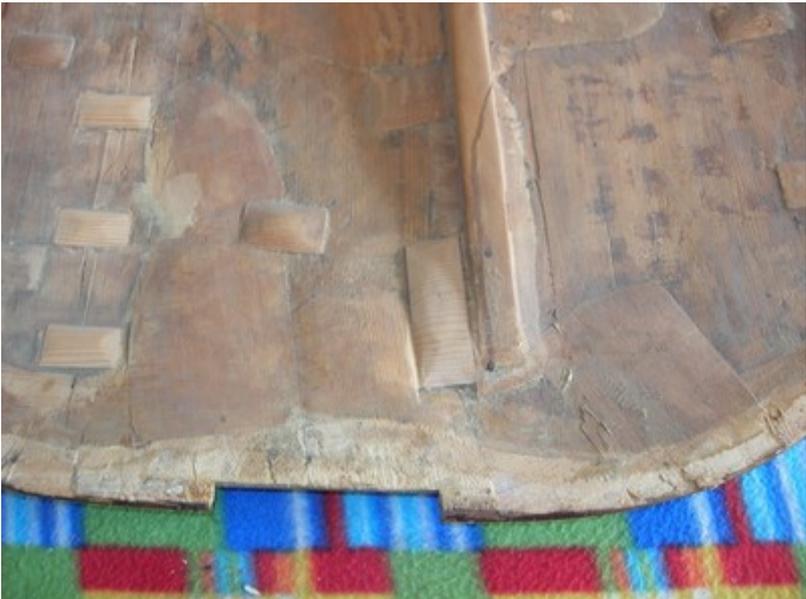
In some areas, upper and lower bouts on the treble side, lower bout on the bass side, at the lower block, the doubling extends inside the top.

The bass bar, which is very long, conical, well shaped, is glued to a large doubling in the middle part of the top, and to reinforcements with perpendicular fiber at the edges. (the grain of the central doubling which is made of multiple pieces, goes in various directions).

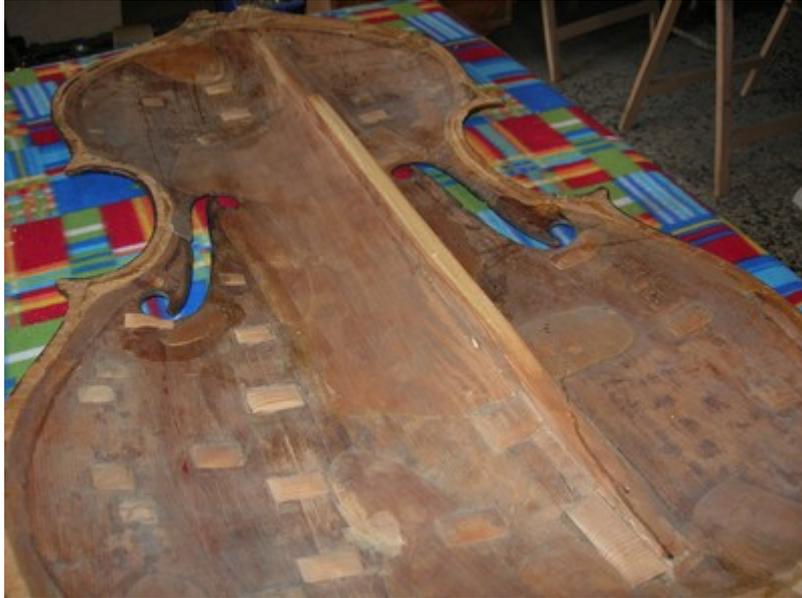
I notice, with no surprise considering the ribs, that the edge of the top is not flat but curves lengthwise, with the C bouts being the highest point.

Doublings, replacements and deformations might have been a cause for it, but is more likely that the curve was given to the ribs by planing them to follow an original curve of the top's carving.

To do so, I plane down the bass bar, which I will replace, to lay the top on a flat surface.

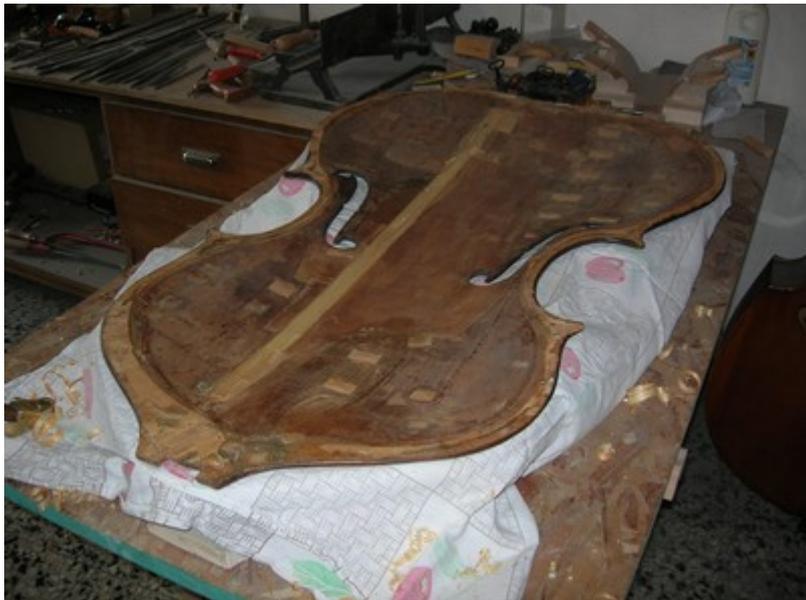
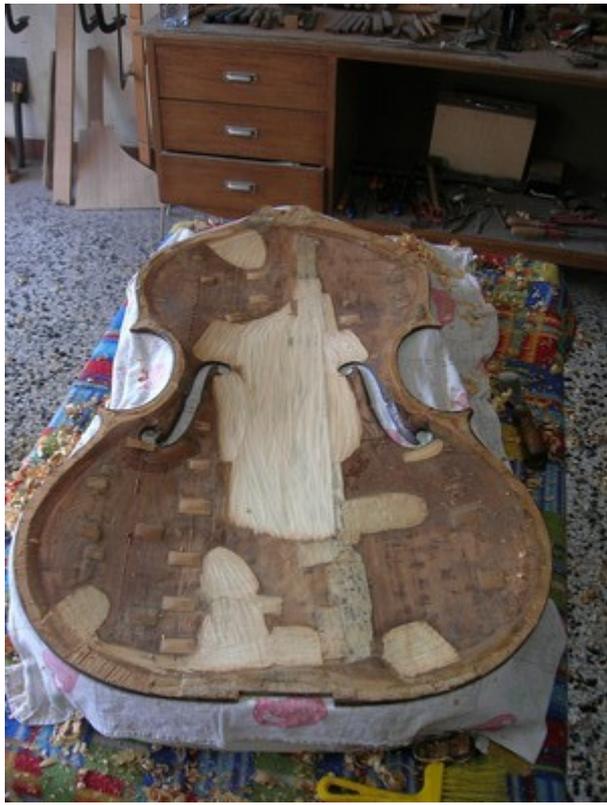
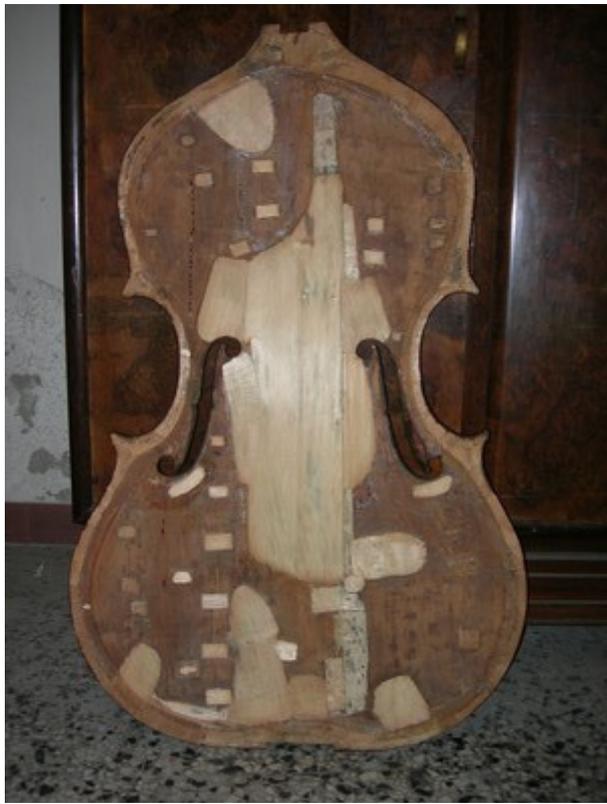
While doing this, I notice that the edge doublings and their extensions toward the inside are older than the ones in the middle of the front, where the wood used seems less oxidized.

There is a second doubling in the lower center of the top, older than the one covering it.

I place the front on the mould, with a cotton cloth to protect the varnish, and remove the bass bar. Then I plane the doublings and cleats down till I can see the glueing surfaces.

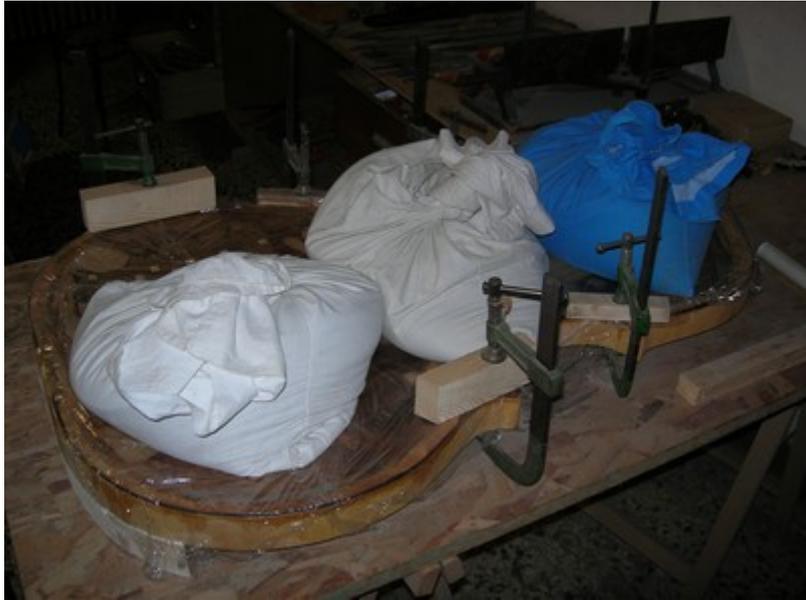
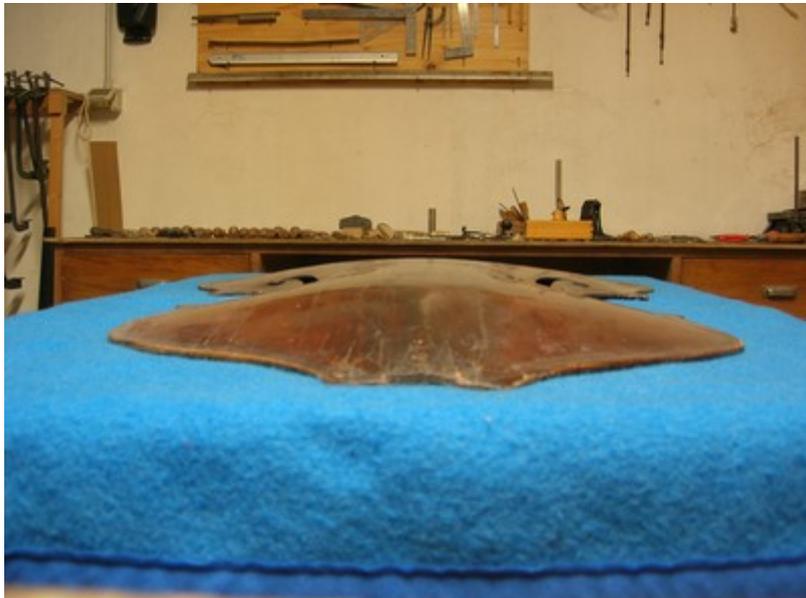
The top takes an acceptable shape in about two months. The area under the bridge's treble foot remains slightly cupped, and it will need more time to get in shape before the making of the central doubling.

Then I press the top against the modified mould, moisturizing it and using sand bags as weights, while clamping the edges down when they rise up.

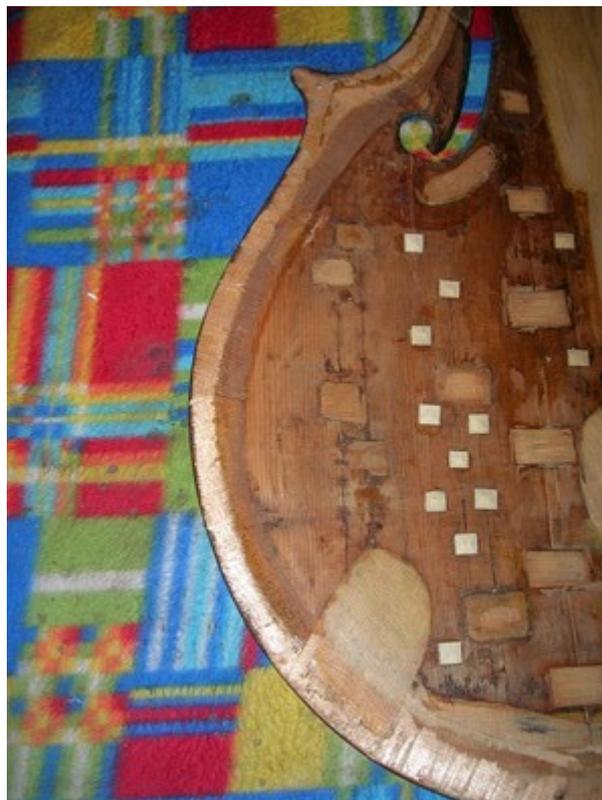
By doing so, I can see that the edge had been replaced in the lower part, at the widest part of the bout and at the corner, where I see a wooden pin.

I start the repair work in the lower part on the treble side, by removing the edge doubling up to the first crack.

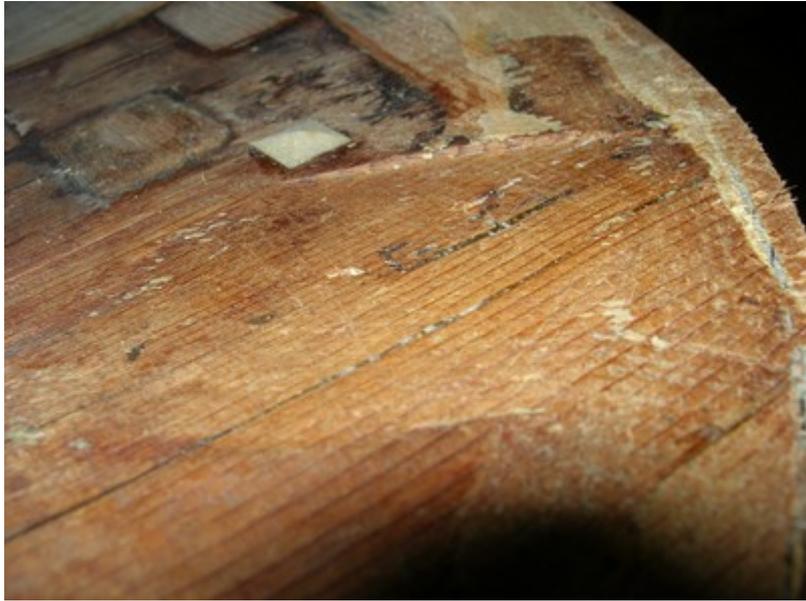
The doubling's extension towards the inside, in the lower part, has been inserted in the plate with a straight joint.

I replace a first part of the doubling in spruce with fiber running slightly sloped.

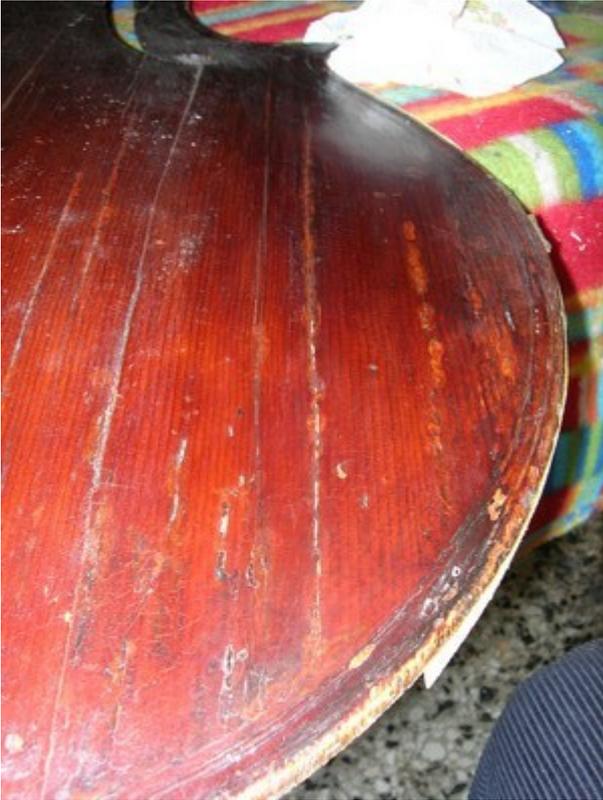
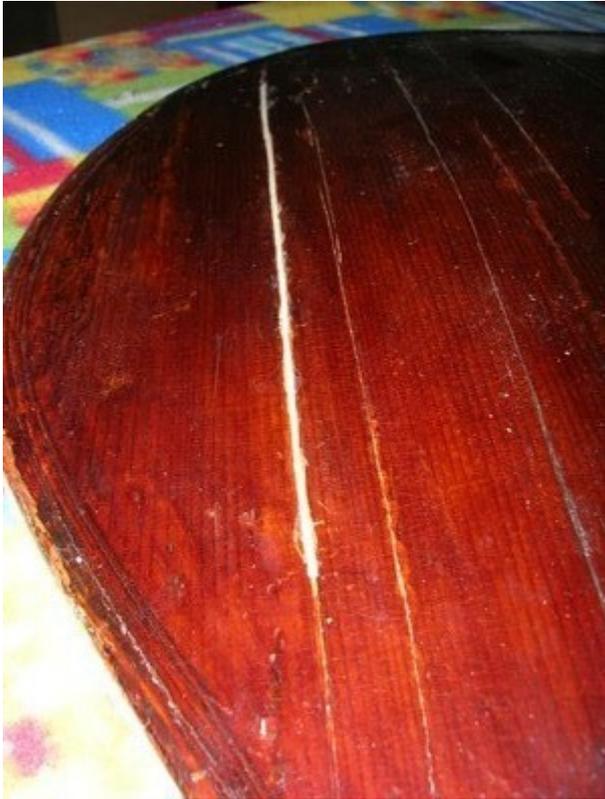
The following crack was glued with non aligned sides.

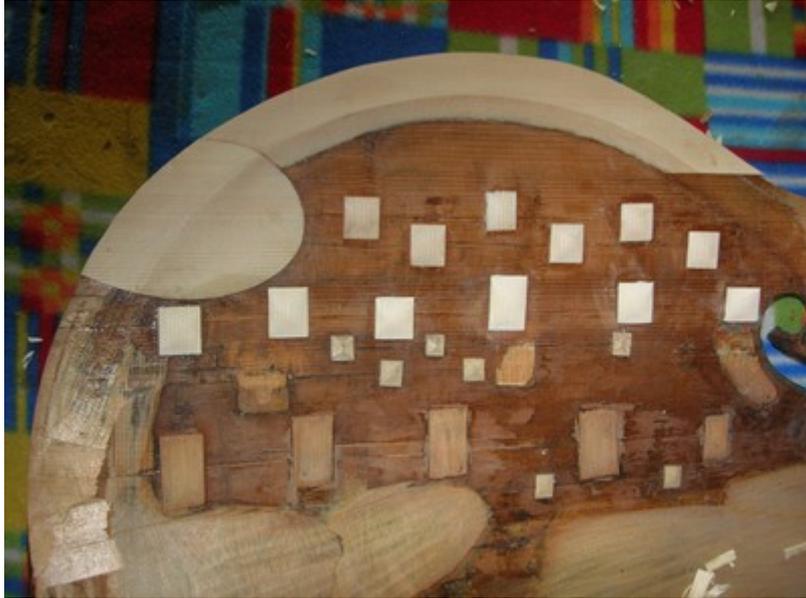
I proceed in the same manner with the following two cracks
The inner one has been repaired with stiches, of which holes still remain.
The outer one has two well made shims.

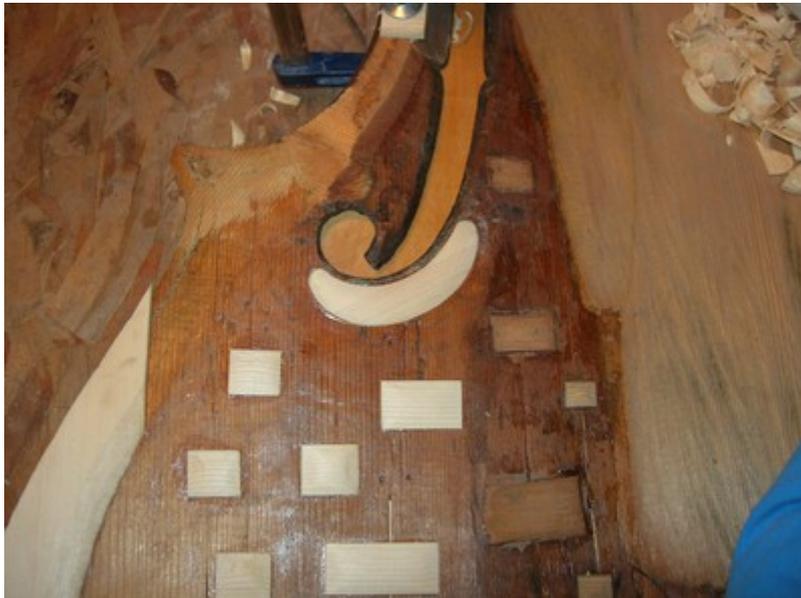
The next two cracks, close to each other, were repaired offset, with shims and filler. The front has been leveled from the outside, removing the varnish, which has been later retouched.

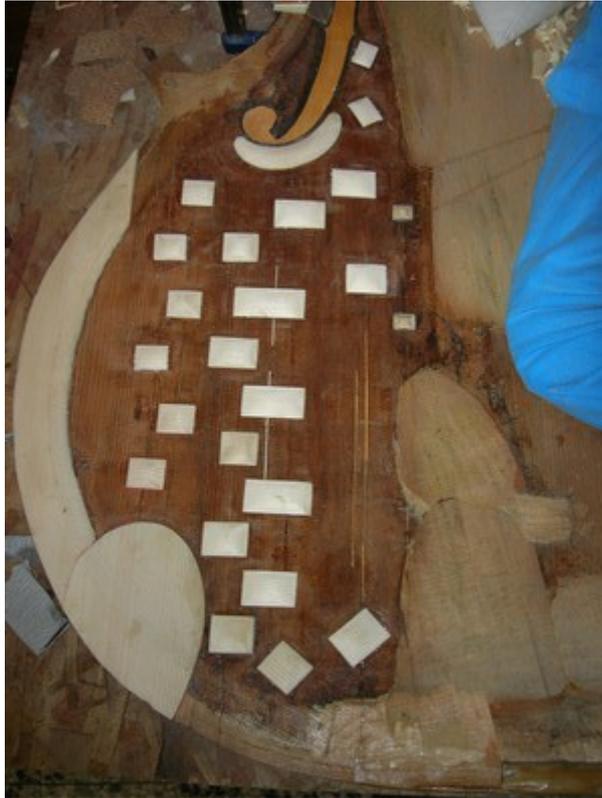
The lower part presents a thickness decreasing, where the cracks have been poorly closed and the top leveled from the outside.

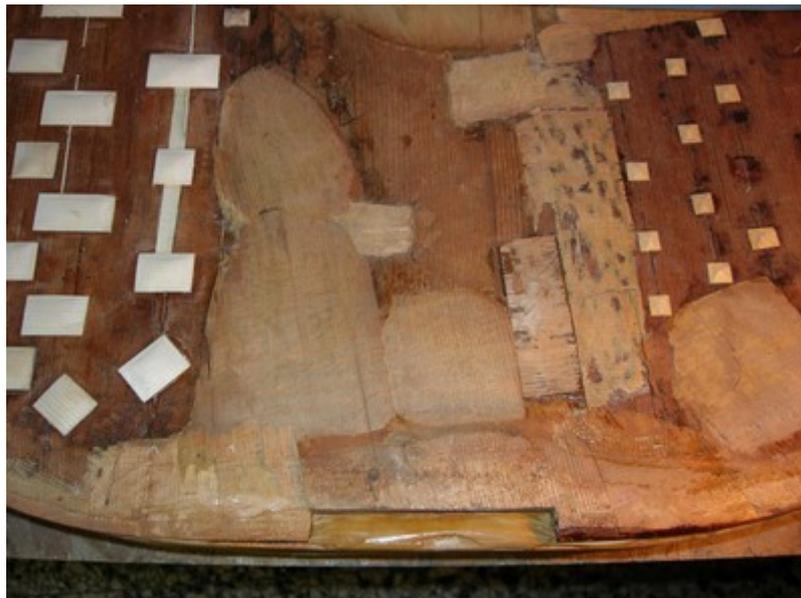
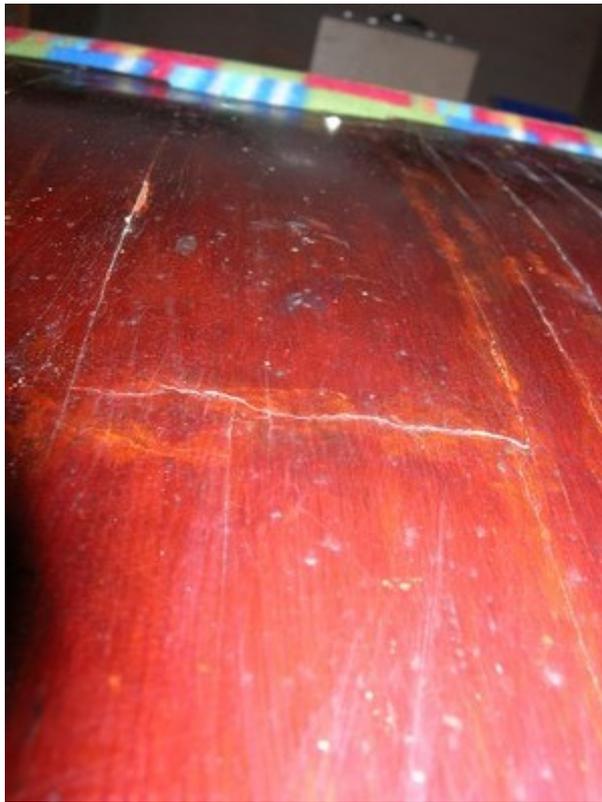
I notice that an old doubling covers the large reconstruction, made before the edge doubling and the lateral reinforcements.

Both doubling and reconstruction show a crack repaired with a walnut shim.

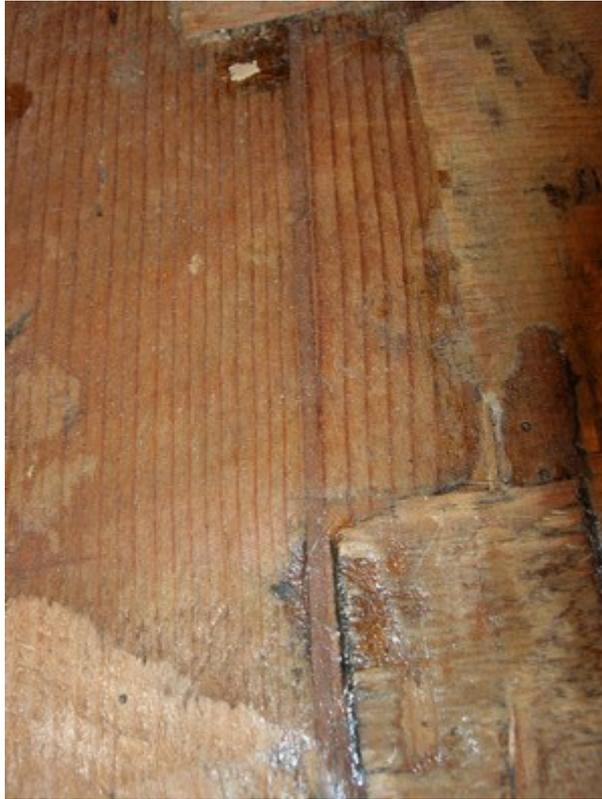
The thickness of the external reconstruction is of about 2 millimetres. The old doubling covering it brings this area to 4,2 millimetres.

The glueing area under the bass bar has been lowered to 4,5 millimetres, and then reinforced with doublings with perpendicular fiber.

The extension of the edge doubling between the bass bar and the lower bout was partially inserted in the top, where it drops to 3,2 millimetres.

This requires a large doubling at the lower part of the top.

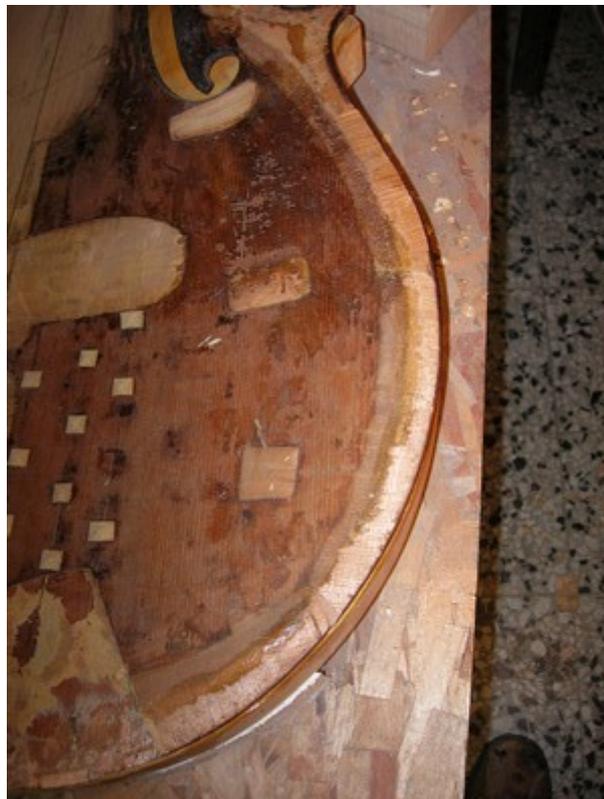
By doing so, edge reconstructions come to light along the whole bout, together with a corner reconstruction.

I remove the edge doubling on the bass side.

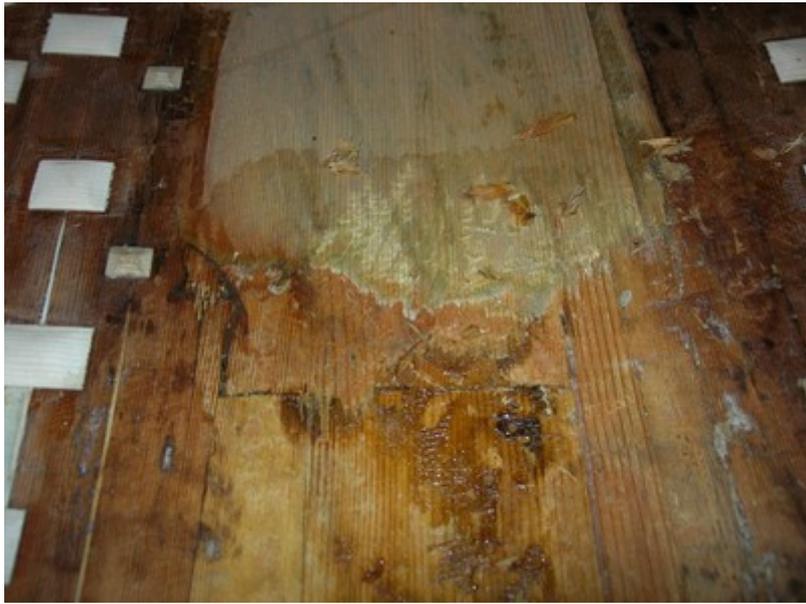
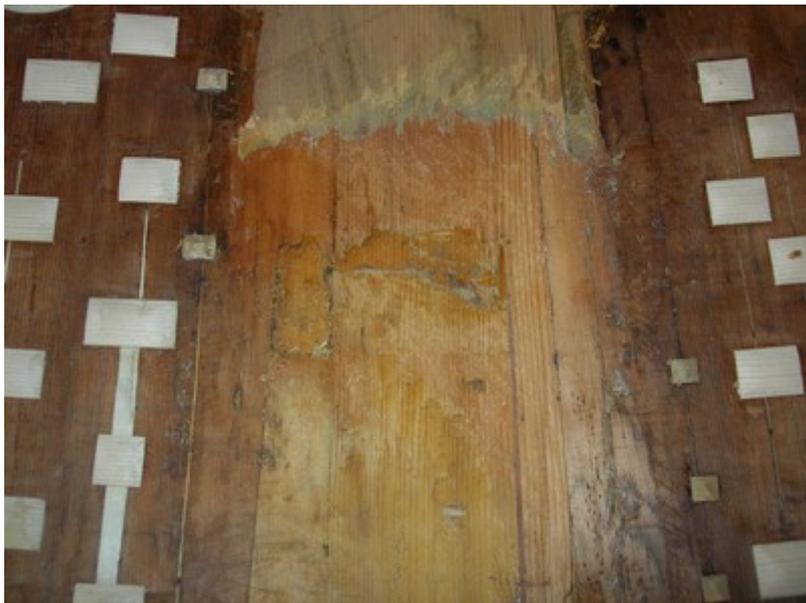
So I can see that the top is in three pieces.

the central reconstruction is connected to the central piece with a slanted joint, while on the sides there is a walnut shim and a larger spruce reconstruction.

I make the lower central doubling, with slightly sloped fiber.

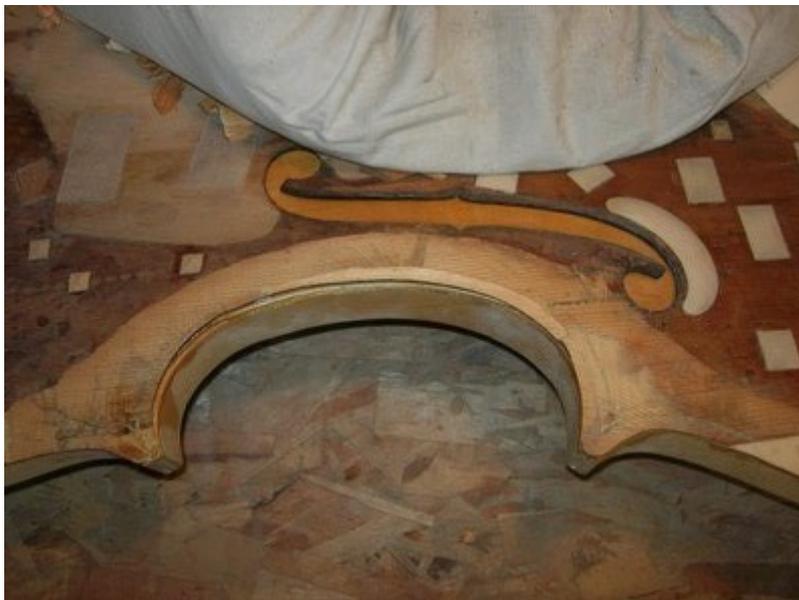
It is possible to see an edge replacement of the treble C bout, maybe made because of the bowing action. The corners have centering pins.

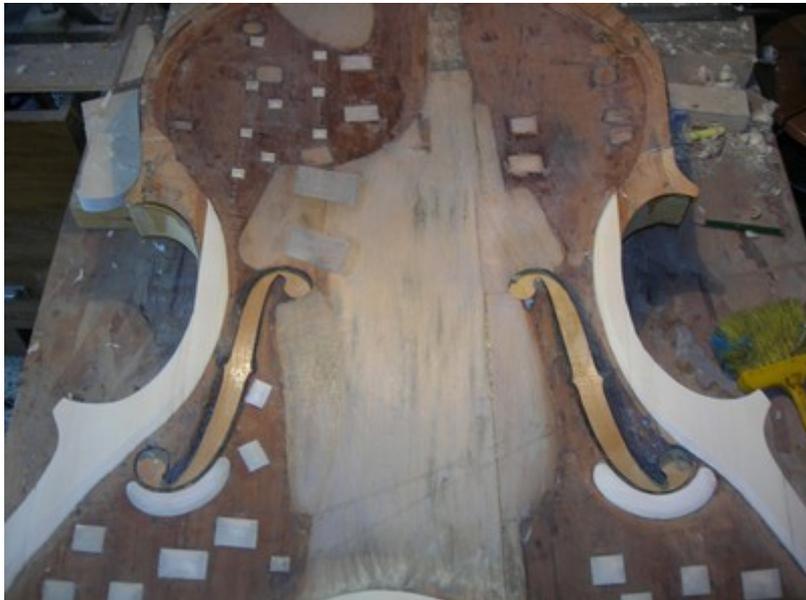
This clearly shows the top in three pieces. The joint on the treble side is parallel to the center line, and internal to where the sound post might be.

On the bass side, next to the joint, there are worm holes.

Under the old doubling, the front was roughly made thin, and worm holes and tool marks were filled with white chalk.

I remove the remaining central doubling.

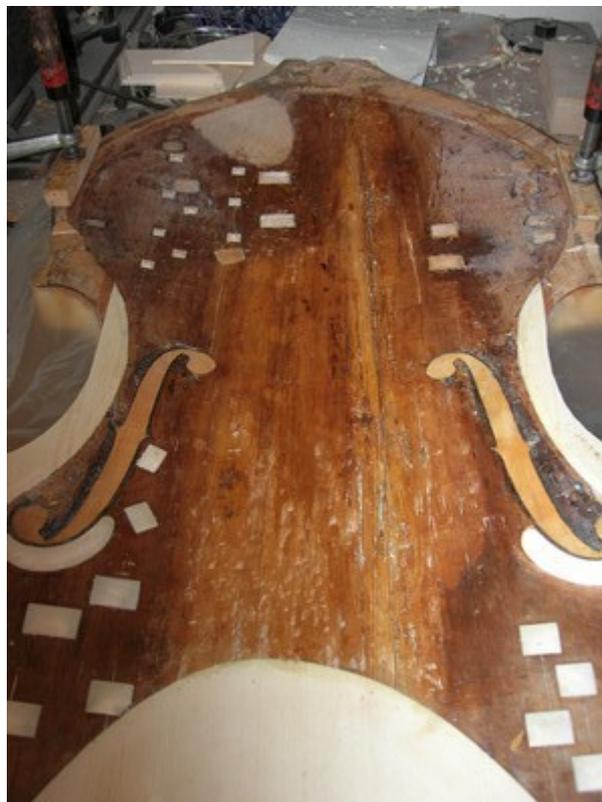
The remaining thickness of original wood varies between 3,4 and 1,7 millimetres, and is particularly thin on the bass side in proximity to the upper part of the bass bar and on the treble side on the upper part of the f hole.

In order to avoid thinning the plate too much, I make partial doublings to level irregularities.

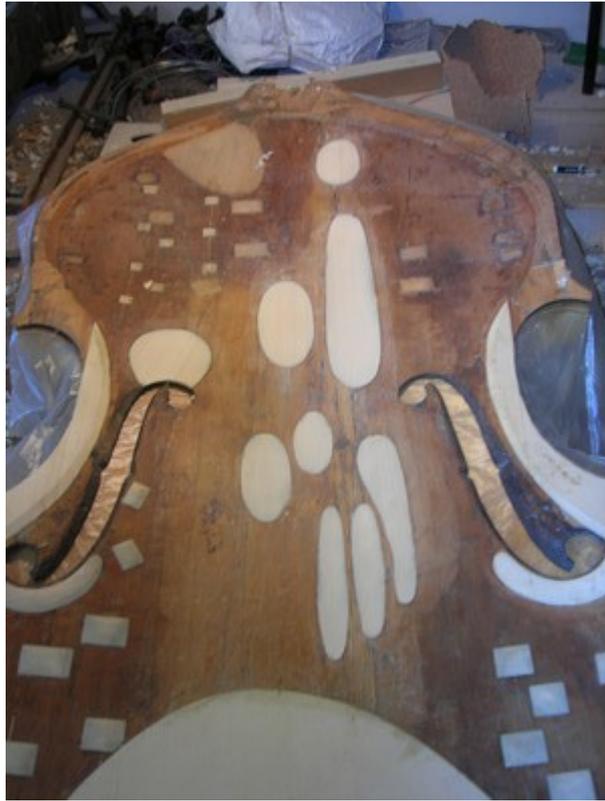
The joint on the bass side has been partially filled with a shim and filler.
I clean, and remake the shim.

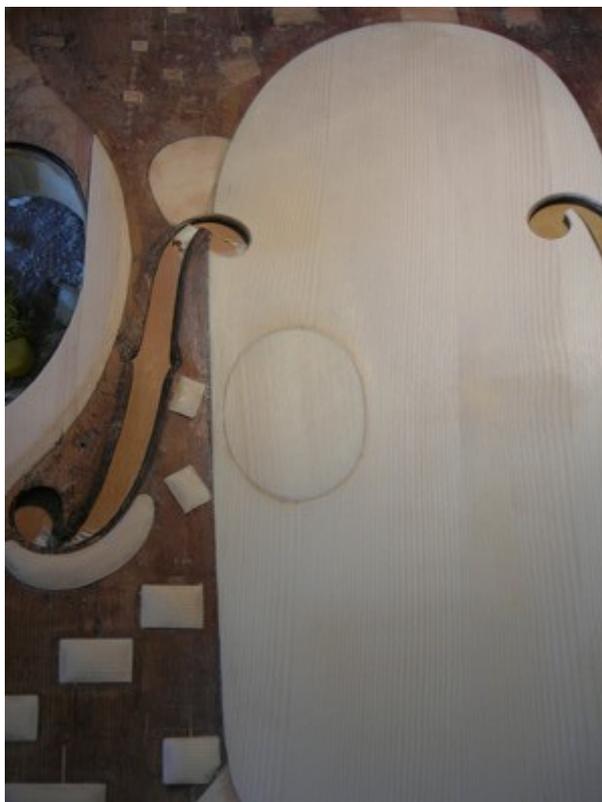
By doing so the edge reconstruction ment to widen the top is clearer. I clean and repair the crack. I apply three new cleats.

I continue by removing the section of the edge doubling covering the first crack on the top's shoulders, on the bass side.

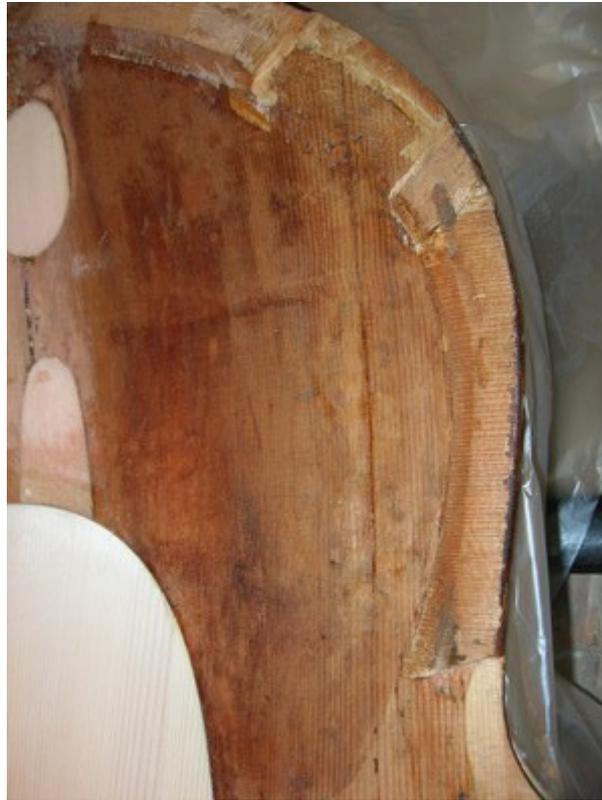
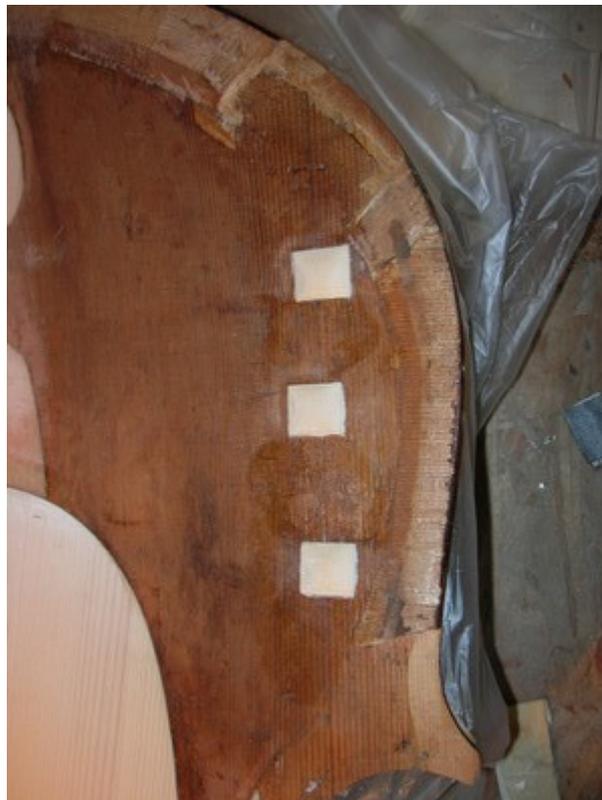
I place a temporary cleat to block the two cracks, properly closed, next to the center doubling, in an area that has been thinned to 2,5 millimetres, that will need a doubling.

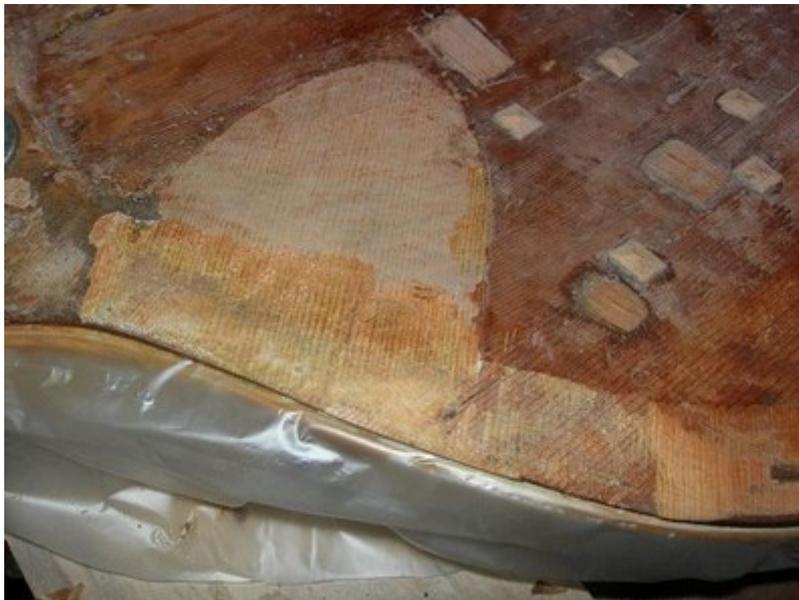
This way the replacement of the top edge made to widen it can be clearly seen.

I remove the sections of the edge doubling interfering with the other cracks that need to be repaired

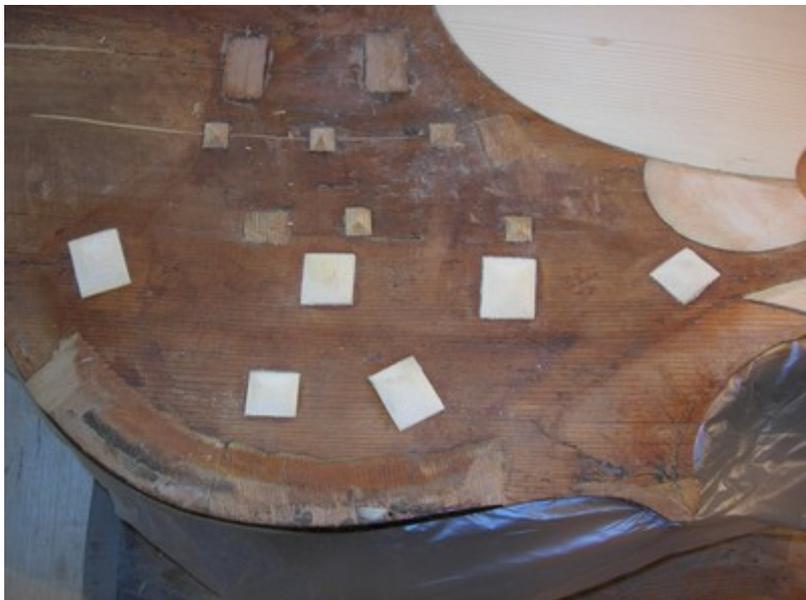
There are two well done shims as well.

I remove the cleats, open, clean and repair the next crack, reinforcing it with new cleats.

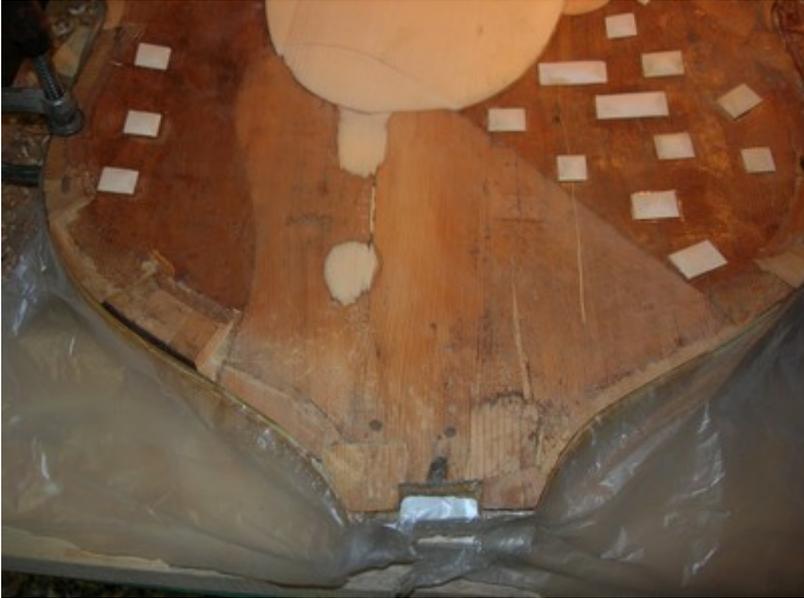
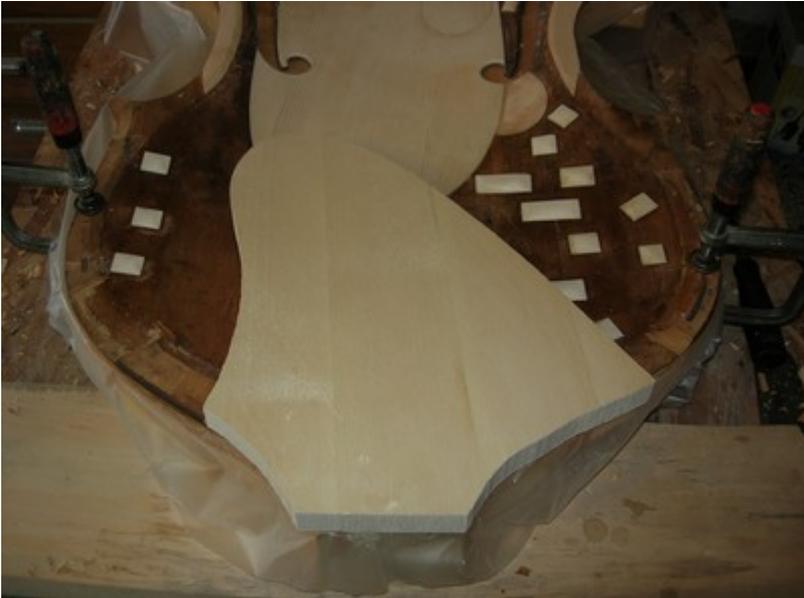
Between the tip of the bass bar and the edge doubling there is an area, 7 millimetres thick, that is maybe original. Unfortunately I will have to thin it to glue the upper new doubling. This area is cracked anyway.

Another thickening of the upper part of the top, up to 11,5 millimetres, can be found in proximity to the central "crest" carved on the outside.

I prepare the surface for the upper doubling.

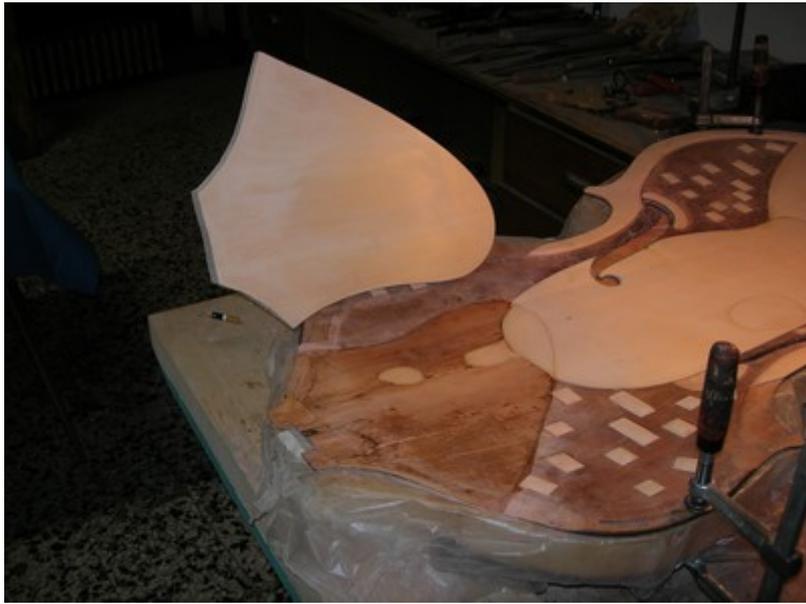
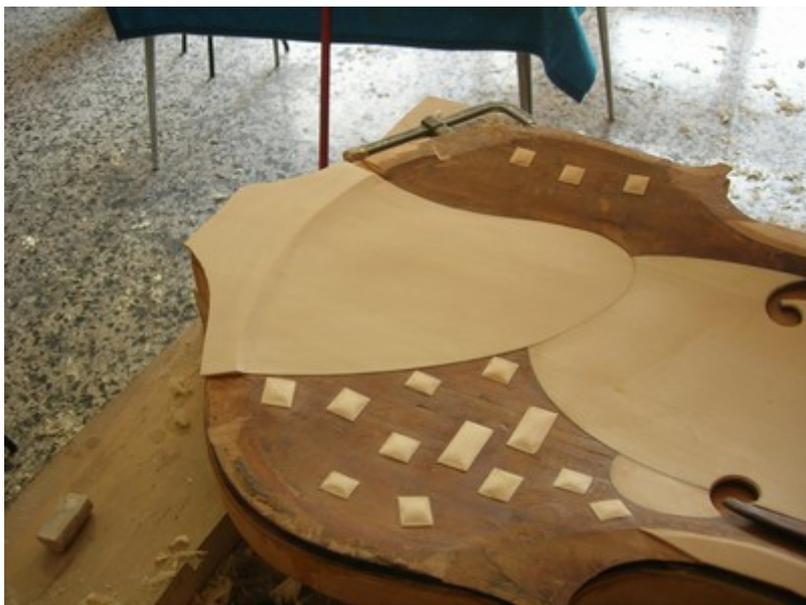
As said before, the areas next to the edge with no doubling are relatively thick, of about 5 millimetres at the upper and lower bouts, and between 7 and 8 millimetres at the C bouts.

The more central areas drop down to 3 millimetres.

I model, glue and thin the doubling.

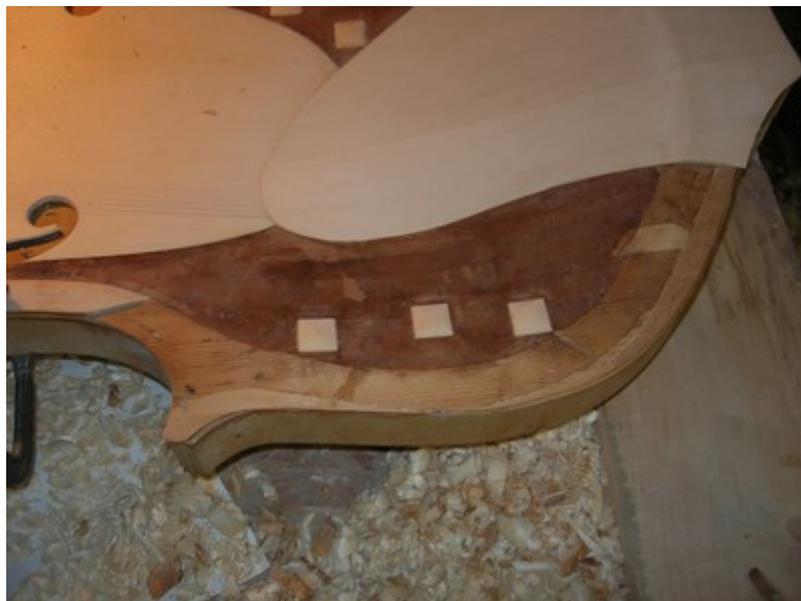
This way, the edge and upper corner reconstruction on the bass side come to light, together with a superficial addition.

I remove the remaining edge doublings.

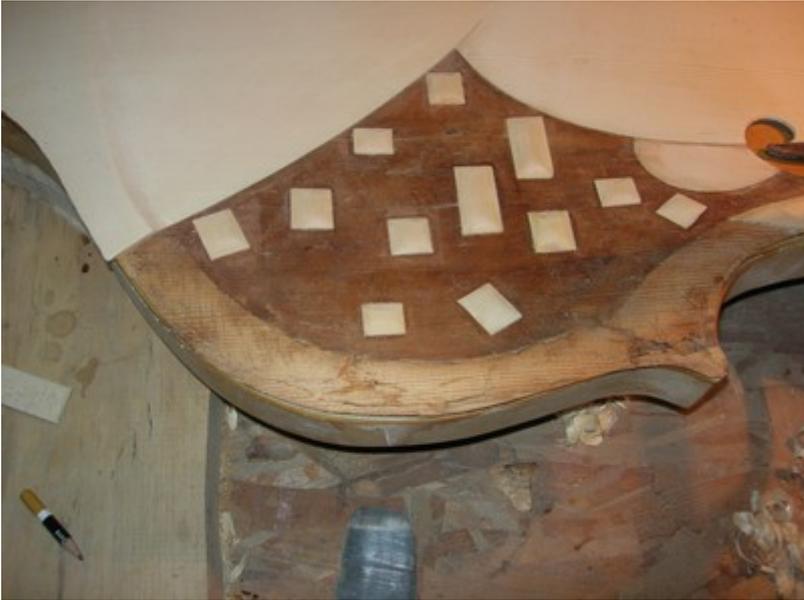
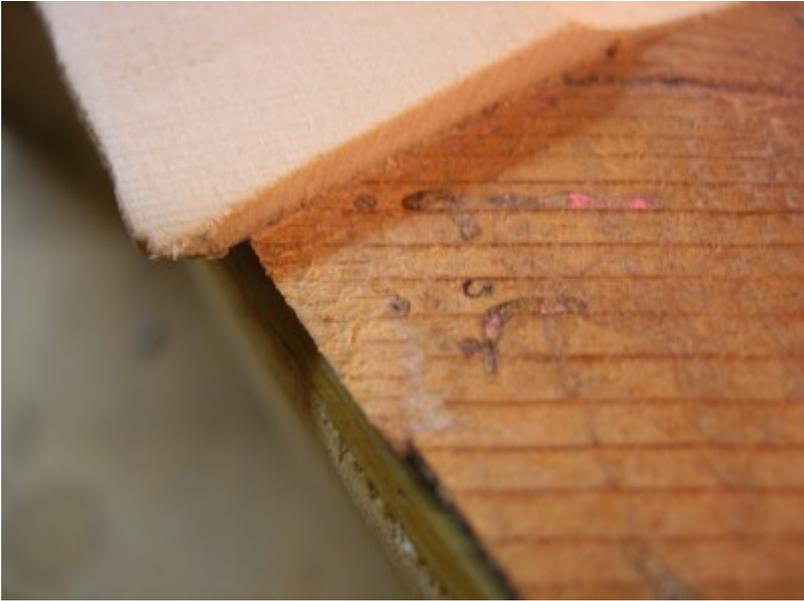
On the treble side, the shorter upper edge reconstruction is almost entirely covered by the doubling.

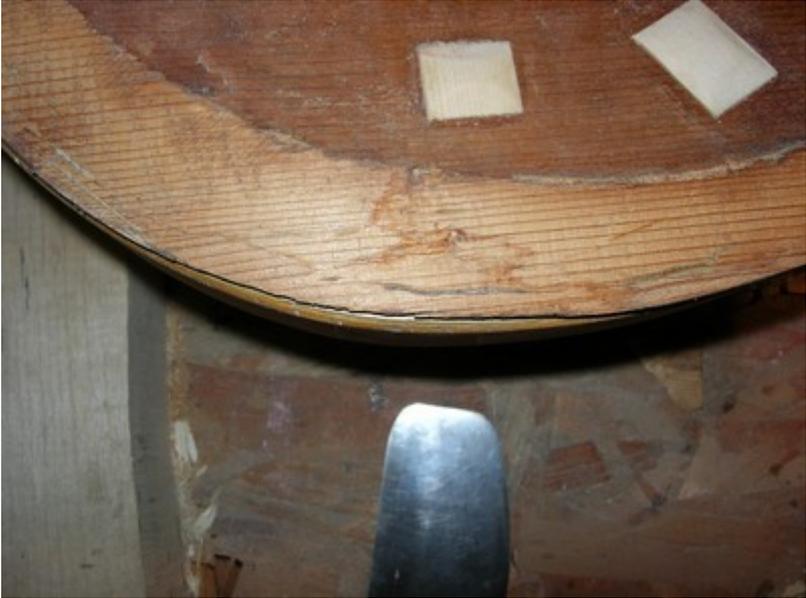
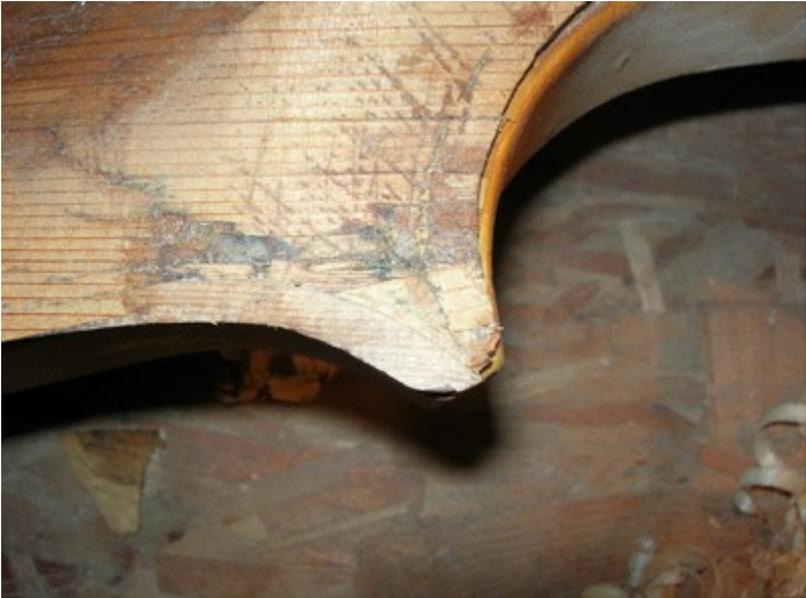
Then there is an edge reconstruction in the widest part of the bout, and the corner rebuilt in multiple pieces.
