Giuseppe Cazzaniga, Liutaio

Bernareggio, July 2009 - June 2012

Restoration of a Brescian style double bass

The instrument is property of Maestro Ezio Pederzani

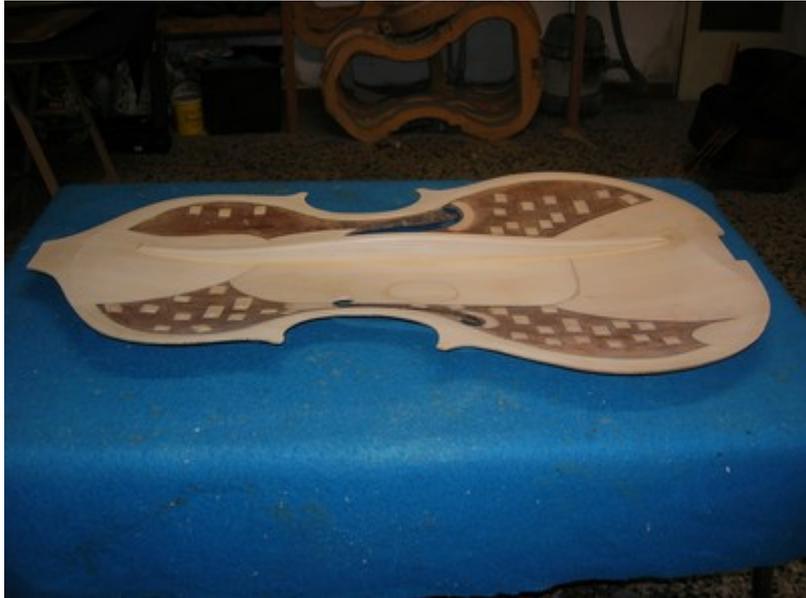
The bass bar is 21 millimetres thick and 840 millimetres long, while the height in the center is 42 millimetres. I consider that the bridge line is not far from the center of the top's length, and position the center of the bass bar on this line. So the upper tip is farther away from the edge than the lower one. However, the shape itself of the top makes it more rigid on the upper part than on the lower one. The inclination is set keeping in mind the different inclinations of the doubling's grain.

I make and glue the bass bar.
